Round Toll House, Pollokshaws, Glasgow

Re-slating works and other repairs

Historic Environment Scotland Refurbishment Case Study 24

The Round House, Pollokshaws, Glasgow

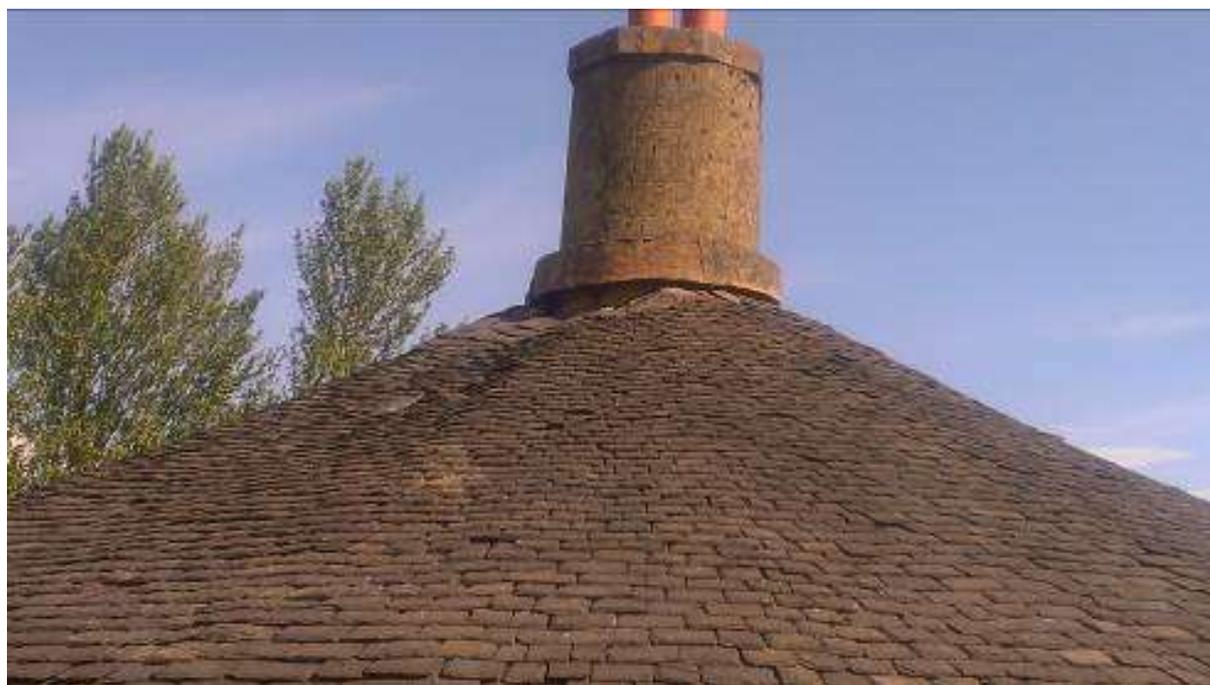
Prior to work commencing, a thorough survey of the building was undertaken to ascertain what repairs were required. It was found that the masonry was generally in good condition with only a small amount of repointing required. Defects were found with the rainwater goods and many areas of the rones and downpipes required repair. However, the most significant defects were found in the roof structure (Figure 2). It had been expected that some slate repair and small areas of re-slating would be required. However, following a survey of the roof it was found that significant amounts of water had penetrated as a result of damage to the roof covering (Figure 3), missing flashing where the roof met the central chimney stack, and also at wall head level where blocked gutters had led to water ingress. This damage had resulted in significant deterioration in sarking and roof timbers and it was clear that several rafters needed replacing.

Figure 2. Water ingress through the chimney and the skew junction had resulted in the rotting and settlement of rafters, seen here middle left.

As several rafters needed replacing, and much of the sarking was defective, the decision was taken to remove the roof covering and re-slate. Despite this deterioration of the roof structure, the slates themselves were generally in good condition with little sign of what is termed “nail sickness”. This occurs when the nails which hold slates in place have rusted away or when decay and softening of the top of the slate takes place around the nail hole. As the slates were sound it was also decided that they should be reused following careful removal and re-sizing. Scots slates are durable and long lasting and this should generally be the approach when re-slating a building. During any removal process and re-sizing there will invariably be losses, but they can be made up with salvaged slates. This is a more sustainable approach to re-slating work using Scottish slate, minimising waste and ensuring that a finite resource remains available for as long as possible.

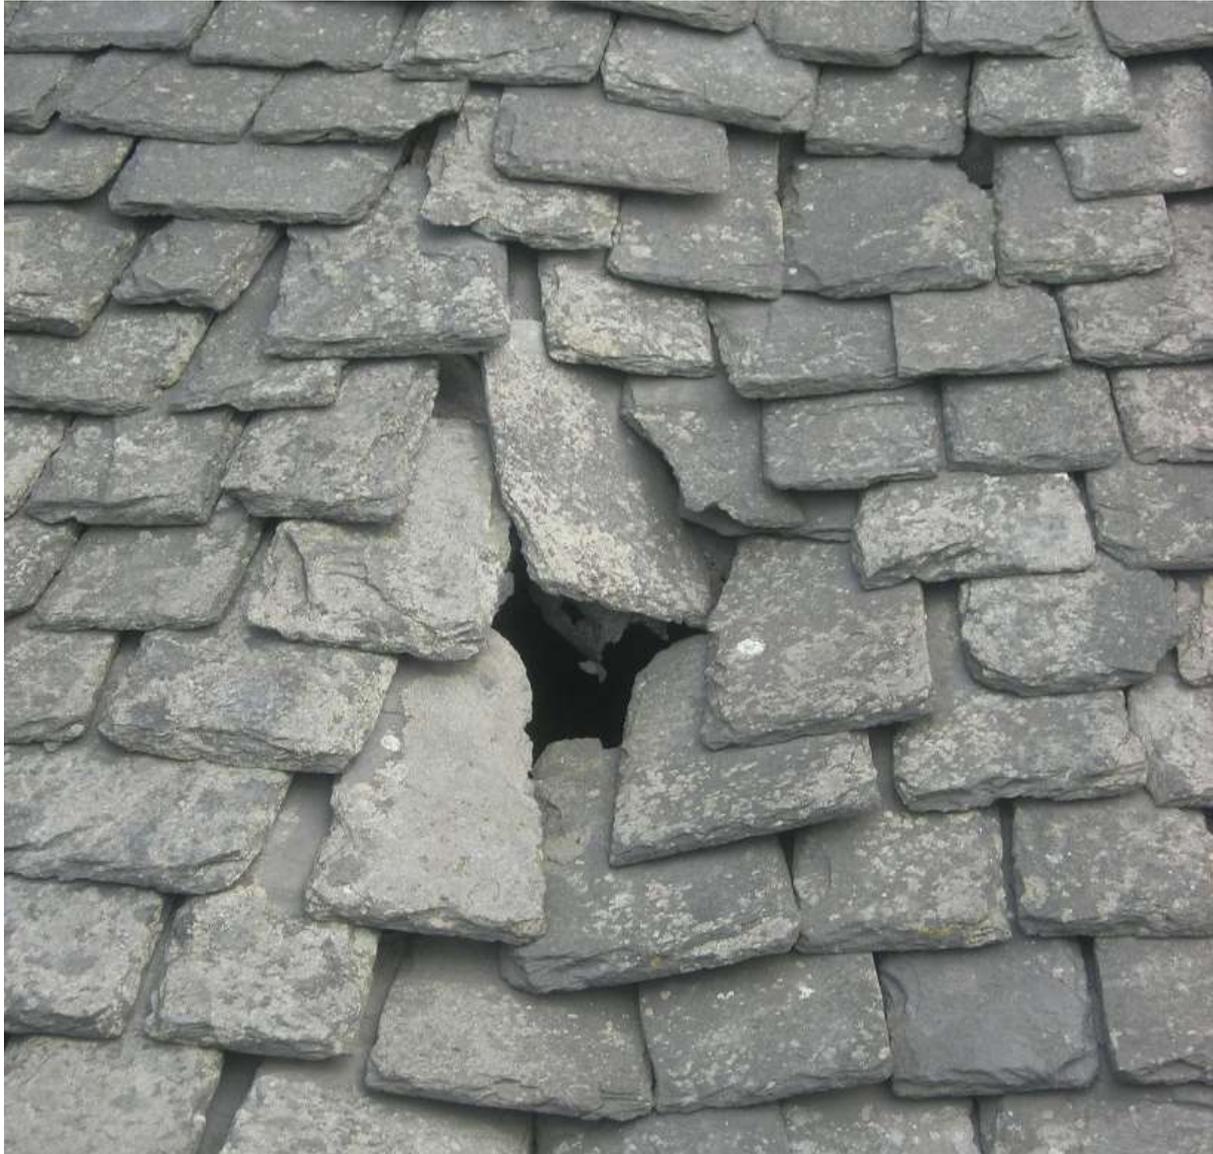
Figure 3. Missing slates and damaged sarking were some of the defects identified.

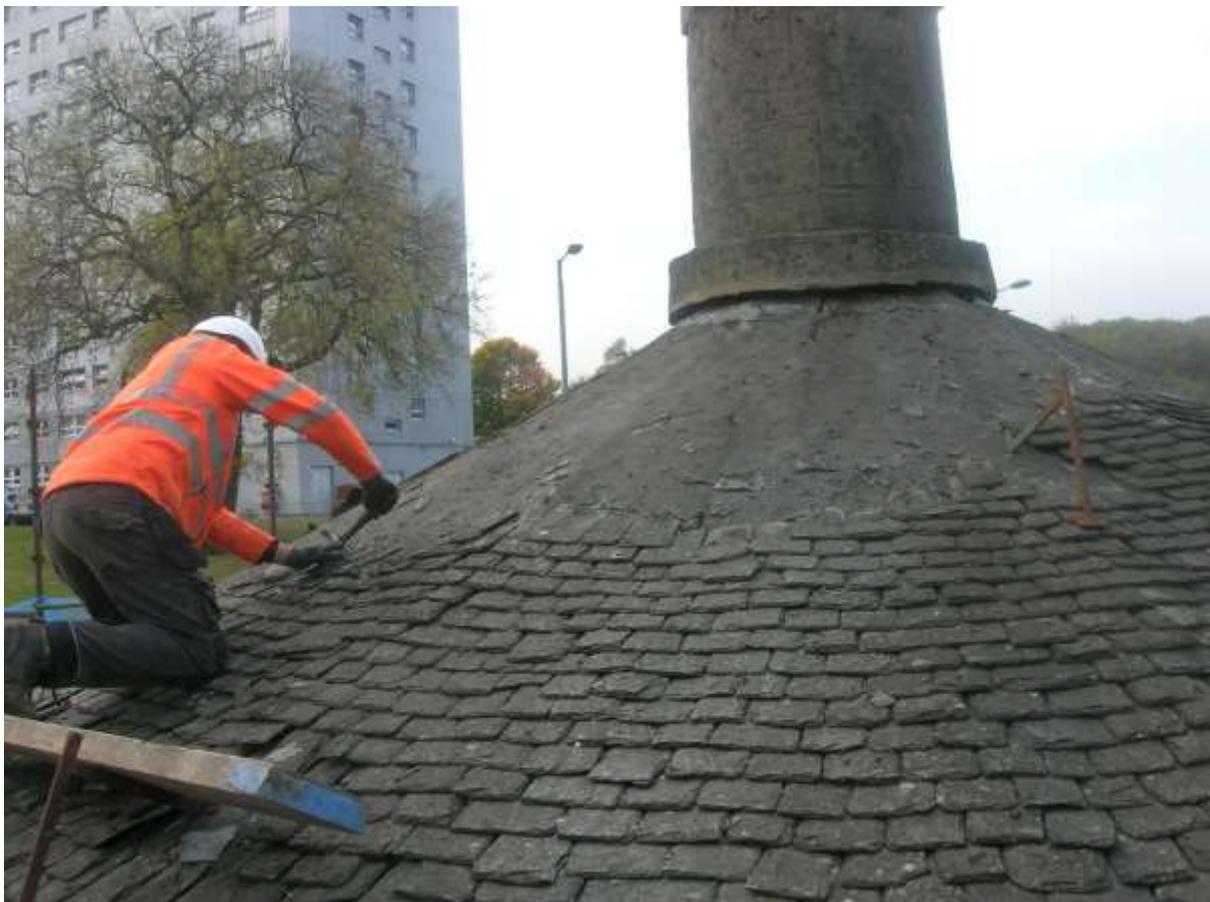
Figure 4. The removal of slates at the Round Toll was undertaken with care in order to maximise the amount of slate which could be re-used.

As the slates were in good condition they were removed with care so they could be re-used. Rather than using a slate ripper to free the slates from the sarking board each slate was removed by hand using the claw of a hammer to ease nails free where required (Figure 4). This resulted in a large proportion of slates being salvaged for re-use. Re-use should be attempted wherever possible and appropriate to do so, due to finite stocks and the discontinuation of Scottish slate quarrying and production. Following removal from the roof, the slates were re-dressed where required and gauged for size (Figures 5 & 6). They were then set out by size on the scaffold to allow re-laying following traditional Scottish practice, in diminishing courses (Figure 7).

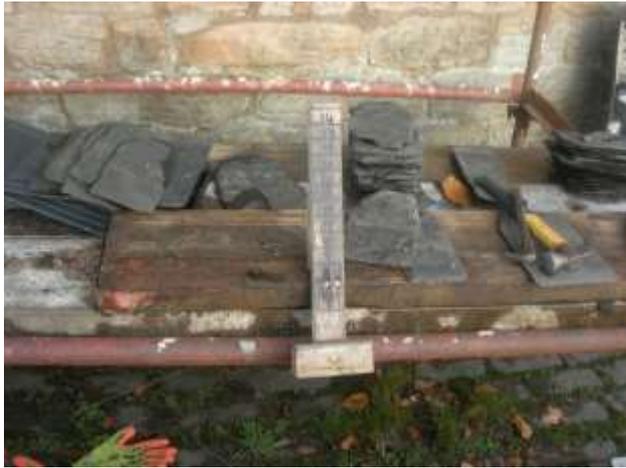
Figure 5. A simple gauge was used to sort slates which had been removed from the roof into sizes for use in re-slating.

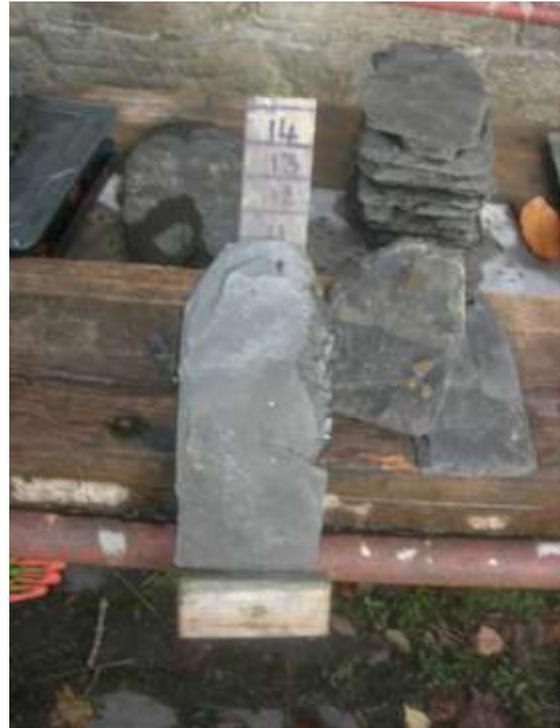
Figure 6. Using the slate gauge to grade slates for size prior to re-use.

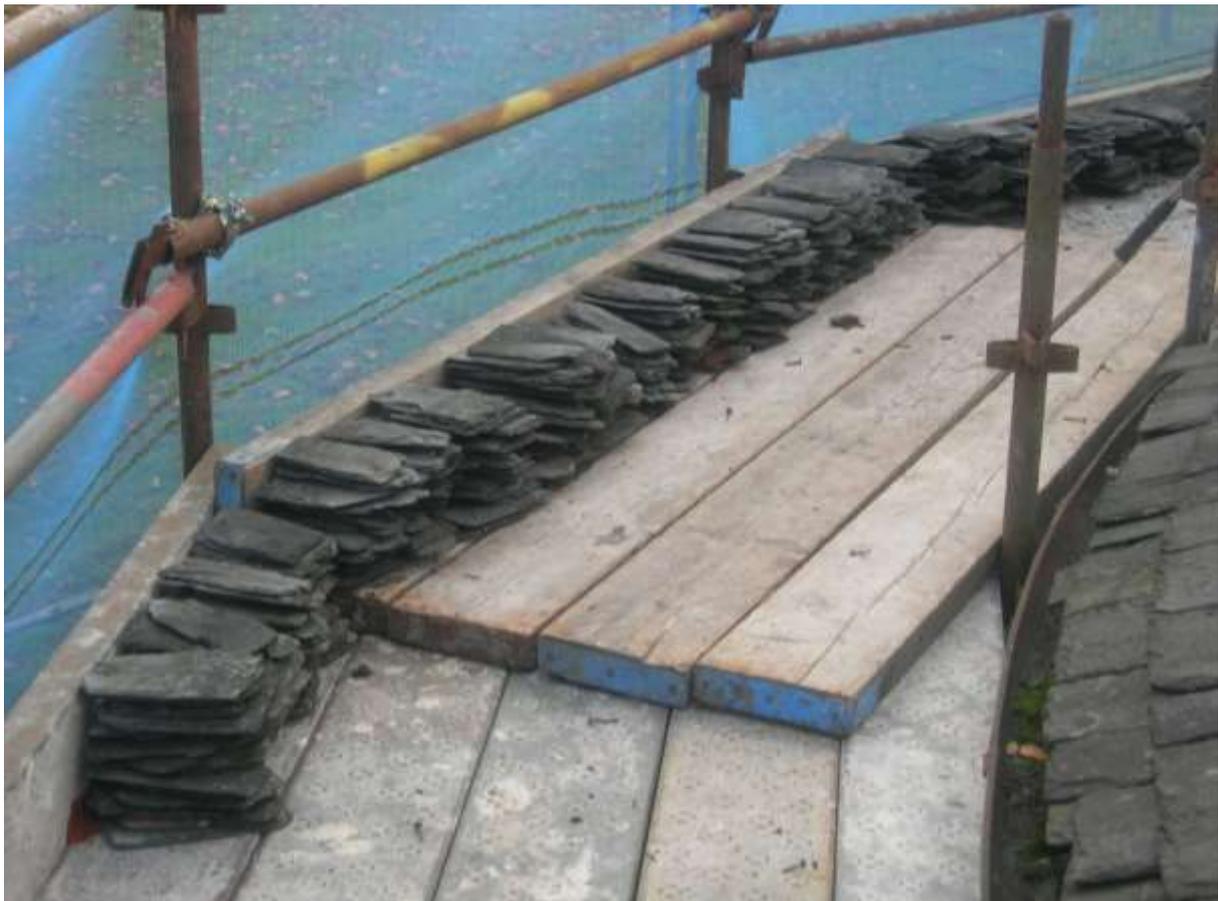
Figure 7. The sized slates laid out on the scaffold ready for re-laying.

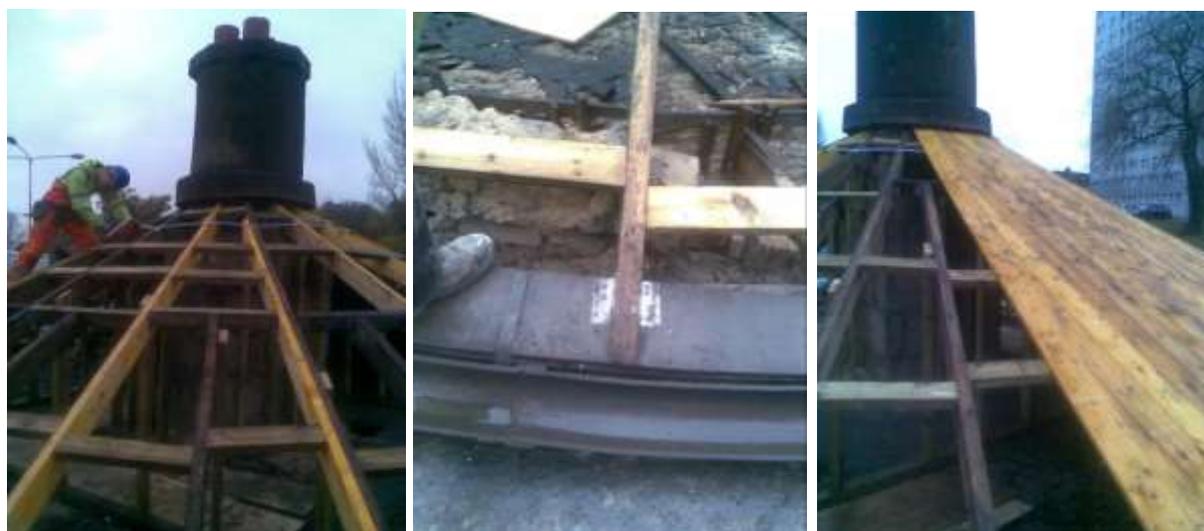
Following the removal of slates from the roof there was found to be decay in several areas of sarking board and on supporting roof structure beneath. A number of rafters were found to have decayed where they met the timber at the wall head. This required the replacement of entire rafters in some cases. In others only partial replacement was required (Figure 8). A large number of the structural timbers were found to be in sound condition, however, and where this was the case these were left in situ. The timber support structure of the roof was strengthened by the insertion of lateral timber braces between rafters (Figure 9). Where sarking boards required to be replaced these were laid according to traditional Scottish practice with a “penny gap” between each board. This aids ventilation and also allows for expansion and contraction in the sarking timbers. Standard practice on pitched roofs would see the sarking timbers laid horizontally between the ridge and the eaves. However, due to the conical shape of this roof, these were laid vertically and angularly cut with increasing width towards the eaves to account for this shape (Figure 10).

Figure 8. Repairing roof timbers; original rafters were retained where in good condition with a number of complete and partial replacements used. Additional lateral bracing was also introduced.

Figure 9. Where rafters met the wall head additional fixings were used to add strength.

Figure 10. New sarking boards were laid onto the repaired roof structure ahead of re-slating work commencing.

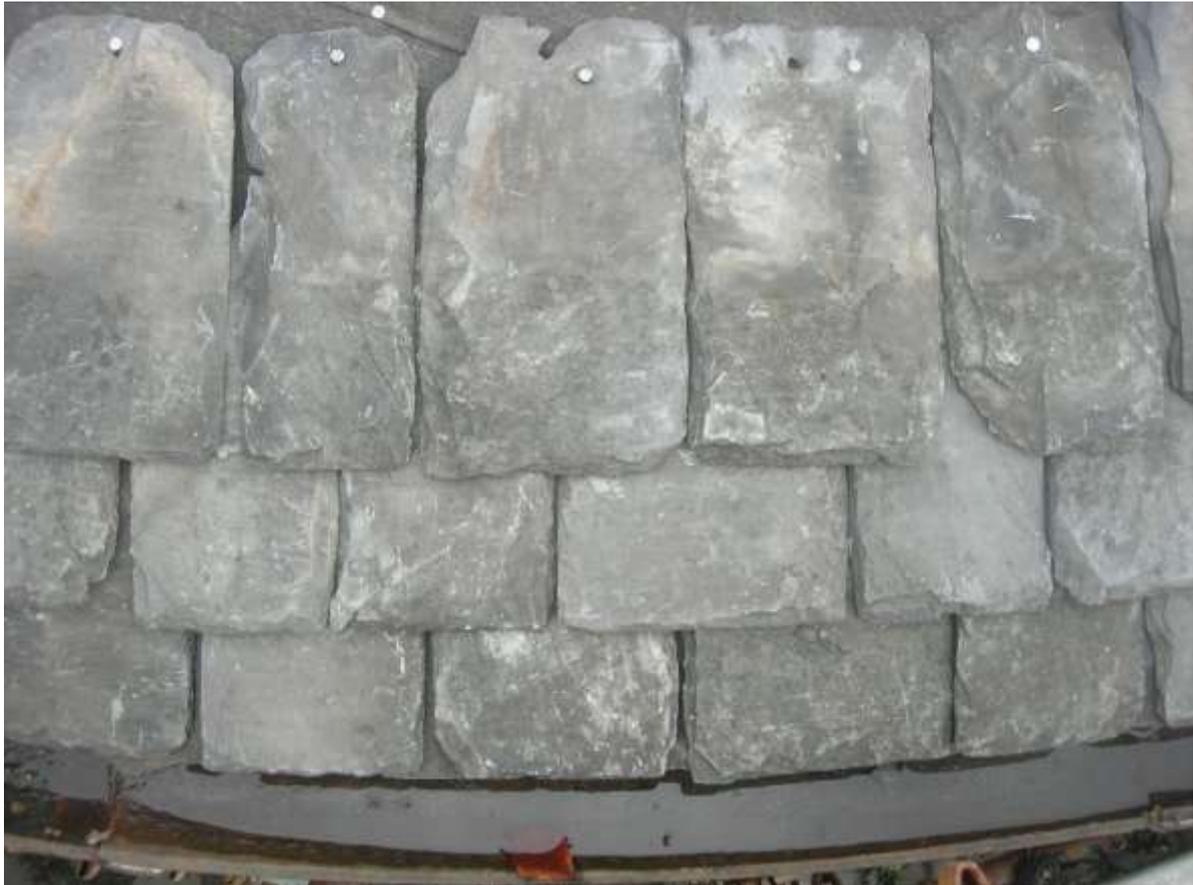
Figure 11. The first three courses of slate re-laid at the Round Toll using the largest slates at the eaves course, using a single nail at the head, as is traditional practice.

The traditional Scottish practice of laying slates in diminishing courses was followed at the Round Toll. As the size of slate produced by Scottish quarries was mostly of random widths and lengths, laying in diminishing courses ensured the most efficient use of the slate produced by the quarries. This means that the largest slates are laid in the courses nearest the wall head (Figure 11) with the smaller slates laid nearer

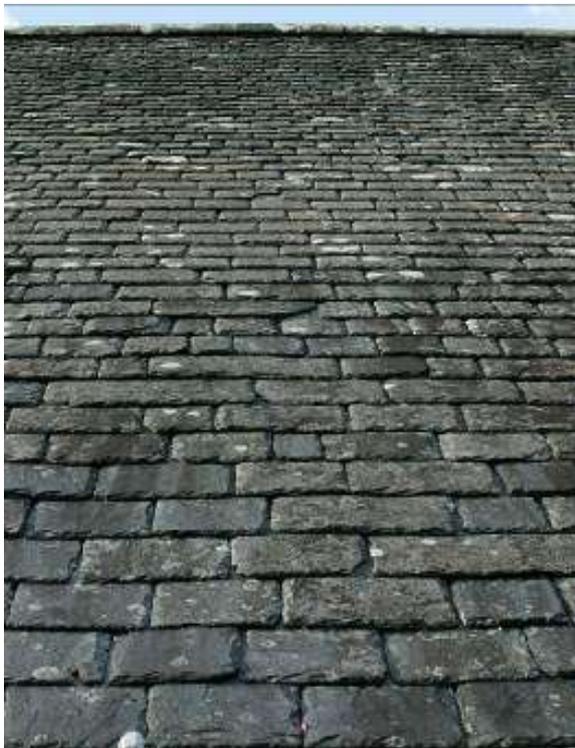
Figure 12. This example of traditional Scottish slating practice, of random widths of slate laid in diminishing courses, was followed during the re-laying of the slate roof at the Round Toll.

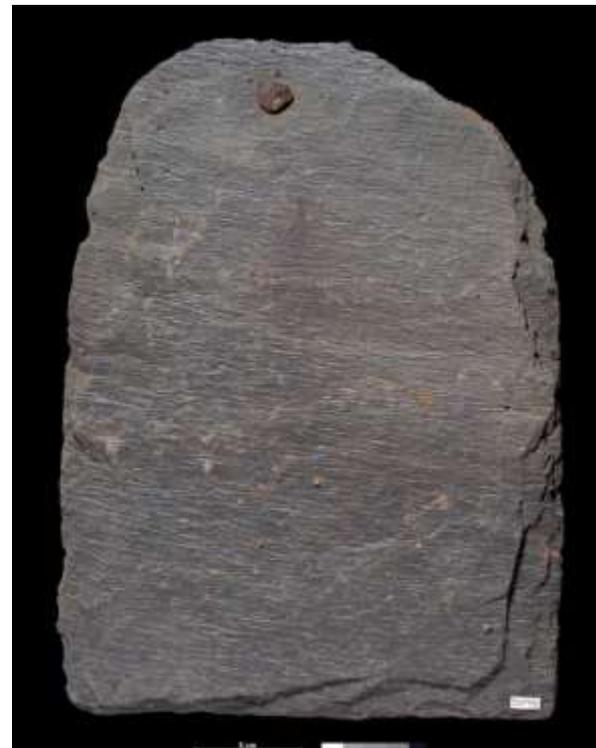
Figure 13: A Scots slate, squared and shouldered with a single nail hole (copyright BGS / NERC licensor www.scran.ac.uk).
