## 11 Annat Road, Perthshire

Thermal improvements to an interwar period cottage.

This publication should be quoted as:  
Historic Scotland Refurbishment Case Study 20

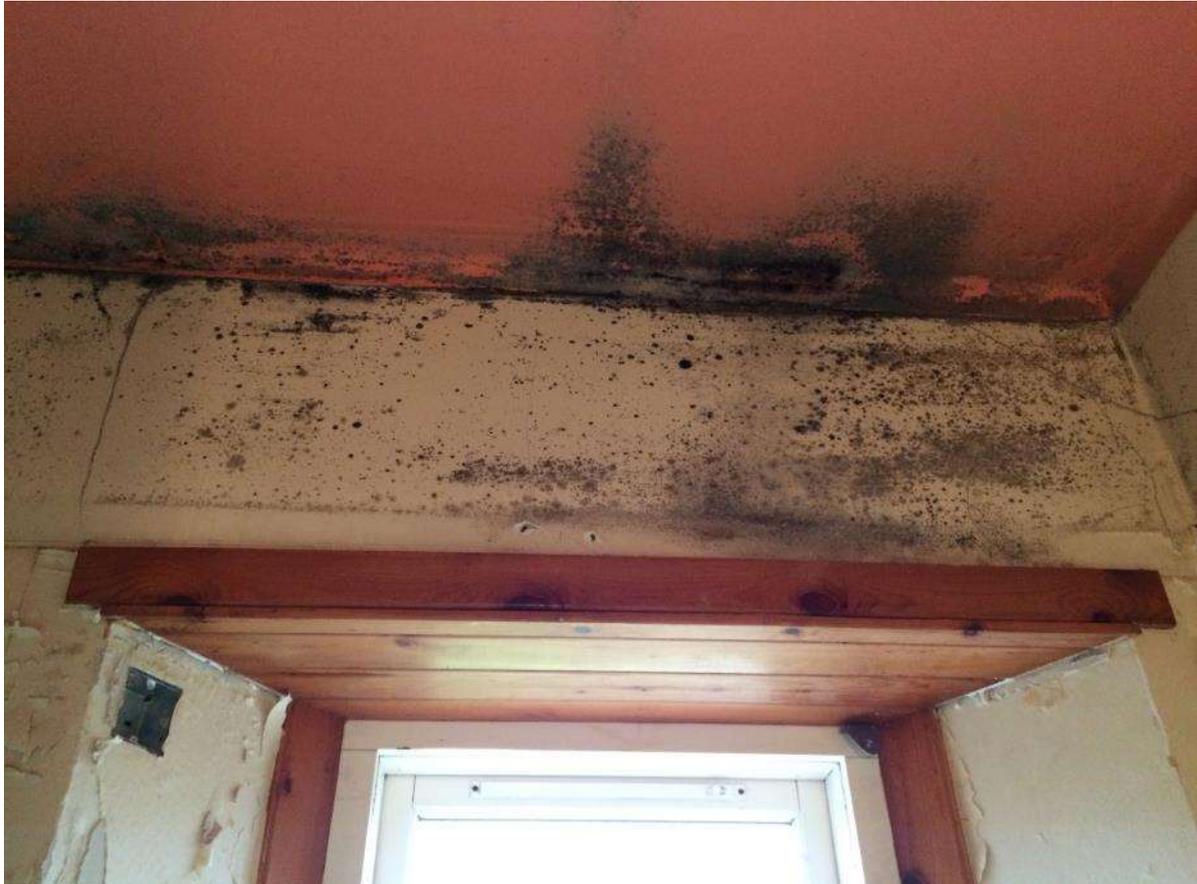
the bathroom were removed. It was of note that on the external wall of the bathroom, exposed by the removal of the modern ceiling, there was an extensive area of mould (Fig. 4). While lowered ceilings are a common feature of some recent work they are not normally an appropriate intervention in traditional buildings, and especially in areas of high vapour loading they can mask changes in building fabric, as well as limiting cleaning.

Figure 4: *Mould uncovered in the bathroom following the removal of the lowered ceiling*

Investigation of the bathroom ceiling had shown considerable areas of mould growth; improved ventilation would be required and the lowered ceiling would be removed. As with many properties, occasional condensation in the bathroom is common, but on occasion there had been excessive amounts in this and other properties. While poor ventilation will contribute to high internal relative humidity, the surface temperature of building elements is also important. To assist in managing condensation in this space a radiant panel heater was fitted above the wash hand basin (Fig. 8). In this small room the arc of radiated heat easily covered the window reveals, the end wall and the wall on which part of the shower is located. By keeping these surfaces at a higher temperature water vapour is not able to condense.

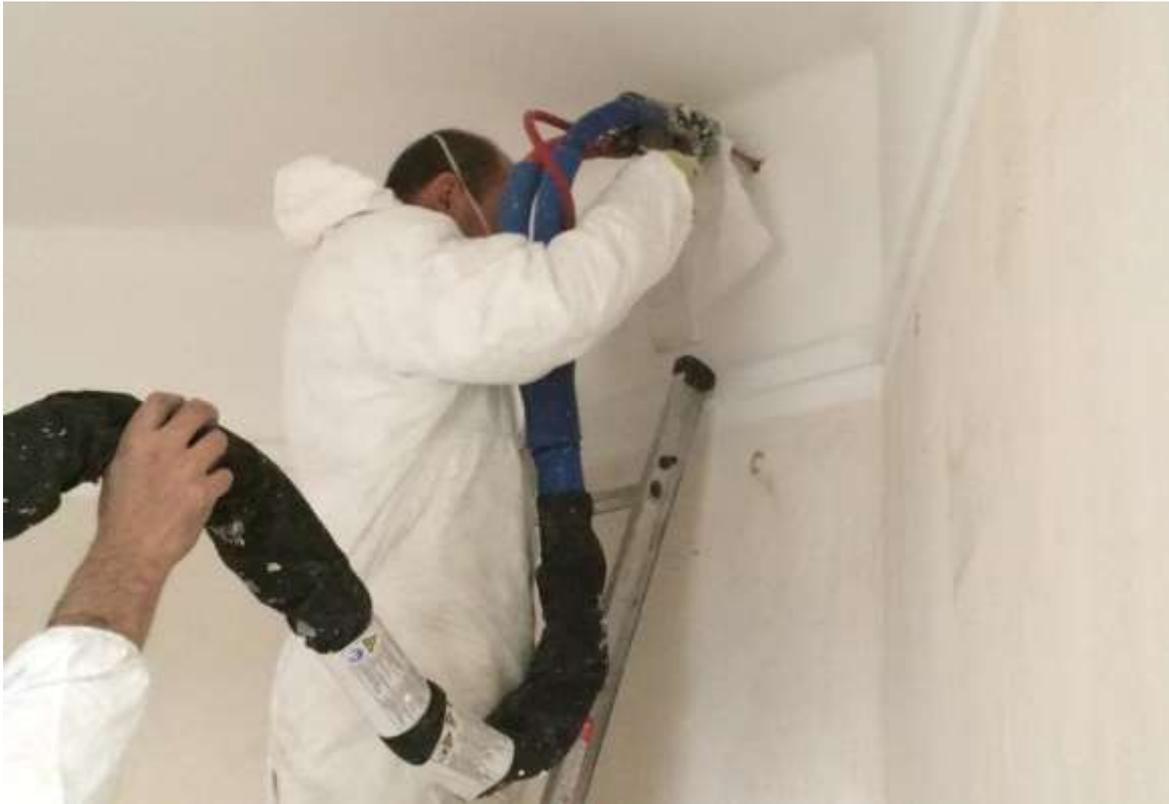
Figure 5: *Installing the foam insulation*

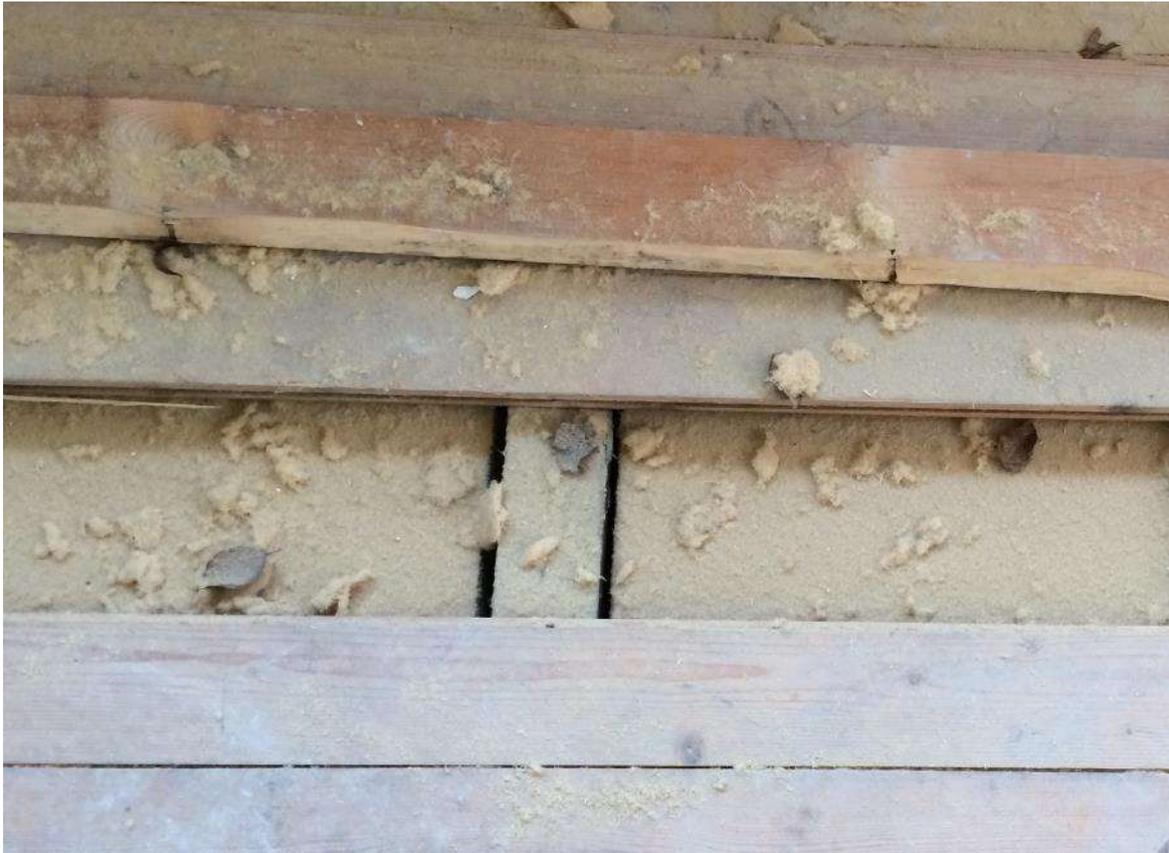
Figure 6: *Wood fibre board insulation installed between the floor joists*

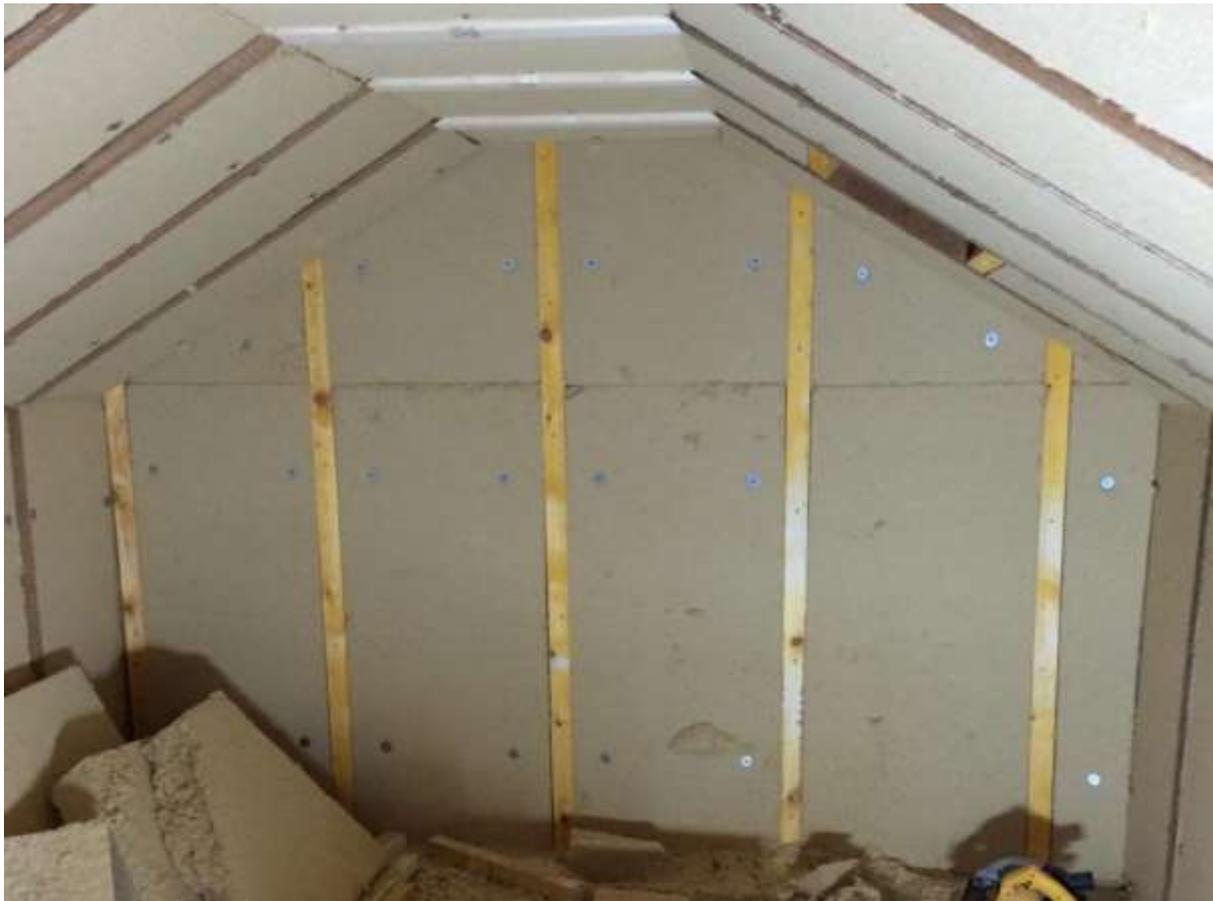
Figure 7: *The wood fibre board insulation installed in the roof space*

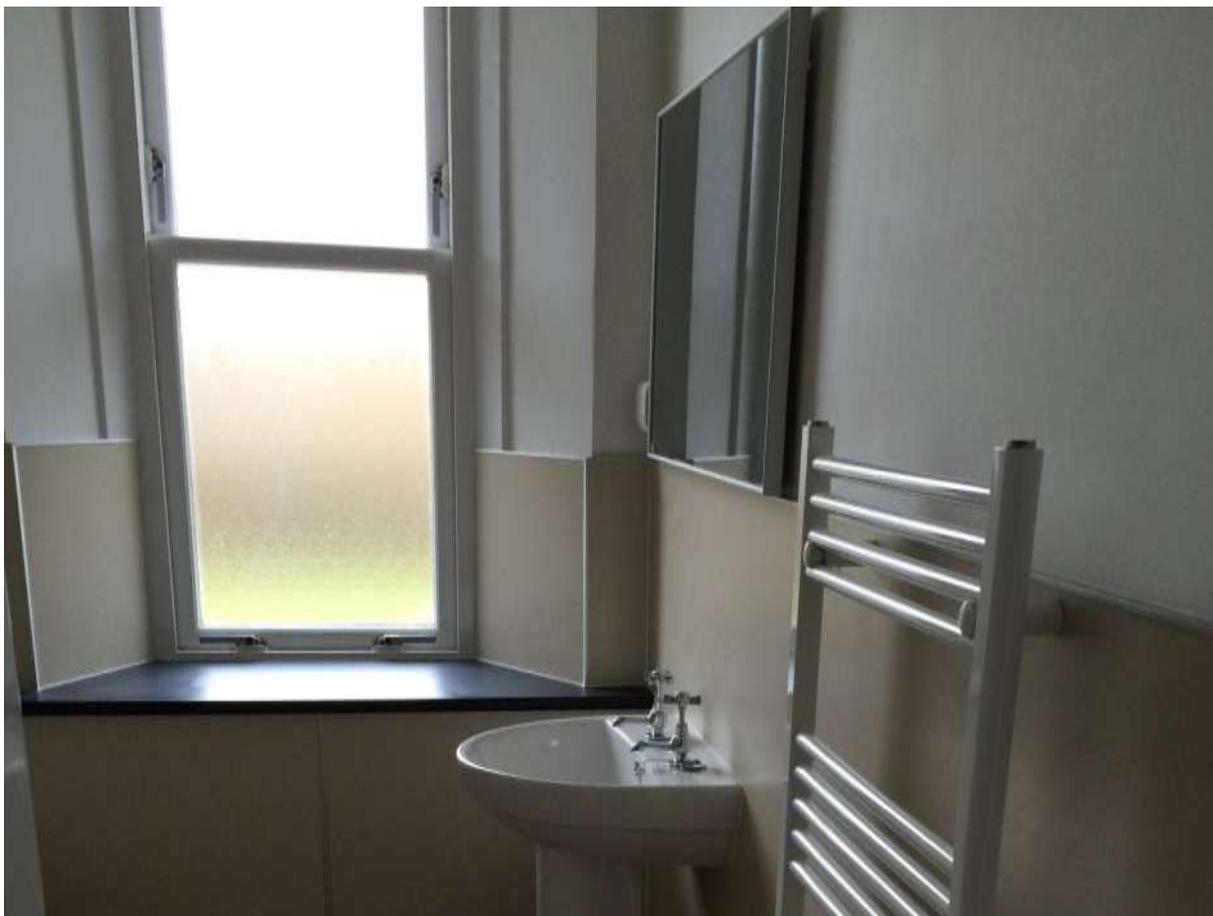
Figure 8: *The mirrored radiant panel in the bathroom*

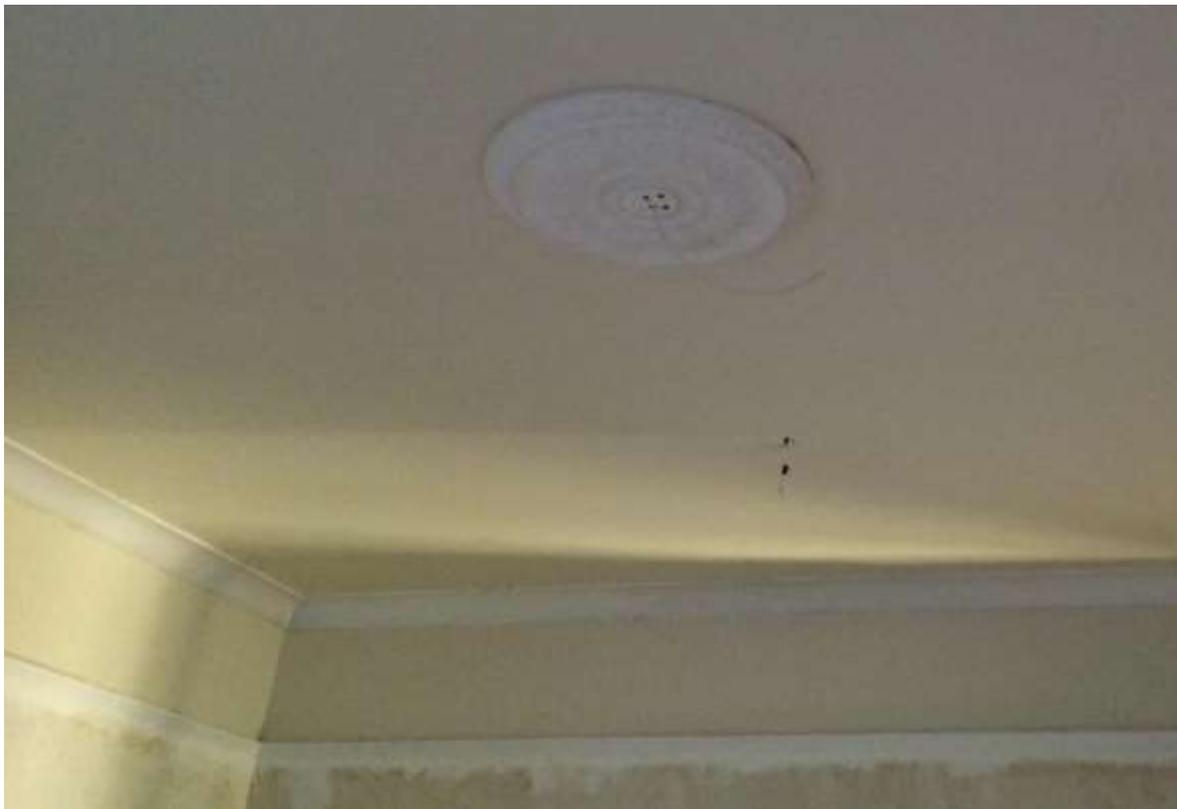
Figure 9: *Areas of completed clay paint*

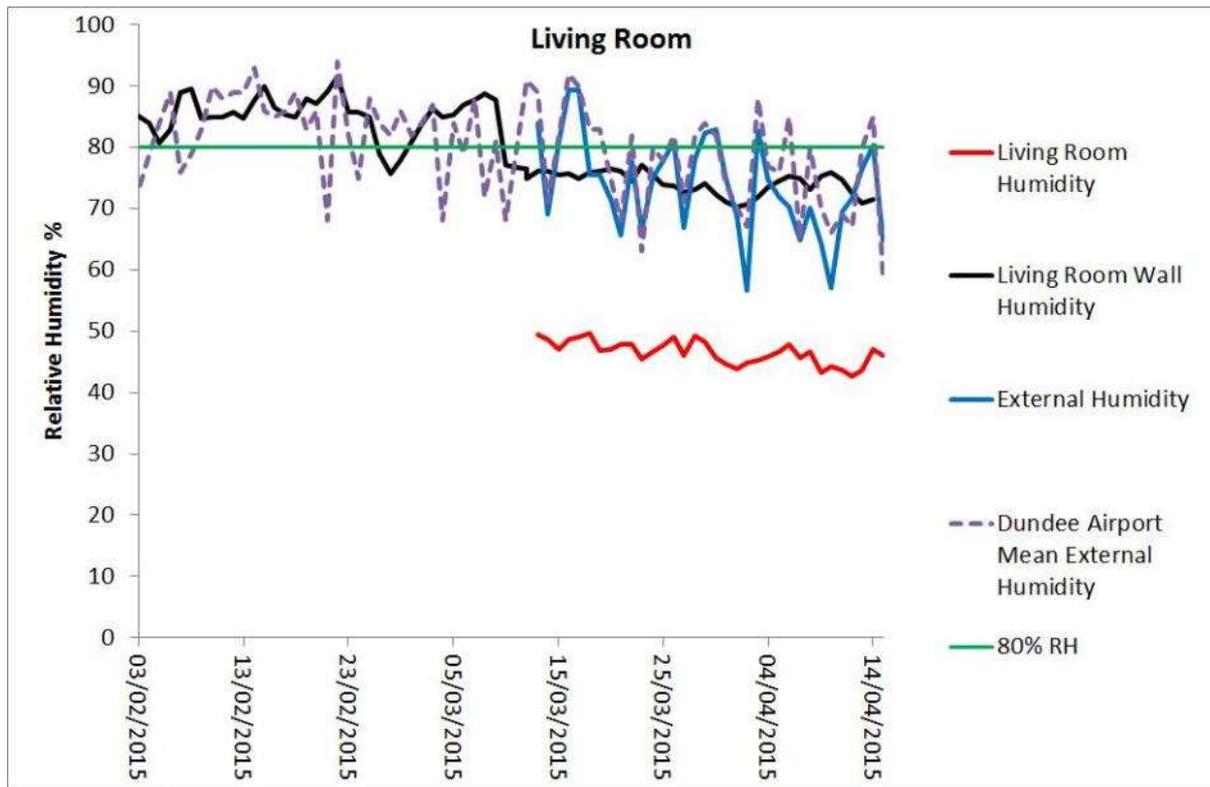
The humidity in the filled cavity behind the lath and plaster was also monitored by the use of temperature and relative humidity probes behind the existing plaster lining. This would allow assessment of how quickly the foam insulation was drying out, and that the wall, once dry, remained so during future weather and calendar cycles. Whilst the measuring period was quite short the trend was downwards in the living room (Fig. 11) and bedroom 1. This will be confirmed by longer term monitoring in this and other properties on the same estate.

Figure 11: *The relative humidity within the living room wall after the works*

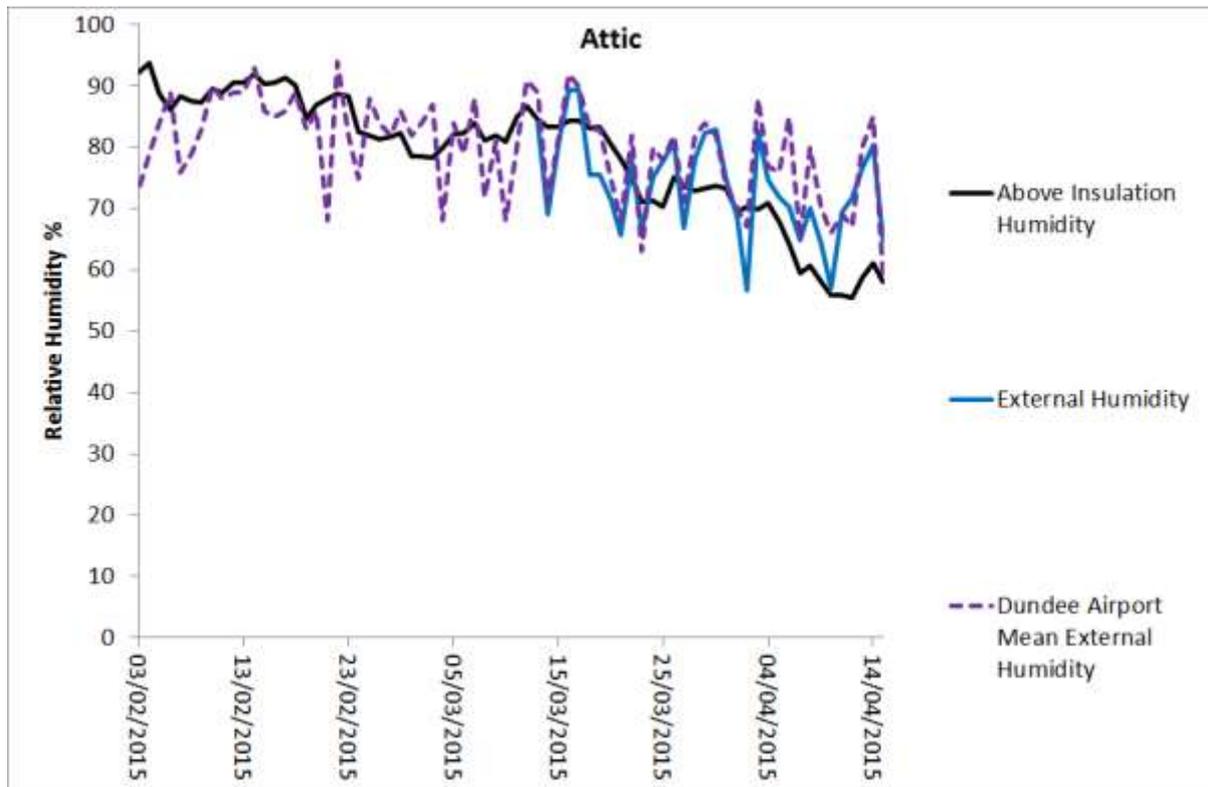
The roof space insulation was also monitored; across the wood fibre board, the air gap and through the sarking and the roof material gave a total U-value of  $0.13 \text{ W/m}^2 \text{ K}$ . In contrast to the walls, relative humidity remained high in the roof space in the winter months, and only reduced later in the Spring of 2015 (Fig. 12). This increase in relative humidity is consistent with the lower roof temperatures resulting from the insulation works. The situation improved as roof temperatures rose in the Spring. Regardless of the recent refurbishment work, these high relative humidity levels echo conditions experienced in other similar properties with partial refurbishments carried out by the Trust in recent years, and issues of defective slates cannot be entirely dismissed. A review of roof space air management will be progressed by the Trust over the next year.

Figure 12: *The relative humidity within the roof space following insulation work*
