## Trial Church Heating: Radiant Panels and Air Source Heat Pump at Kilmelford Church

This publication should be quoted as:  
Historic Environment Scotland  
Refurbishment Case Study 19

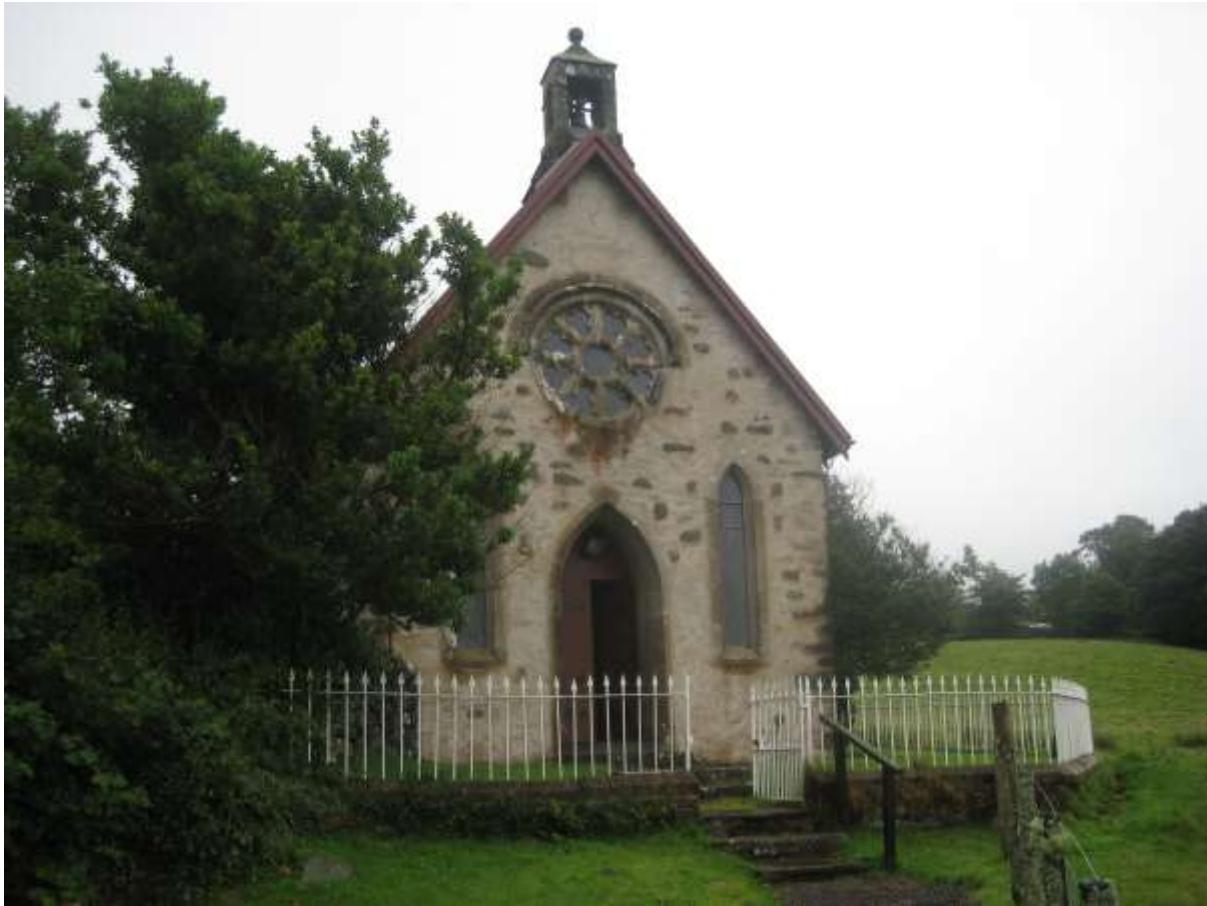
Fig. 1: *Kilmelford Church viewed from the West; the lime mortar repairs to this elevation were an important first stage in the building upgrade*

Water ingress to the west gable had progressively become worse since the 1970s. Various repairs had been attempted, with extensive use of cement that occasionally gave temporary respite, but ultimately resulted in progressive saturation of the masonry and wall core. This gable, and other areas of the walls were re-pointed in a lime mortar in 2009 (Fig. 2), and works to the roof and some stone repairs resulted in an improvement to the internal conditions as the walls dried out. Although the

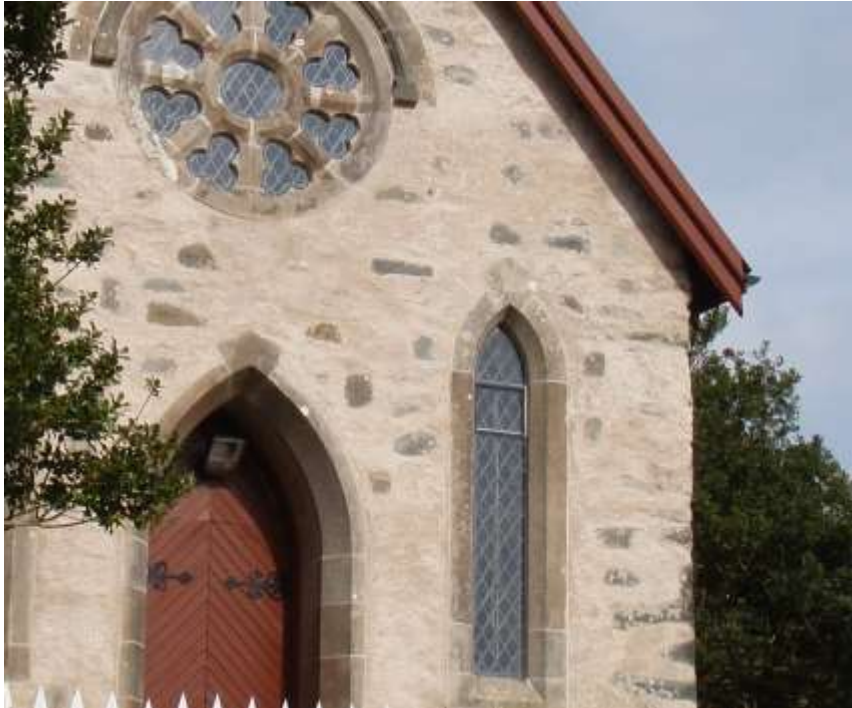
Fig. 2: Detail of the lime pointing on the west gable; this resulted in much drier masonry

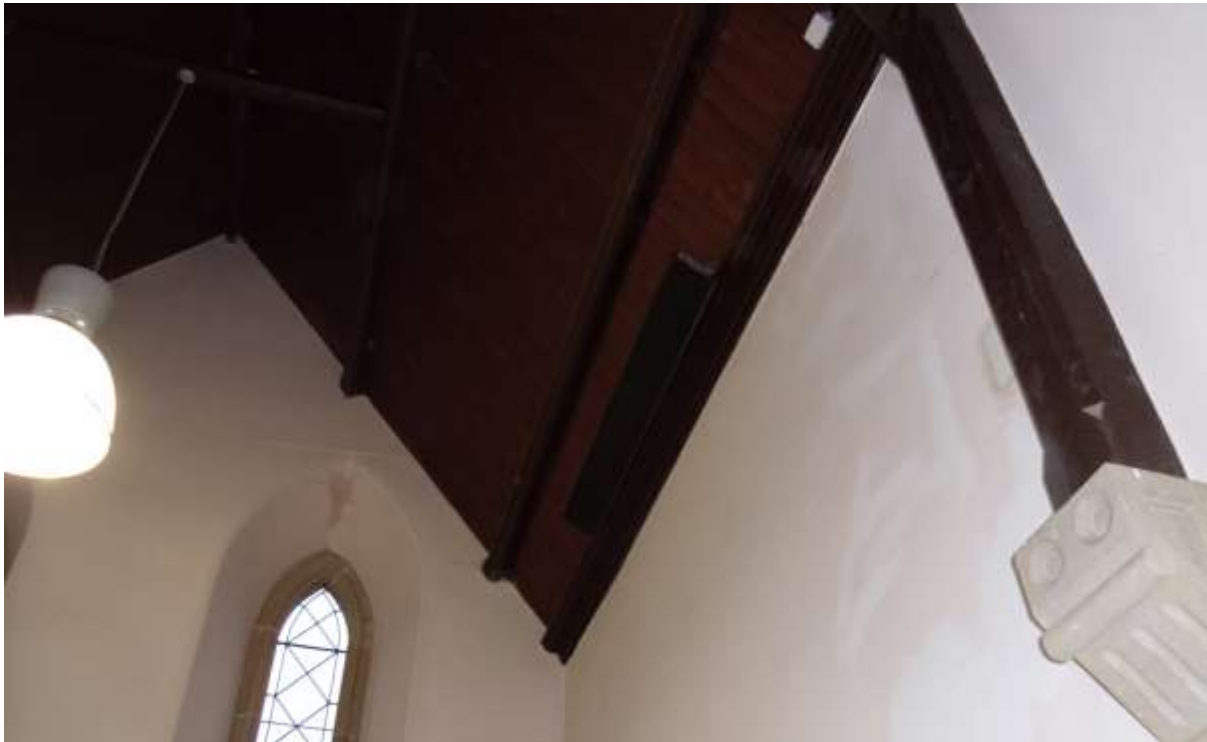
The selected radiant sources were two wallhead level panels mounted on the timber at the base of the roof (Fig. 4), radiant panels mounted on the back of the front ten pews (Fig. 5), and radiant panels mounted on the underside of the mezzanine layer (Fig. 6). The heated cushions on the pews were not selected as worshippers simply became too hot, and the low level wall mounted radiant heater in the chancel was judged to be ineffective. The radiant heating panels were designed and supplied by

Fig. 4: *The radiant panels visible middle right, just above wallhead level*

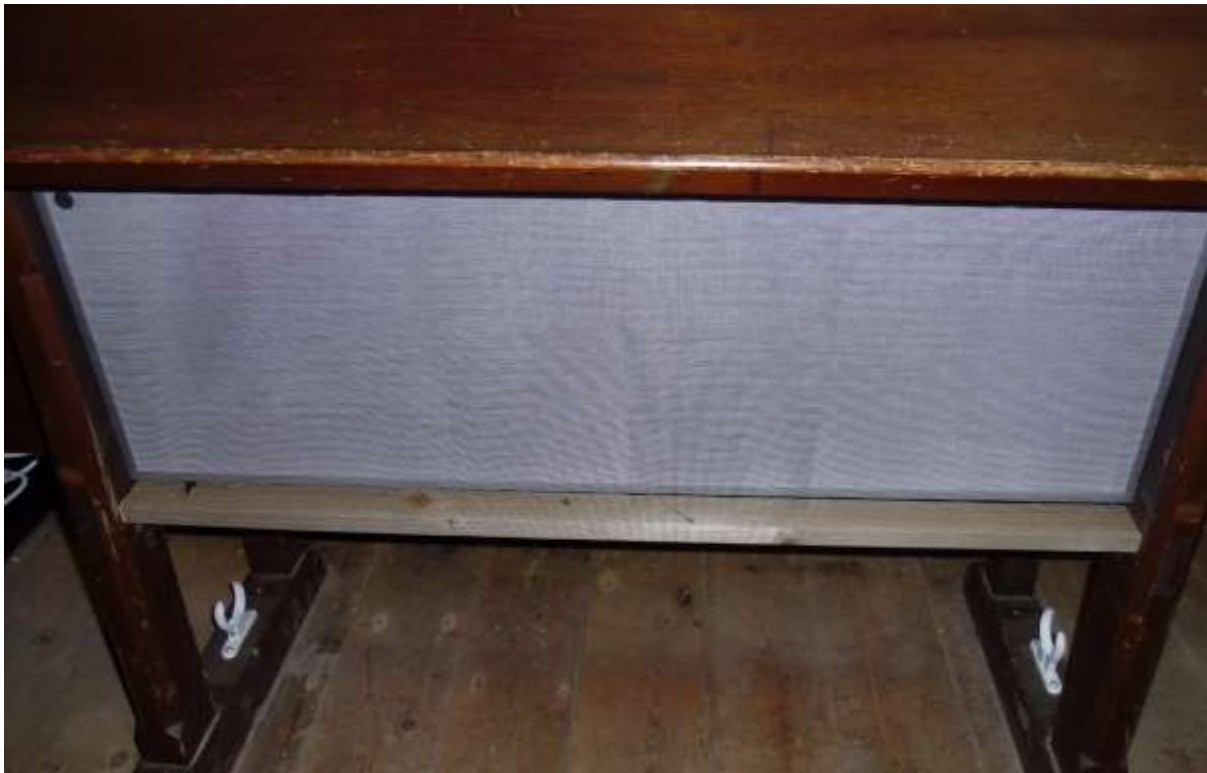
Fig. 5: *The new pew backed radiant panels*

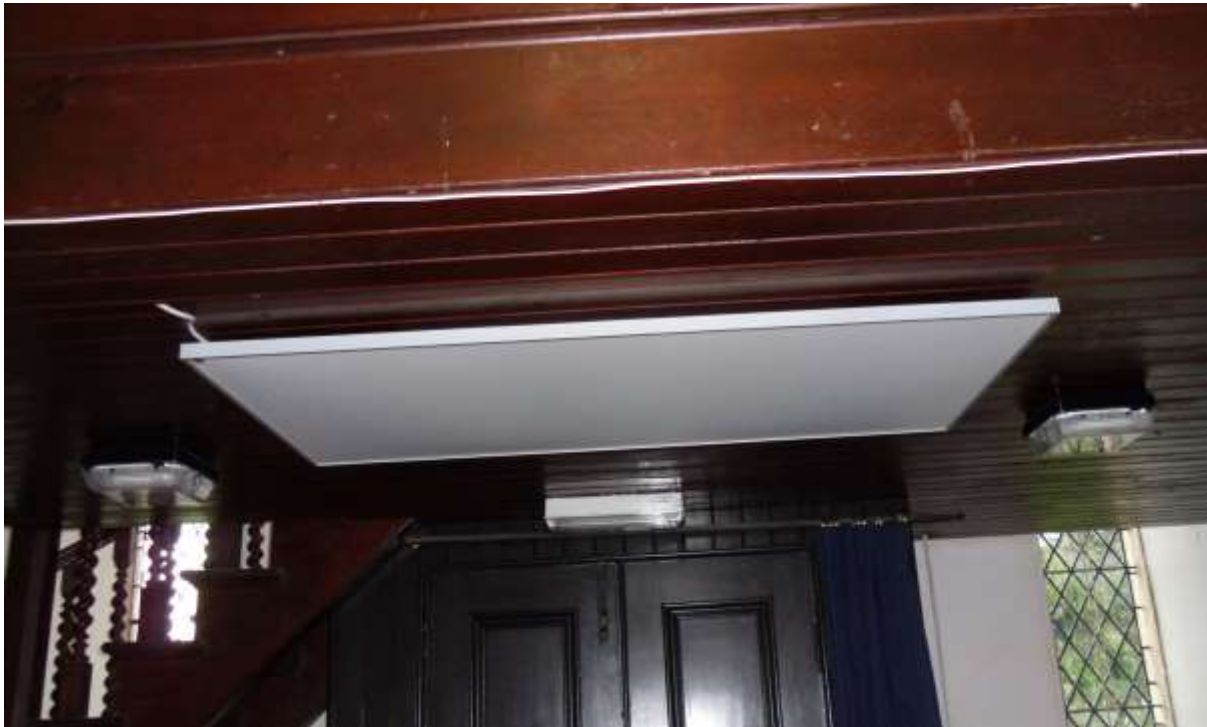
Fig. 6: *The radiant panels underneath the mezzanine layer*

The improvement in the average temperature in the church was obvious and most parishioners were pleased with the results of the trial. The panels mounted on the underside of the mezzanine floor proved to be very effective in conveying a sense of welcome to the property, experienced immediately on entering through the front door.

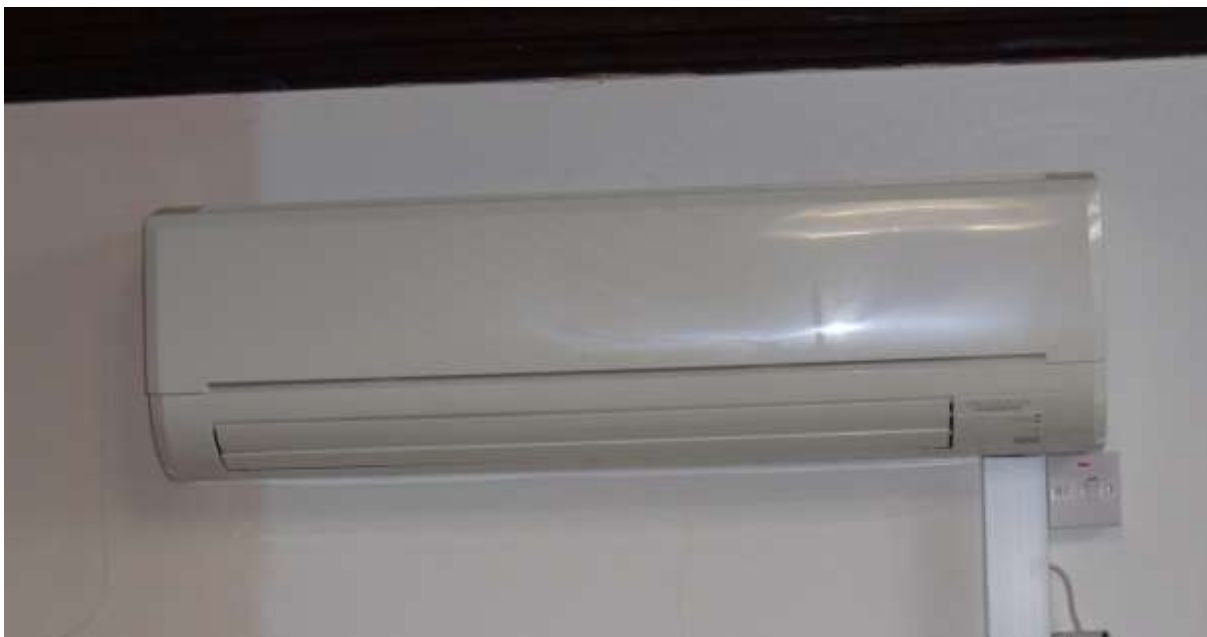
An Oban based electrical contractor with the supplier of the heaters to ensure that the church had a local contact. The siting of the ASHP indoor fan unit was discussed, and a compromise was reached. It was placed at the top of the stairs, with the aim of providing a good air recirculation path up the small spiral staircase (Fig. 7). The pipes and cables were routed under the floor of the mezzanine layer.

Fig. 7: *The fan unit fitted above the mezzanine stairs*

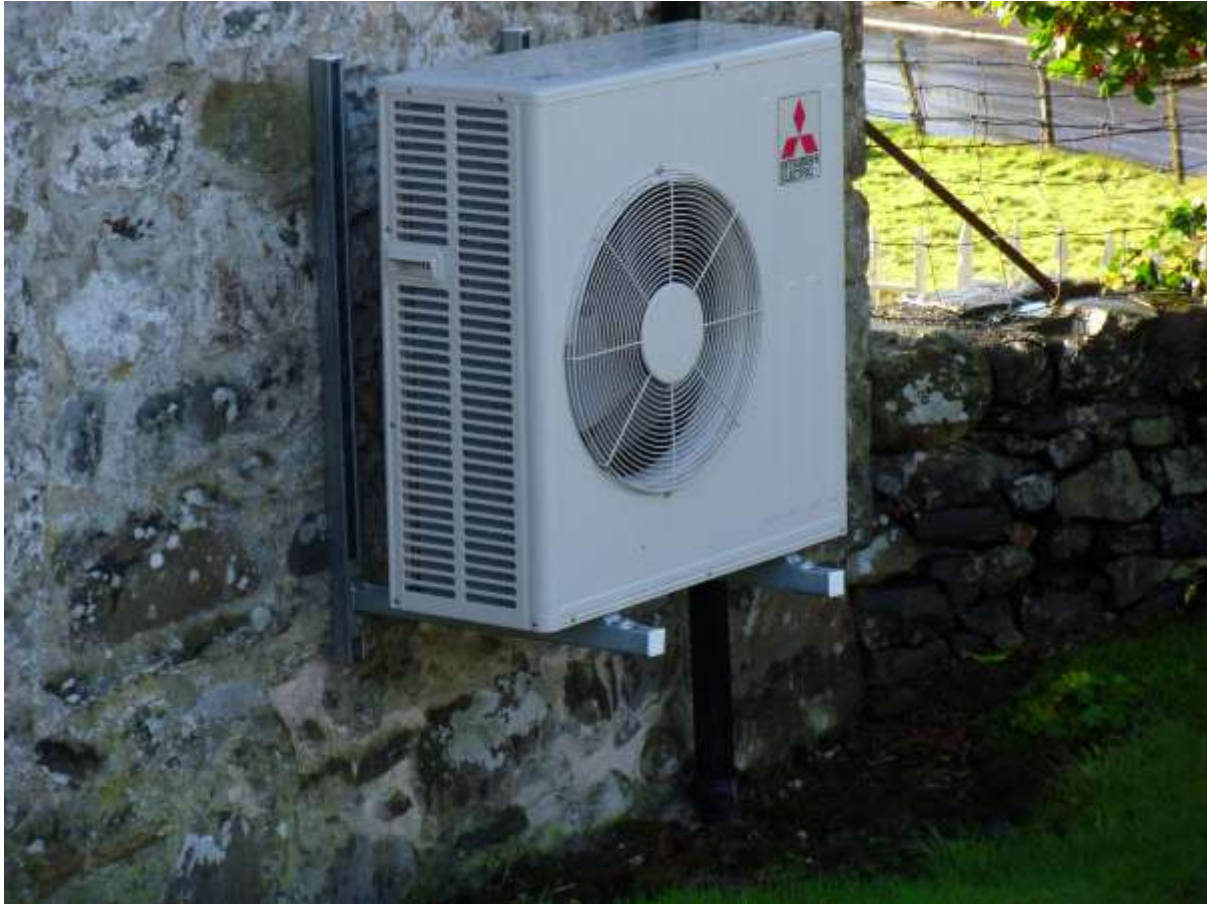
The external unit was located on the NW corner of the church where it was felt to be the least visible place (Fig. 8). The installation, testing and commissioning of all the devices was completed early in September 2014.

Fig. 8: *The external fan unit of the ASHP on the NW corner of the church*

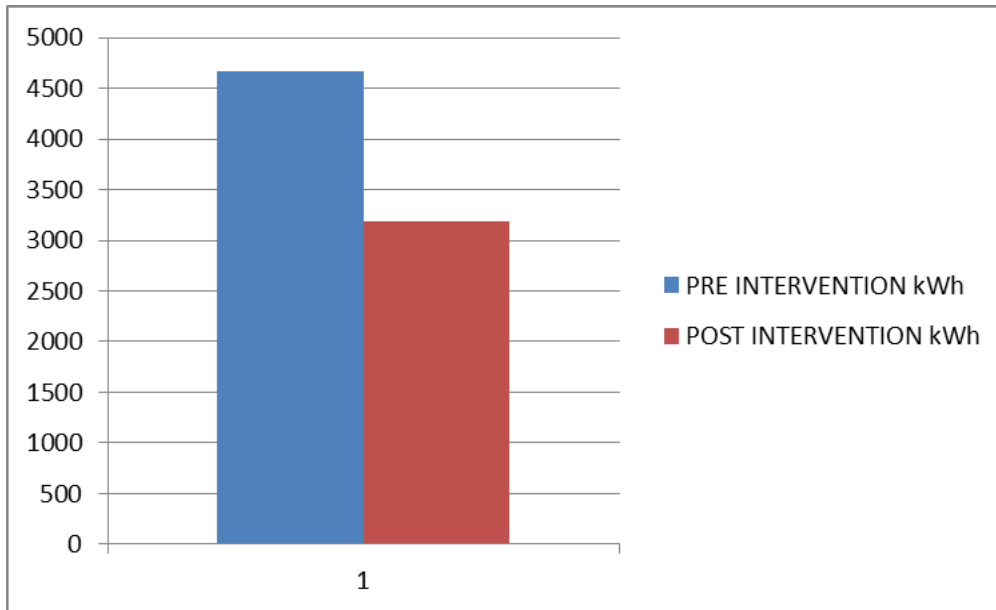
Fig. 9: Graph showing the pre- and post-intervention energy consumption

Figure 9 shows that following the intervention, the energy usage of the church has reduced. In the four years before the intervention, energy usage was on average 4674.25 kWh per year, and in the year following the intervention, energy usage was 3185 kWh per year. While more data is required for accurate assessment, initial indications are that the new heating regime has resulted in a saving of approximately £250 per year, whilst also delivering improved thermal comfort and heating to the building fabric.

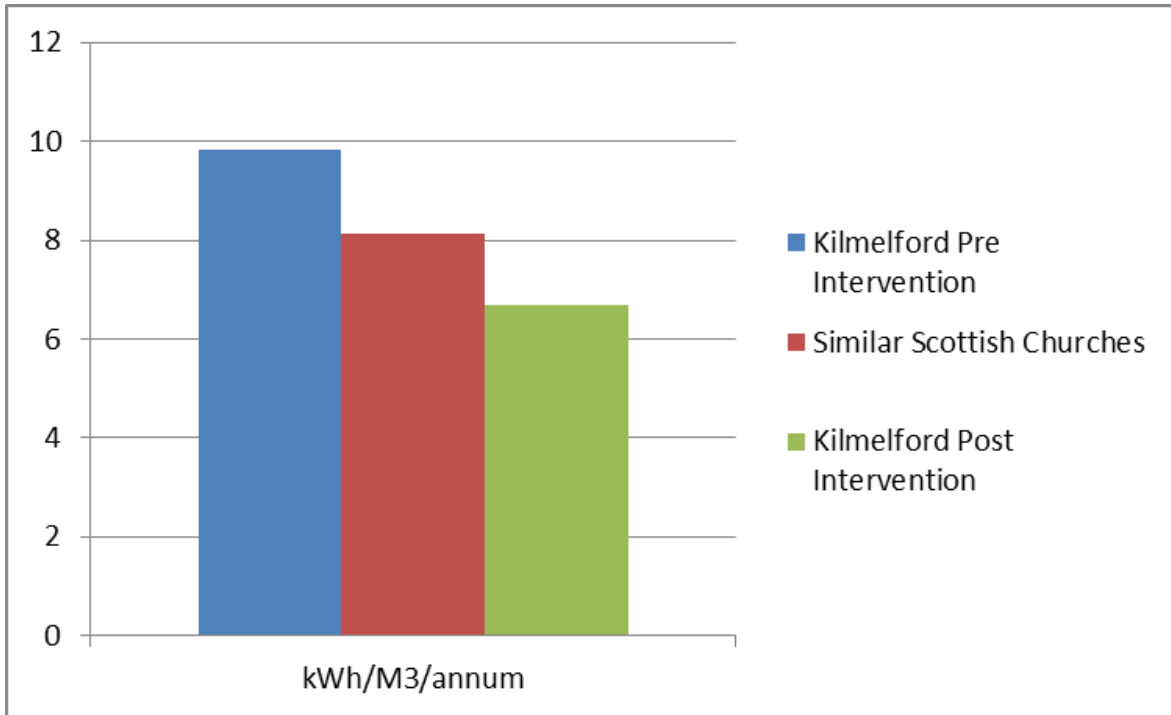
Compared with the average energy consumption for 16 similar Scottish churches, the post-intervention energy consumption for Kilmelford Church was considerably lower (Fig 10).

Fig. 10: Graph showing Kilmelford Church's pre- and post-intervention energy consumption compared with similar Scottish churches
