INFORM

# DAMP GABLES

HISTORIC  
ENVIRONMENT  
SCOTLAND

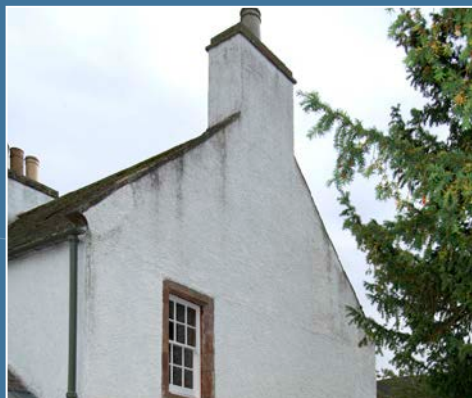
*Fig. 1 The gable end of a traditional building showing signs of staining caused by water run-off.*

Gables and chimneys take the brunt of the impact from severe weather. Water can penetrate through open or degraded masonry joints, poorly protected junctions and through cracks or defects in external coatings (Fig. 1).

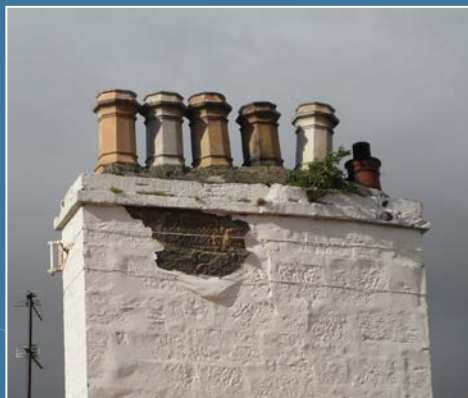
*Fig. 2 The poor condition of this chimney is likely to cause problems to the gable below.*

Defects typically occur at the chimney (Fig. 2) and skewers first. Masonry saturated due to driving rain, high level defects and poor water management is vulnerable to damage from frost and stress caused by wetting and drying cycles.

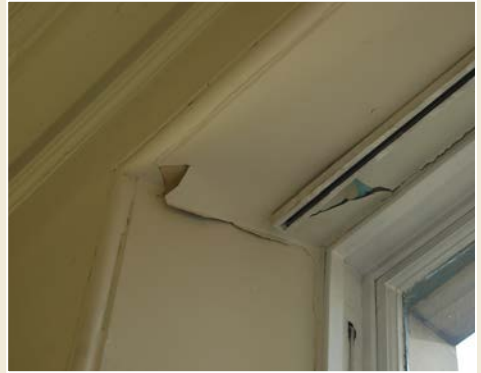
Internally, flaking paintwork and stained or bulging plasterwork can be indicators of wet masonry (Fig. 3). If these internal linings are adjacent to wet masonry they will be cold, attracting condensation, and consequent damage and mould growth.

*Fig. 3 Damage to internal finishes as a result of dampness caused by a defective cornice on the external masonry.*

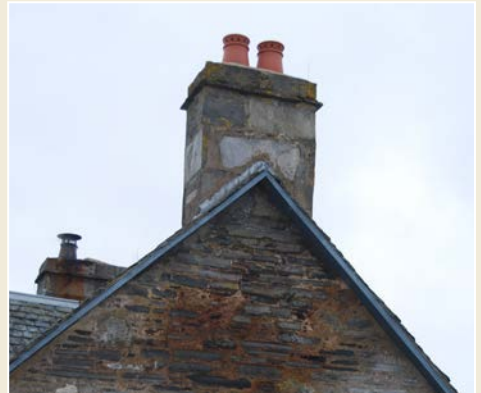
Externally, damp masonry is normally darker than dry stonework (Fig. 4). Lime-based finishes may show discolouration, especially near chimneys. Harder cement or hydraulic lime finishes may not always show symptoms of damp stonework behind, but moss growth between cracks, and black or dark green discolouration from algae indicates high moisture levels in the masonry (Fig. 5).

*Fig. 4 Salt staining in saturated masonry caused by a chimney in poor repair.*

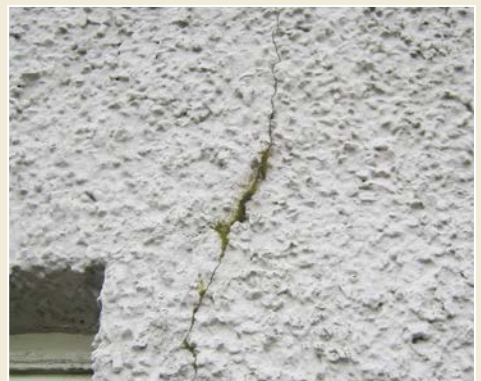
*Fig. 5 Moss growing in a crack in cement roughcast, indicating wet masonry behind.*

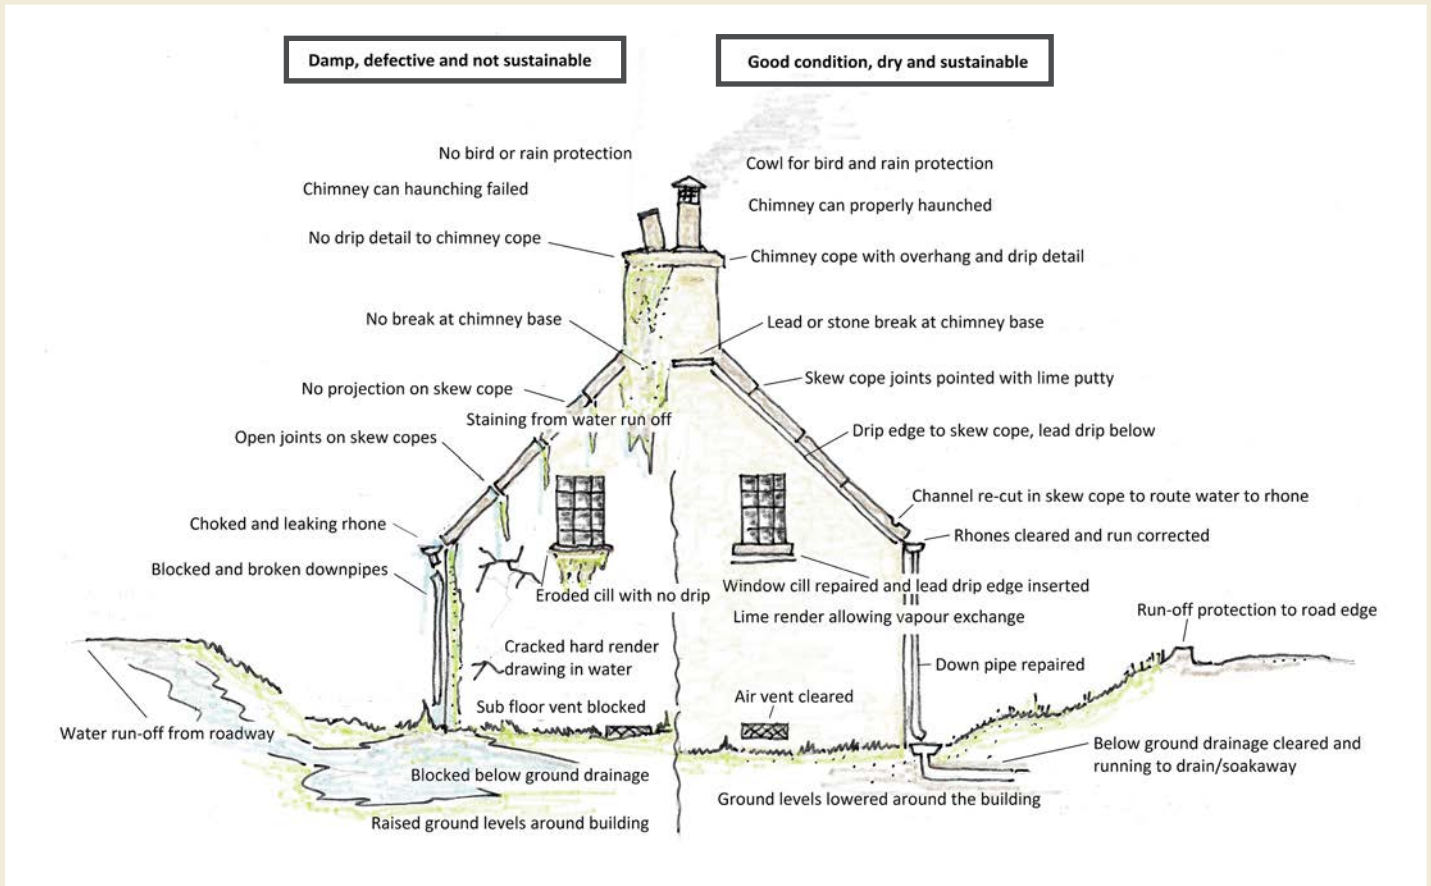
Other types of plant growth on masonry suggest that there are defects causing saturation. Fig. 6 shows common defects in a gable end of a house, and areas for improvement.

Fig. 6 Sketch of a traditional gable end showing common areas of weakness and water ingress (left), and repairs and measures that resolve them (right). For further details please see the Historic Environment Scotland Short Guide 11: Climate Change Adaptation for Traditional Buildings.

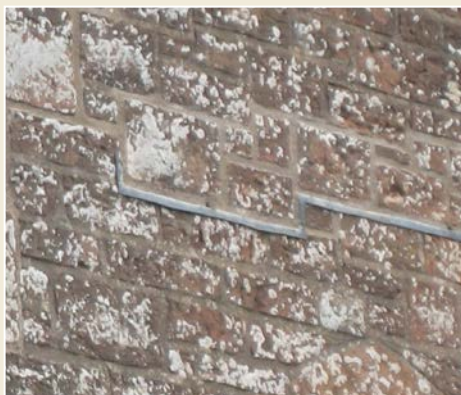
*Fig. 7 Lead trays in the mortar to direct water away from the masonry.*

Lead trays inserted into the masonry are costly to install and don't prevent water ingress. They only manage localised routing of the water within the masonry rather than preventing it coming in (Fig. 7). To maintain the breathability of the wall, lime-based mortars and finishes are generally considered the best material for repairs on traditional buildings. They should be carefully specified to be fit for purpose. This may mean using more robust mortars for exposed areas at high-level. A suitable repair plan may require additional masonry work or new lead details.

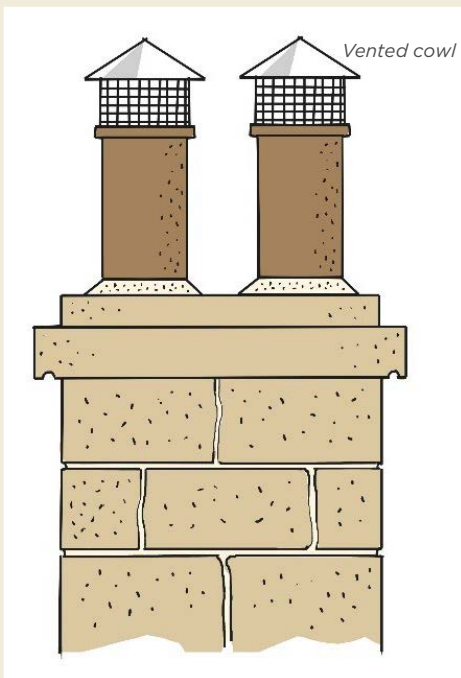
*Fig. 8 Well detailed chimney, vented cowl and overhang with drip detailing.*

These should be secured with a durable mortar. A vented cowl should be fitted to the chimney can to maintain air movement and keep water out of the flue (Fig. 8). Ceramic caps, sometimes called 'elephant's feet' (shown in Fig. 10) are only effective if there is a good overhang with the chimney can, otherwise water can be routed back into the chimney.

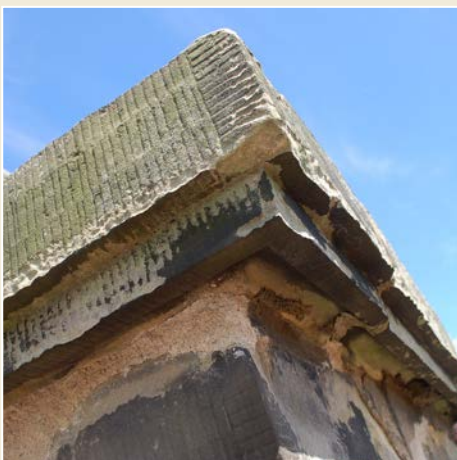
*Fig. 9 A chimney cope showing the drip detail to the underside, designed to shed water.*

The cope, or top of the chimney stack, should have some form of overhang or drip to throw off water (Fig. 9). This is usually an integral part of the masonry design, but if absent a drip detail can be formed from lead, slate or stone.

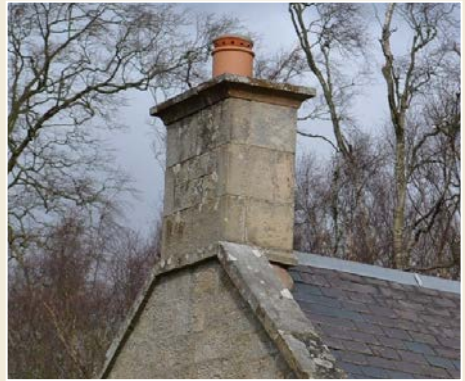
Fig. 10 Well detailed overhanging copes or 'tabling', and ceramic chimney cap.

Sometimes wallheads are finished with an angled line of flat stones called skew copes or 'tabling' (Fig. 10). The narrow joints between them are vulnerable and often found to be in poor condition. They should be well maintained and pointed in a fine lime mortar. To improve resilience, copes can be fully or partially covered (cloaked) in lead, or packed with lead wool before re-pointing.

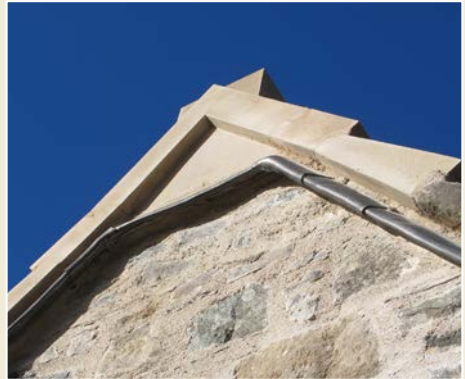
Fig. 11 Lead drip under a skew cope, angled to shed water (Photo credit: Jonathan Gotelee Architects).

Copes are typically flush with the gable wall. Occasionally this area may need to be modified to provide an overhang, which can be achieved by the addition of lead (Fig. 11) or slate. Where copes are being replaced, creating or increasing the overhang may improve water management. Any drip detail added should be angled to shed water away from the masonry below.

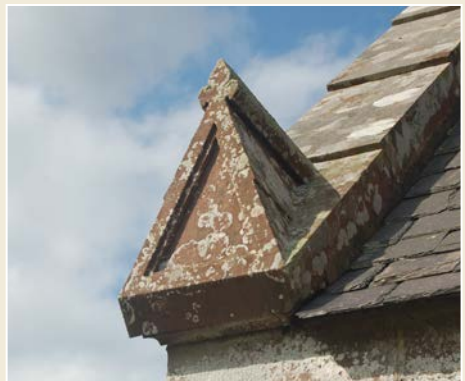
Fig. 12 A skew putt detail designed to assist the shedding of water.

The lower end of the skew, where the copes meet the wall, is vulnerable to the run off from the cope. A 'skew putt' is a decorative detail at the end of a cope which also sheds water from the corner of the building (Fig. 12).

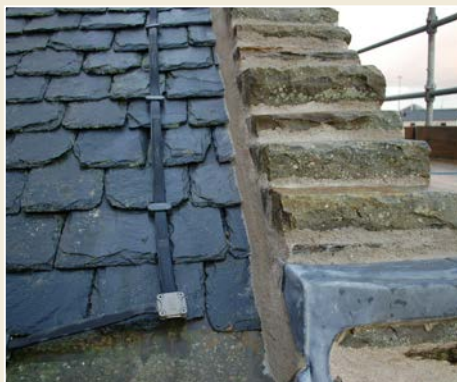
*Fig. 13 A mortar skew fillet, which forms a weathertight seal between roofing slates and masonry.*

The point where the roof covering meets the masonry is a significant area of vulnerability. The addition of small sections of lead (soakers) underneath the slates, covered by a mortar fillet (Fig. 13) is often

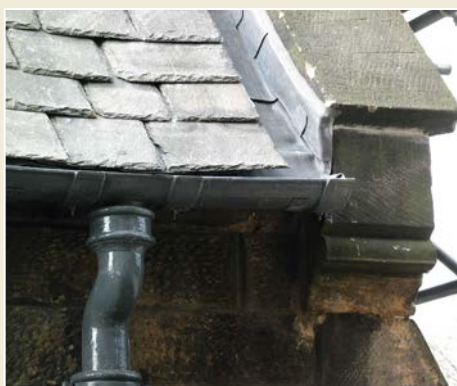
*Fig. 14 A reworked skew junction with lead watergate.*

sufficient, but a more robust lead junction, 'secret gutter' or watergate is sometimes required (Fig. 14).

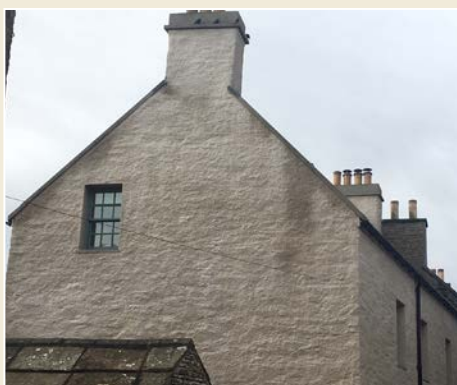
*Fig. 15 Dampness persists on new harling due to inadequate detailing on the skew copes.*

External finishes are often replaced without due attention to defective elements which may be allowing water ingress. Simply replacing external coatings will not always reduce dampness (Fig. 15). The design and condition of the chimney and the skew copes should also be addressed. However, when masonry details have been addressed and appropriate finishes used, the improvement can be considerable. In a recent project at a historic cottage in Culross, Fife, improved skew details and new lime harling have significantly improved internal conditions, and the previously saturated masonry continues to dry out (Fig. 16).

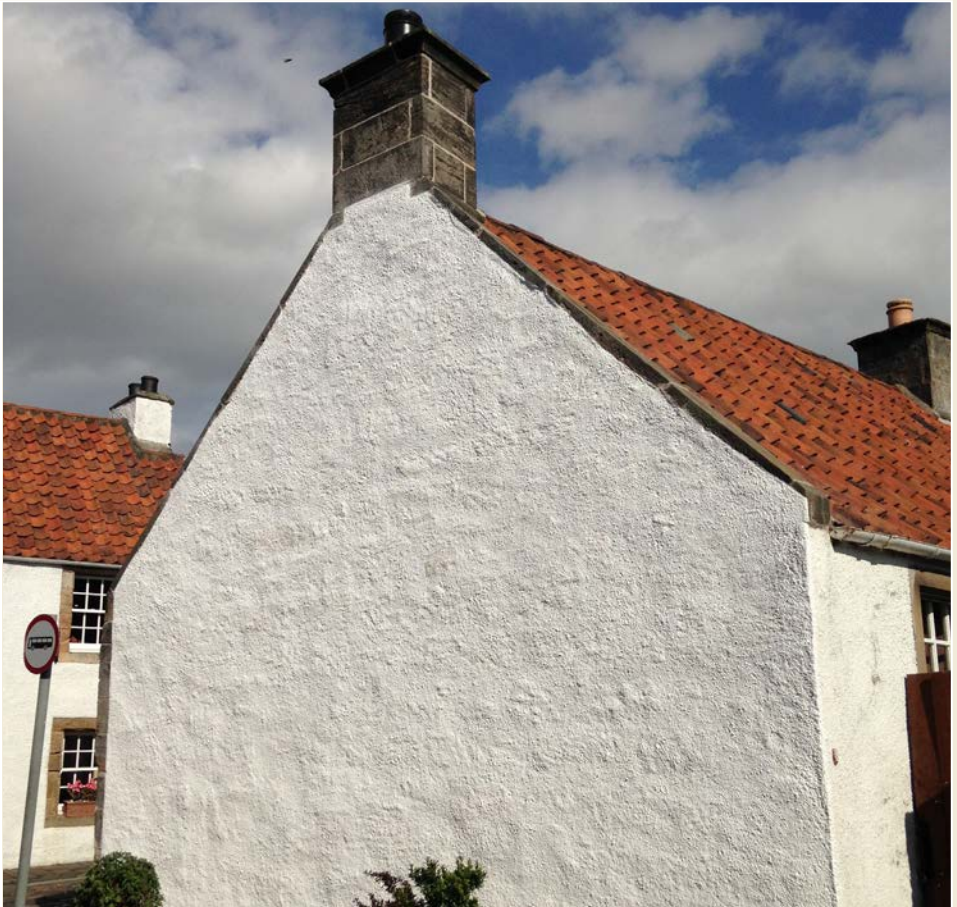
*Fig. 16 This gable end is drying out following repairs and improved detailing at the skew copes, and the application of traditional harling and limewash.*
