Trial Church Heating: Radiant Panels and Air Source Heat Pump at Kilmelford Church

This publication should be quoted as:
Historic Environment Scotland
Refurbishment Case Study 19

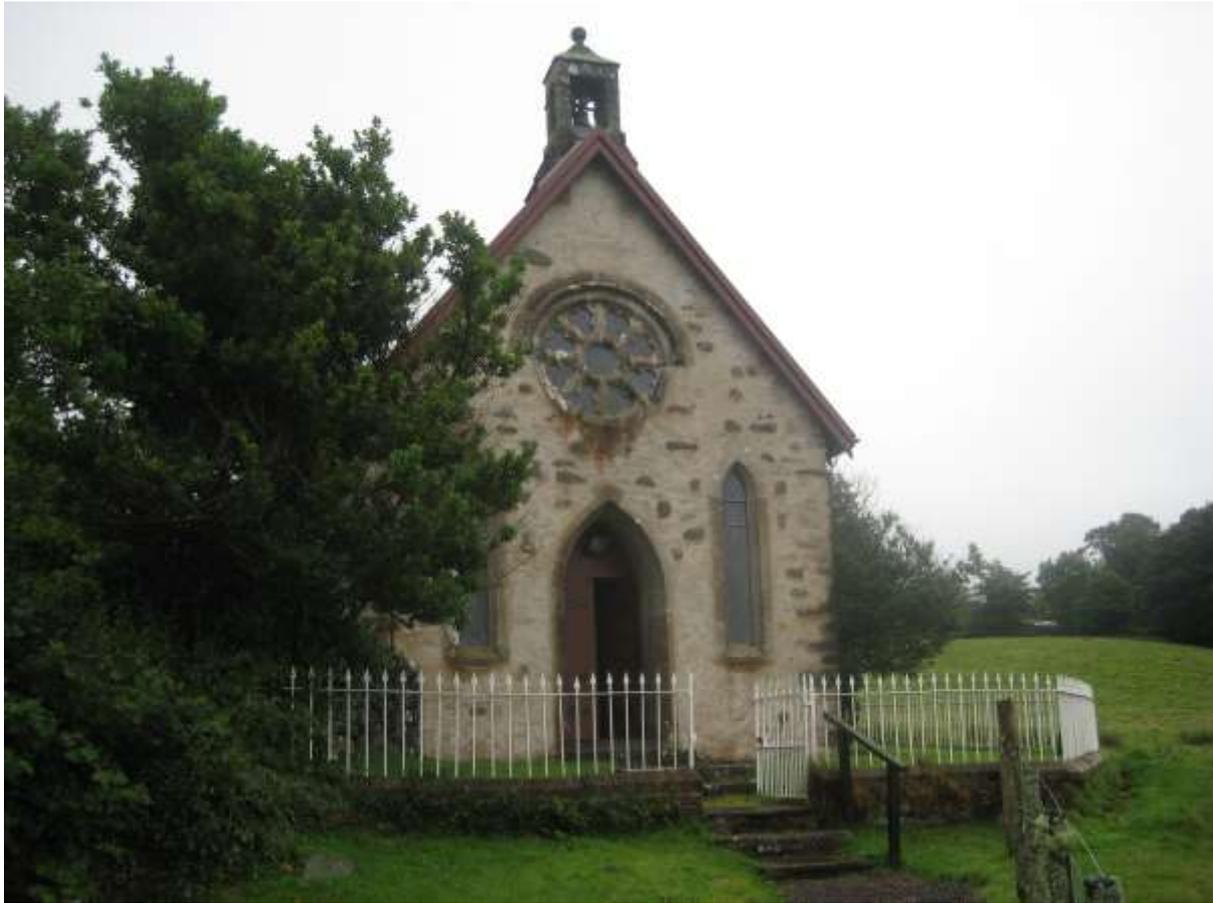
Fig. 1: *Kilmelford Church viewed from the West; the lime mortar repairs to this elevation were an important first stage in the building upgrade*

Water ingress to the west gable had progressively become worse since the 1970s. Various repairs had been attempted, with extensive use of cement that occasionally gave temporary respite, but ultimately resulted in progressive saturation of the masonry and wall core. This gable, and other areas of the walls were re-pointed in a lime mortar in 2009 (Fig. 2), and works to the roof and some stone repairs resulted in an improvement to the internal conditions as the walls dried out. Although the

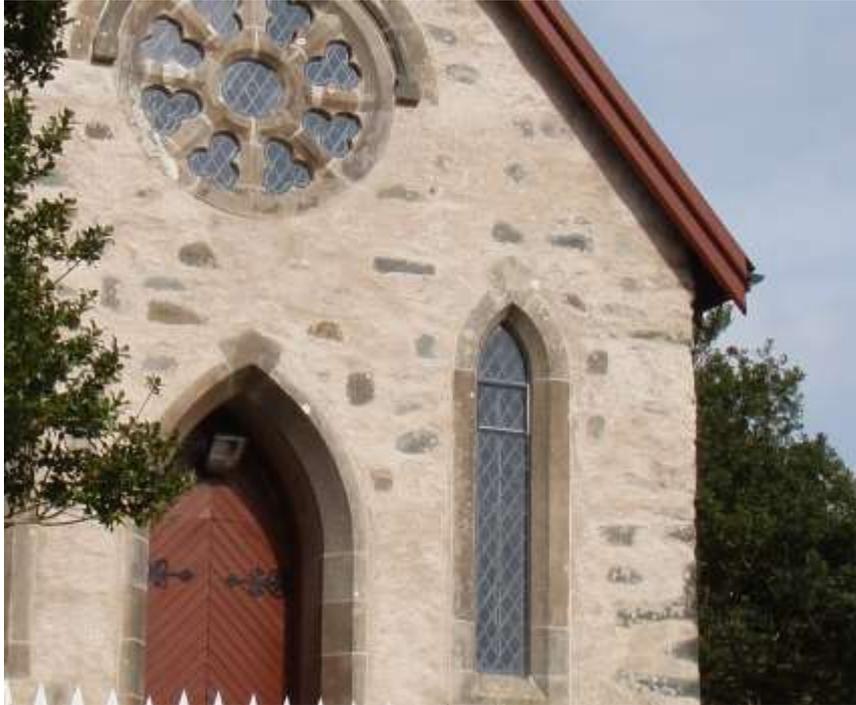
Fig. 2: Detail of the lime pointing on the west gable; this resulted in much drier masonry

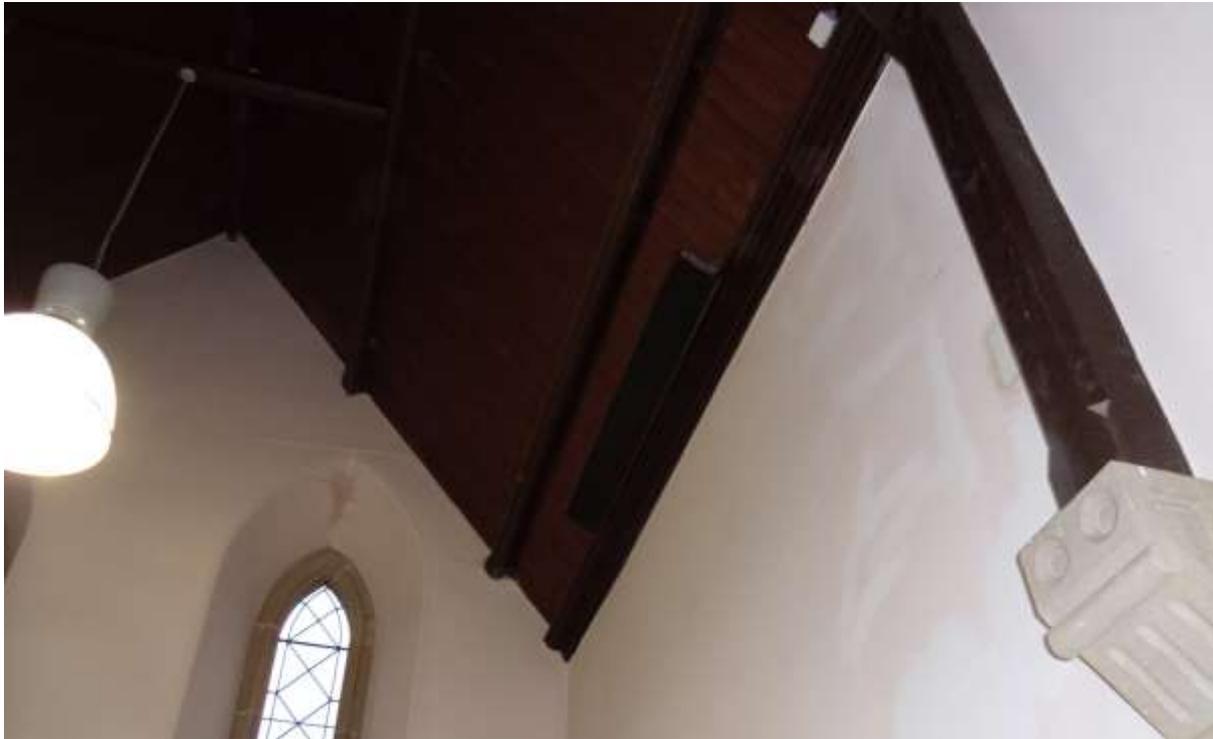
Fig. 4: *The radiant panels visible middle right, just above wallhead level*

The selected radiant sources were two wallhead level panels mounted on the timber at the base of the roof (Fig. 4), radiant panels mounted on the back of the front ten pews (Fig. 5), and radiant panels mounted on the underside of the mezzanine layer (Fig. 6). The heated cushions on the pews were not selected as worshippers simply became too hot, and the low level wall mounted radiant heater in the chancel was judged to be ineffective. The radiant heating panels were designed and supplied by

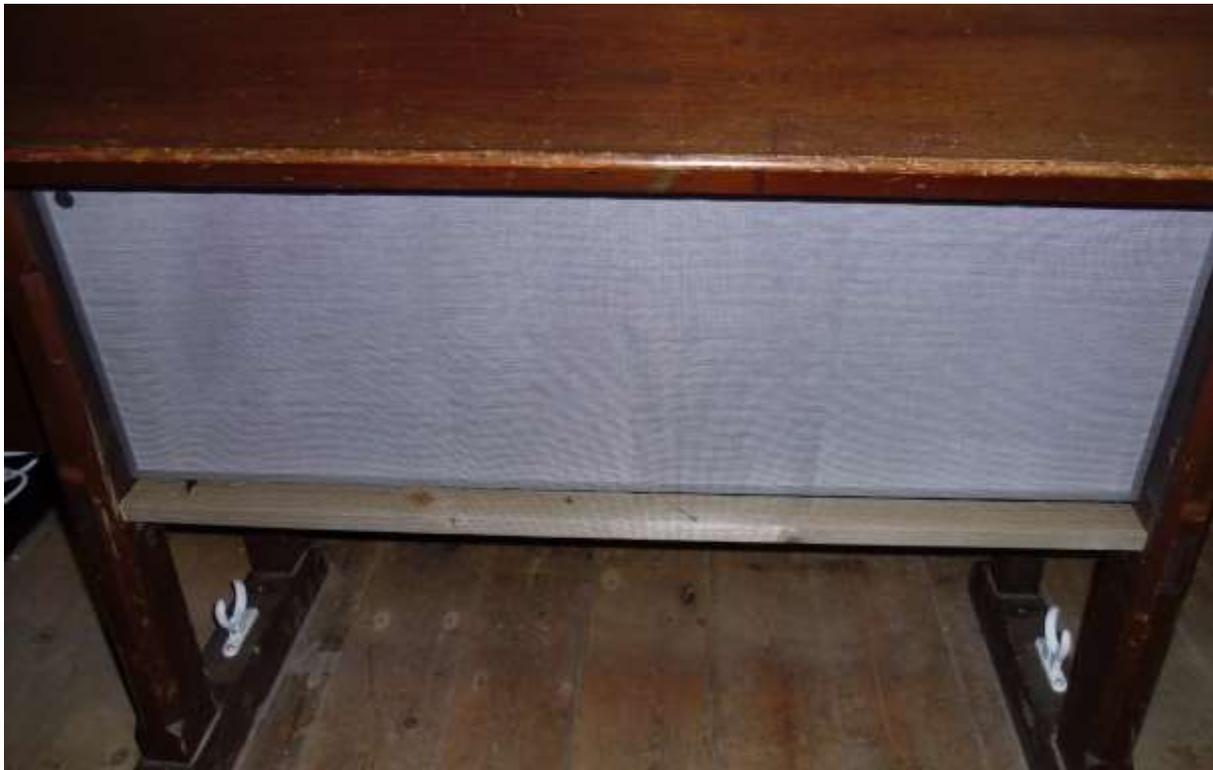
Fig. 5: *The new pew backed radiant panels*

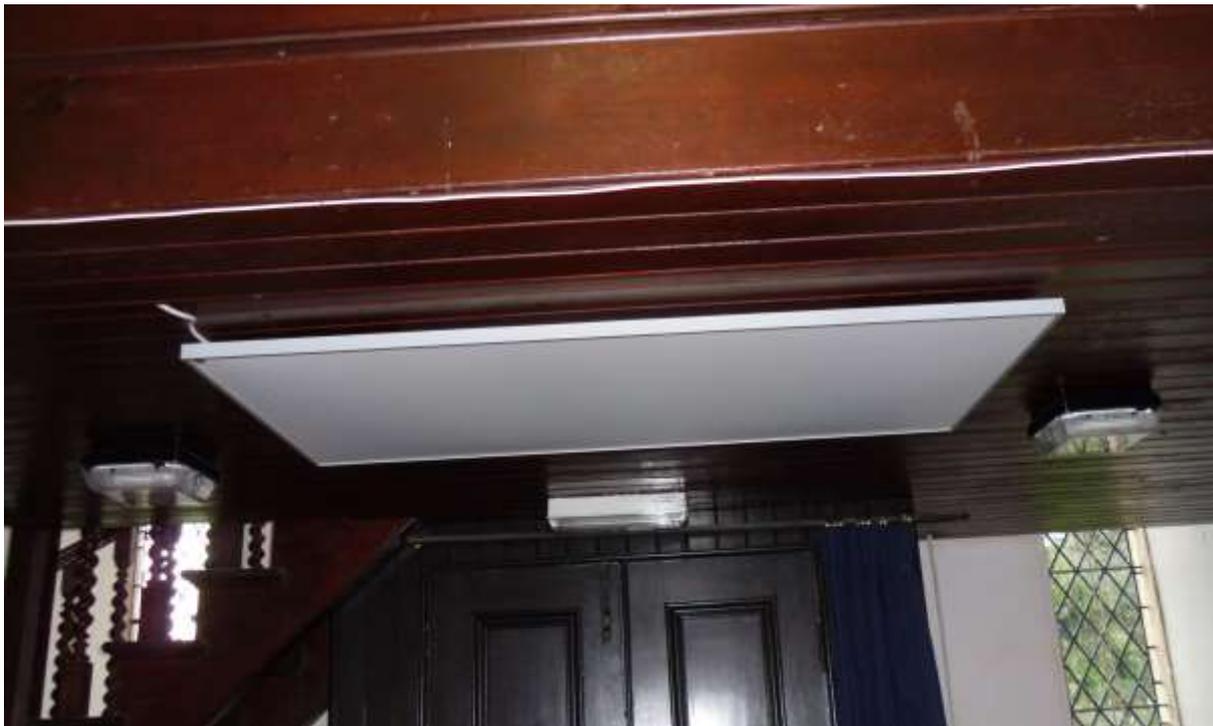
Fig. 6: *The radiant panels underneath the mezzanine layer*

The improvement in the average temperature in the church was obvious and most parishioners were pleased with the results of the trial. The panels mounted on the underside of the mezzanine floor proved to be very effective in conveying a sense of welcome to the property, experienced immediately on entering through the front door.

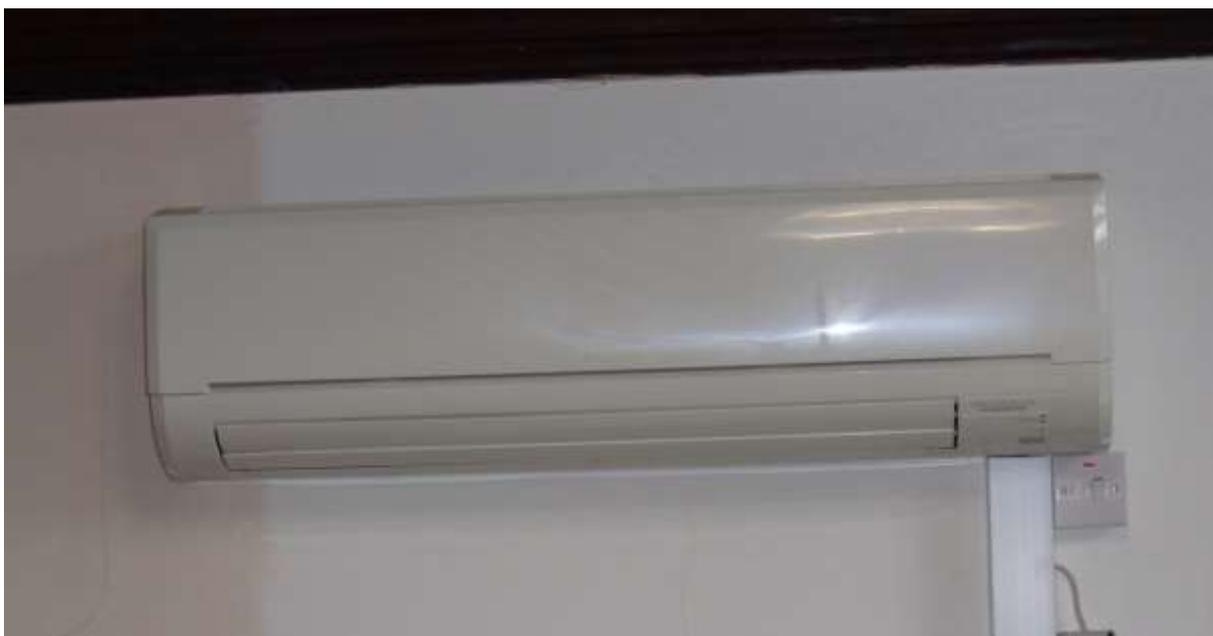
Fig. 7: *The fan unit fitted above the mezzanine stairs*

An Oban based electrical contractor with the supplier of the heaters to ensure that the church had a local contact. The siting of the ASHP indoor fan unit was discussed, and a compromise was reached. It was placed at the top of the stairs, with the aim of providing a good air recirculation path up the small spiral staircase (Fig. 7). The pipes and cables were routed under the floor of the mezzanine layer.

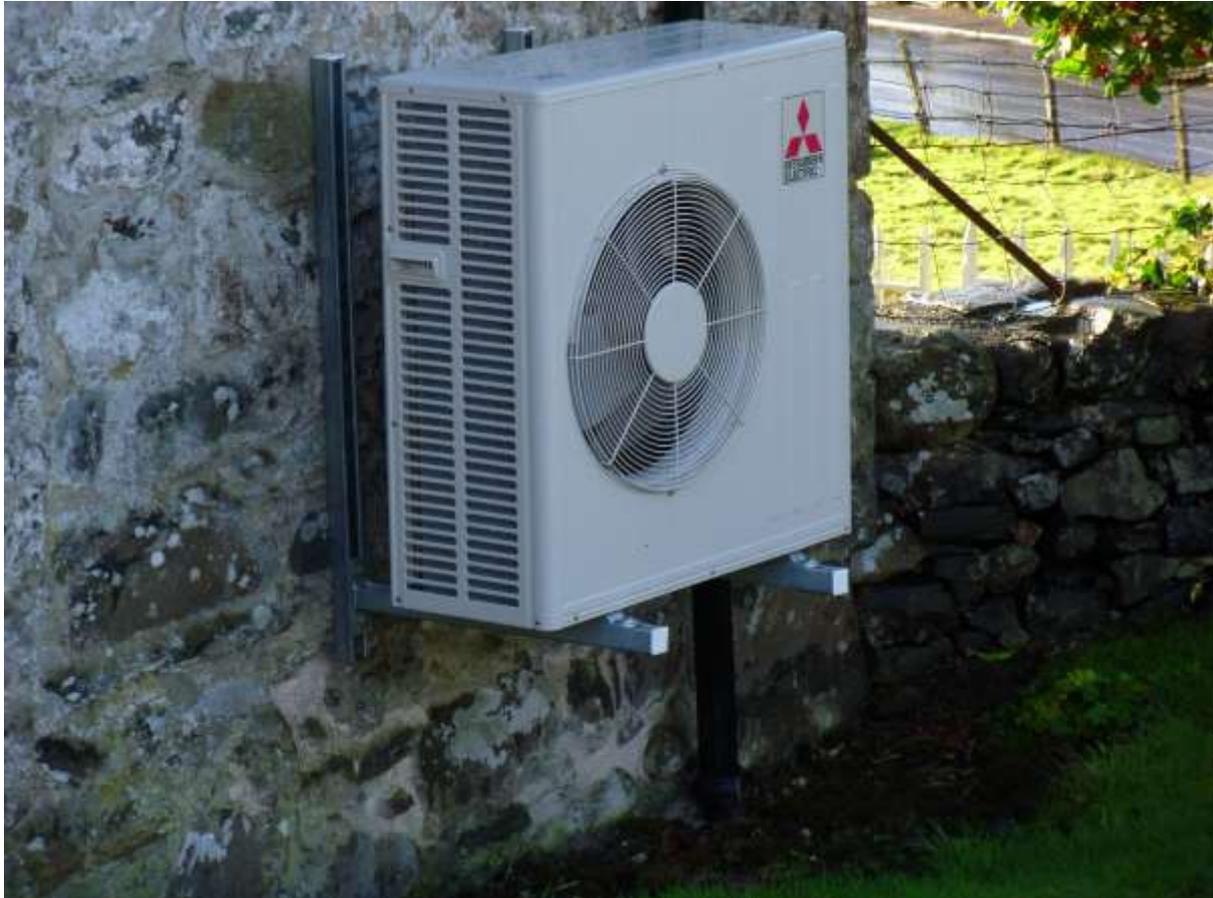
Fig. 8: *The external fan unit of the ASHP on the NW corner of the church*

The external unit was located on the NW corner of the church where it was felt to be the least visible place (Fig. 8). The installation, testing and commissioning of all the devices was completed early in September 2014.
