INFORM

INDENT REPAIR FOR SANDSTONE ASHLAR MASONRY

INDENT REPAIR TO SANDSTONE ASHLAR MASONRY

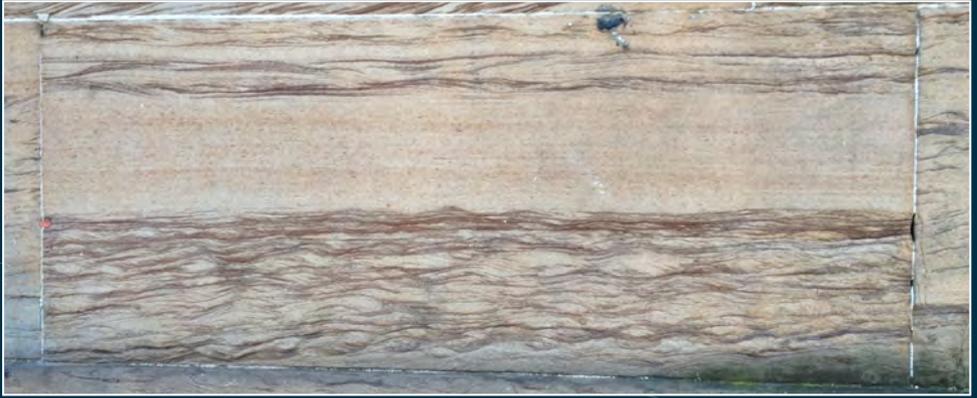
Fig. 1: Visible bedding planes in this sandstone ashlar.

were guided by the natural qualities of the sandstone, using the bedding planes of the stone – the visible layers marked by differences in size or composition of the sand grains making up the rock (Fig. 1) – as markers for correct alignment.

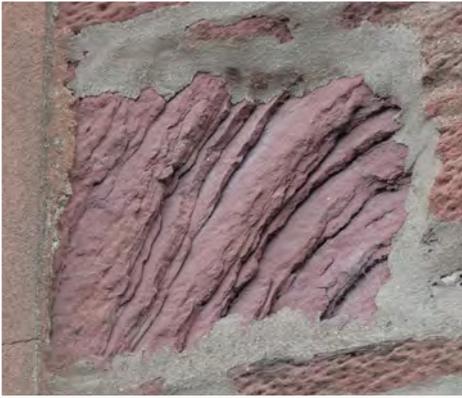
Fig. 2: Face bedded sandstone, pointed with cement mortar, exhibiting delamination.

The strength and durability of sandstones, highlighted by their evident longevity as building materials, comes primarily from the materials and processes that shaped them through geological time, but also in the mason's understanding of the stones' natural characteristics. When laid with the natural bedding planes horizontal, the stone exhibits its maximum compressive strength. However, when set vertically, not only is strength reduced, but the stone is much more vulnerable to erosion by natural forces. Blocks set in this way, with their bedding planes vertical, are described as being 'on cant'. Where the bedding planes are set parallel to the external face of the building, the stone is said to be 'face bedded' (Fig. 2). Such blocks are prone to failure through 'delamination', a process whereby layers or sheets of the stone detach and sheer off. This relatively

rapid weathering process can trigger the need for a considerable degree of indent work, as the characteristic failure of the bedding planes can lead to the complete loss of the exposed face across a building's elevation. Fortunately, it is more usual to find buildings constructed in the appropriate manner, with only a few individual stone blocks face bedded.

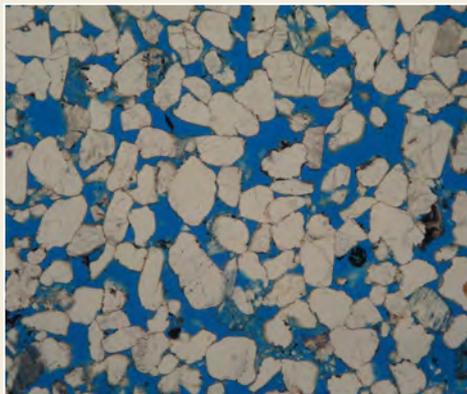
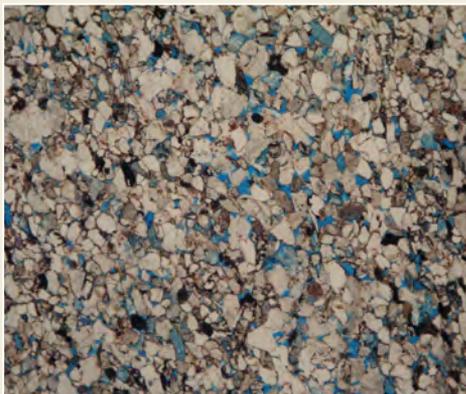
Fig. 3-4: Studying sandstones under the microscope can reveal significant differences in stone structure. The images show red sandstones from different quarries, which appear visually similar, but have very different physical properties.

properties and, as such, should not be relied upon in isolation for stone matching (Figs. 3-4). In order to ensure compatibility and success of the indent, the replacement stone should have physical properties as close as possible to those of the original stone. This includes strength, porosity and water absorption characteristics. A specialist in the field of stone matching should be consulted to assess the compatibility of potential replacement stones.

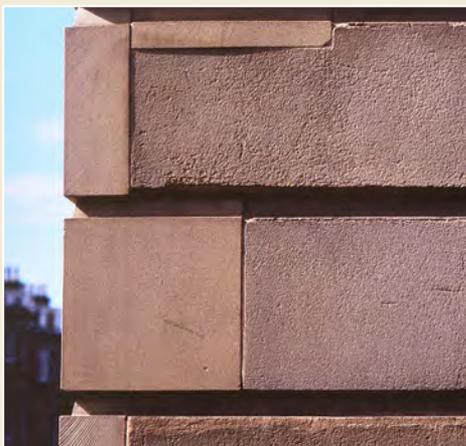
Fig. 5: Ill-fitting replacement stones in the top corner. Circular saw marks can also be seen on the stone faces.

Due to the limited number of building stone quarries currently in operation in Scotland, it is often difficult to find an exact match with which to carry out an ashlar indent. Where an exact match is not possible, the new stone should be slightly less resistant to the effects of weathering compared to the existing stone (i.e. softer), acting sacrificially so as to preserve the original masonry. Choosing the wrong replacement stone can have unfortunate and permanently disfiguring effects. Using the correct sizing for the individual replacement blocks is also important. Size differences can make the replacement block sit uneasily with the original (Fig. 5); the uneven

surface can encourage local patches of biological growth to flourish; joint patterns can be disrupted; and the surrounding original masonry may be unnecessarily notched to accommodate the larger dimensions of the new blocks.

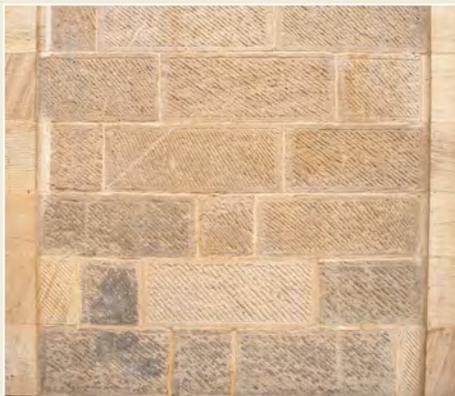
Fig. 6: Ashlar indents cut to fit and tooled to match existing masonry.

cutting, tooling and setting the indent without damaging the surrounding masonry, should be employed to do the work. The original construction needs to be studied and accurately measured to record the precise dimensions of any stone that needs to be replaced; scaffolding should be carefully designed and constructed around the original stonework and erected without damaging the existing masonry. Inspection and documentation of the existing masonry is necessary to ensure that the new stone fits exactly in the correct location and that the dimensions of the surrounding mortar joints do not alter in size (Fig. 6).

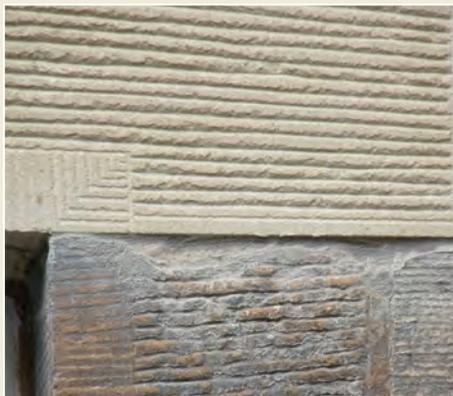
Fig. 7: Damage to existing masonry caused during indenting.

Care must be taken when cutting out the decayed stone to avoid chipping the edges of the remaining surrounding blocks (Fig. 7). A sufficient depth of stone needs to be removed to provide a 'bed' for the new stone (typically 100 mm deep), ensuring that it sits securely once inserted into the space previously occupied by the decayed stone.

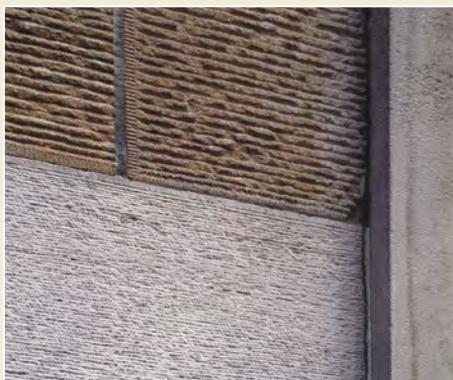
Fig. 8: Variations in tooling due to differences in stone properties. It was not possible to tool the coarser grained replacement stone to the same fine detail as the original stone.

original surface tooling should be noted. Particular attention should be paid to the angle and depth of any chisel marks, the size of any borders, and the number of grooves that are incised into the face of the stone. Whilst failure to accurately replicate all of these features on the replacement stone will produce an unsatisfactory result, it may be impossible to achieve the required effect in the first place, if the 'wrong' stone is chosen (Fig. 8). This is likely to happen because of differences in the size of sand

grains between the two stones.

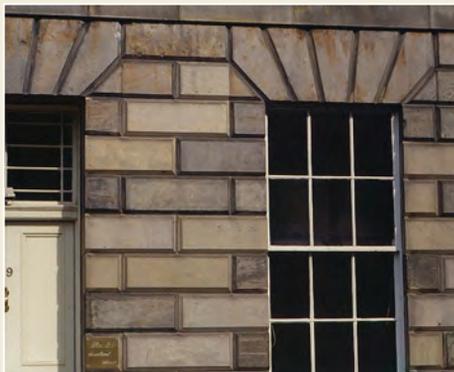
Fig. 9: Successful ashlar indents that are 'weathering down' and blending in with the original masonry.

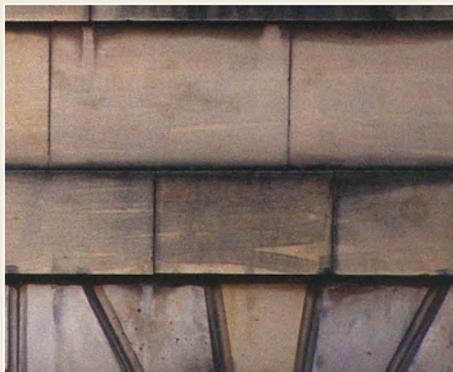
Fig. 10: Stone indents painted in an attempt to blend in to the adjacent masonry.

Occasionally, only a partial indent of a damaged ashlar block will be required. This approach requires additional attention to detail so that the surface tooling and edge border detailing accurately and closely match the remaining tooling. In addition, the joint between the two stones should be cut as finely as possible to help the indent tie in better. If properly chosen, newly indented stones will 'weather down' from a fresh appearance over time to acquire a surface patina similar to the original (Fig. 9). No attempt should be made to artificially weather or distress the finished surface of the replacement blocks; doing so can have a serious impact on the building's aesthetics (Fig. 10).
