WEE CAUSEWAY, CULROSS

INSULATION TO WALLS & ROOF

Historic Scotland Refurbishment Case Study 3

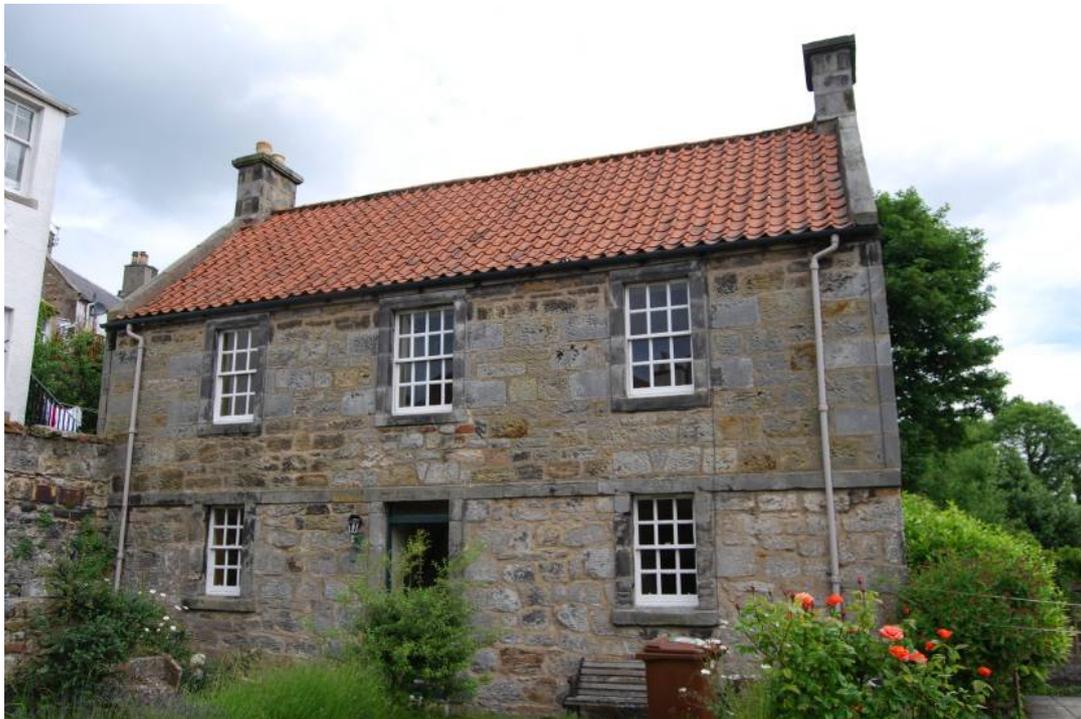
The building used in the upgrade trial described here was a detached cottage known as 'Wee Causeway' (Fig. 1), which dates from the mid 18th century. It is formed of sandstone rubble masonry bound with lime, although has been re-pointed with cement in several areas. It has a pitched pantile roof of a type common in many parts of the east coast of Scotland. The windows are single glazed sash and case and are likely to date to a refurbishment in the 1960's. The walls were lined with lath and plaster in one ground floor room, the others being plastered 'on the hard' (i.e. directly onto the masonry). All rooms had a standard cornice detail in place. During the course of the work described here the tenant vacated the property. Situated in a small village on the Firth of Forth, the property is exposed to only modest wind driven rain.

Fig. 1. The front elevation of Wee Causeway, a detached cottage in Fife

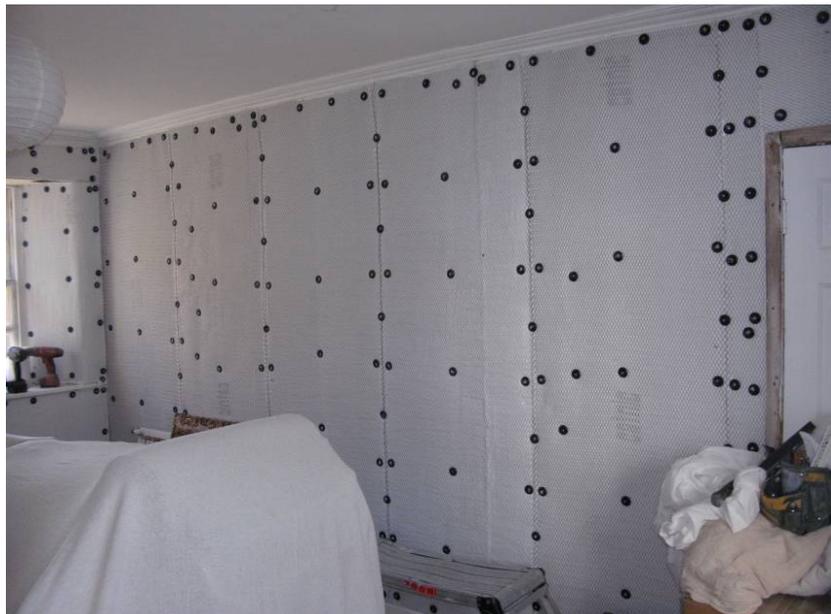
The insulation used in all external walls in the first floor rooms (excluding the bathroom) was a 10 mm thick aerogel blanket (Fig. 2). Historic Scotland tests have shown aerogel to have a reasonable level of vapour permeability and it was therefore felt appropriate to apply this directly to traditionally constructed mass masonry.

Fig. 2. Aerogel insulation applied as a blanket prior to application of a plaster finish

This was secured to the wall using thermally-decoupled expansion fasteners. Metal mesh was then applied to allow the application of a plaster finish. When applying the plaster, a slim timber bead was fitted below the cornice to ensure a neat junction with the new plasterwork.

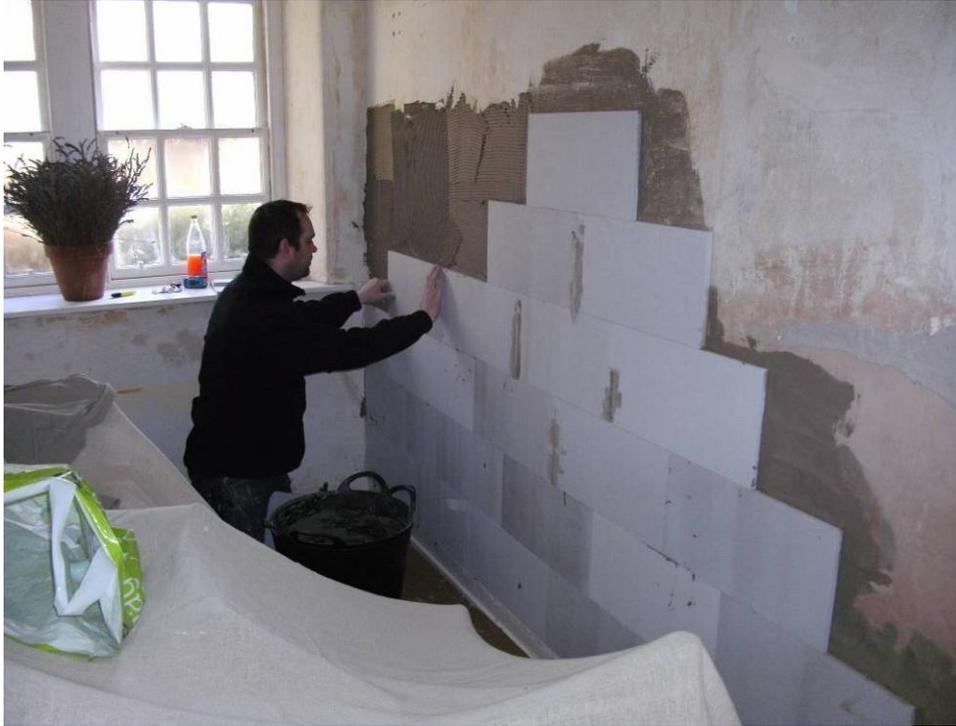
In one room of the ground floor, calcium silicate board insulation was applied directly to the internal face of the masonry. Calcium silicate board is manufactured from sand and lime treated with heated steam to produce an open-pored structure which is permeable to water vapour. The board therefore has a high capillary action and is vapour open, which helps regulate internal humidity. Before application, the existing wallpaper and paint was removed from the wall to give a good base for the adhesive mortar (Fig. 3), which fixes the board to the masonry. Board 15 mm in thickness was used, cut to shape, where required, using a standard hand saw. The adhesive mortar was mixed and applied to the wall using a notched trowel, with a notch size below 12 mm. As each panel was placed on the wall, mortar was applied to the edges of adjacent panels and the new panel slid to sit tightly against it (Fig. 4). The board was finished with two coats of plaster - a rough base coat and a smooth top coat.

Fig. 4. Calcium silicate board being applied to a masonry wall at Wee Causeway

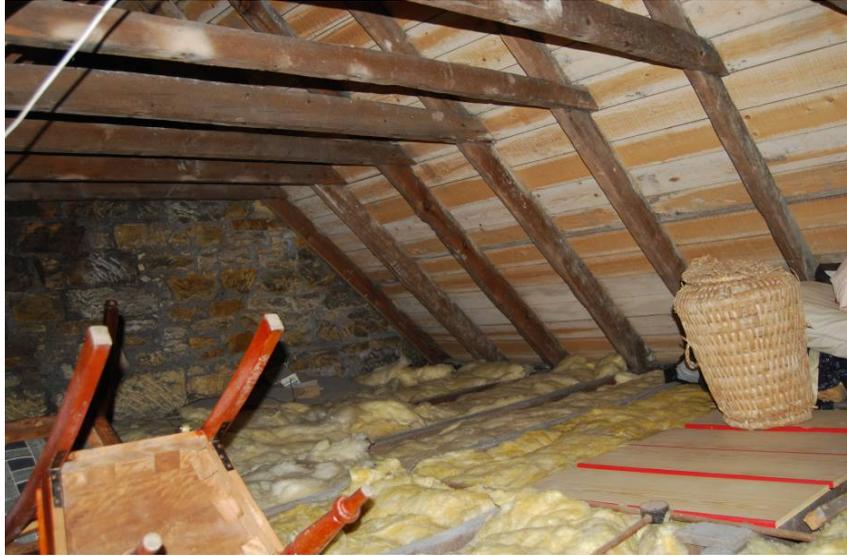
Fig. 5. The roof space prior to the work

The second element of the building fabric to receive upgrade work was the roof space (Fig. 5). This took the form of 250 mm thick hemp wool insulation laid in the loft, achieved by laying two layers of 100 mm and one of 50 mm. Following previous trials using sheep's wool, it was felt that a different material should be tested. Hemp wool was selected because of its ability to absorb and release moisture and its ability to be installed relatively simply and quickly. Prior to the work commencing, the roof space was cleared of debris and previous insulation.
