INFORM

INFORMATION FOR HISTORIC BUILDING OWNERS

**Growing
Old
Gracefully**

HISTORIC SCOTLAND
ALBA AOSMHOR

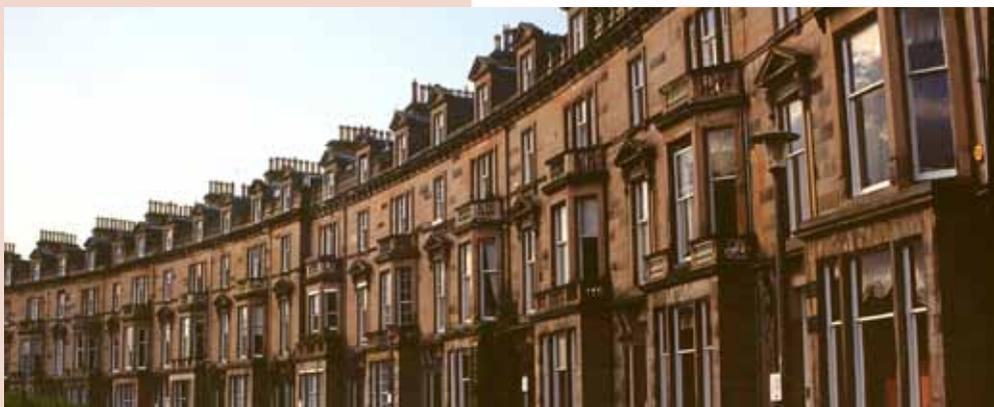
Fig 1 The aged appearance of older buildings adds to the quality of the built environment.

The visual appeal, or aesthetics, of a building are influenced both by personal tastes and shared attitudes about what is considered appropriate and beautiful. Such attitudes are culturally driven, and may change over time. The aesthetic appreciation of any building or streetscape is extremely subjective, and evidence of ageing observed on a building may generate varied and extreme opinions. Nevertheless, it is a well-established conservation principle that the fabric of a building, and its authenticity, are of paramount importance to its cultural significance. The process of ageing leaves an imprint of the passage of time, which is irreplaceable and inimitable. This patina is considered to be of high value to the overall significance of historic buildings, and should be conserved wherever possible (Fig 1).

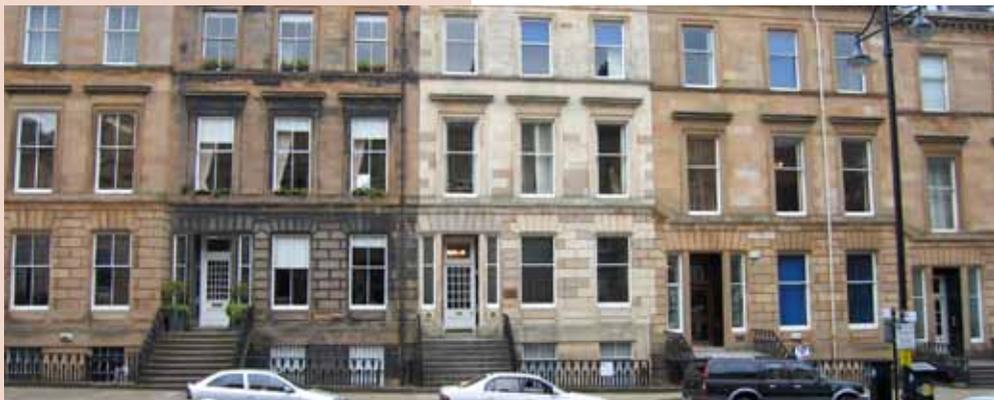
Fig 2 Different approaches and cleaning methods can disrupt the visual integrity and aesthetics of an historic streetscape.

Just as a very new building with an extremely dirty appearance would not be appreciated, an excessively cleaned very old building would also look artificial and out of place. This is particularly true when several historic buildings are next to each other and have not been maintained uniformly (Fig 2).

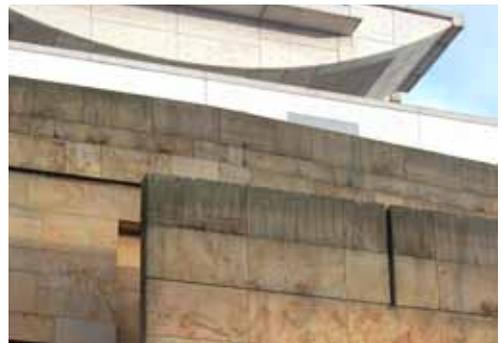
Fig 3 New buildings will quickly exhibit soiling and a fresh appearance cannot be maintained forever.

in its construction. New buildings with smooth lines constructed with glass or other highly polished or consistently coloured surfaces are expected to appear "as new" for as long as possible. However, aging processes begin almost immediately, and such a fresh appearance cannot be maintained forever (Fig 3).

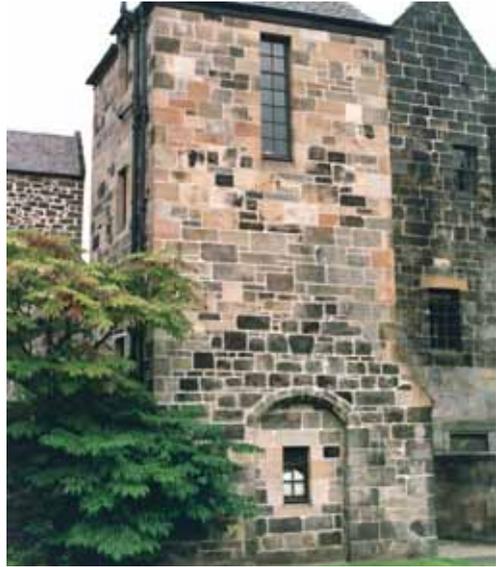
Fig 5 An historic masonry building displaying variable soiling.

Soiling is a process that may include the deposition of airborne particles on the surface of a building, as well as biocolonisation by various organisms such as algae, bacteria, fungi and lichens. Over time, soiling patterns may vary as particulate sources change; for example diesel pollution is more common today whereas soot was most common in the past. Environmental conditions may also change and support different types of biological growths on buildings, or climatic changes may alter natural wetting and drying processes, also affecting soiling patterns (Fig 5).

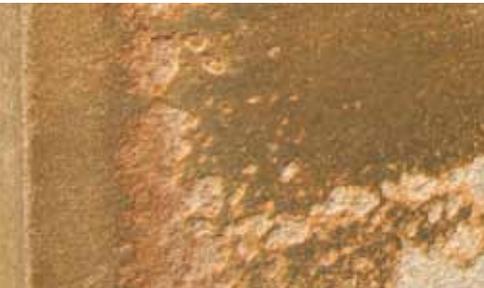
Fig 4 Damage to a stable surface patina can expose weaker masonry underneath that is prone to decay.

Original building material displaying decades or even centuries of accumulated ageing alterations preserves the true history of a place. The combination of these processes may lead to the development of a patina that forms a protective layer over the interior of the building stone or brick. In some cases, if removed, material behind such a surface layer may be more vulnerable to damage, and the re-establishment of a stable patination layer may take many years (Fig 4).

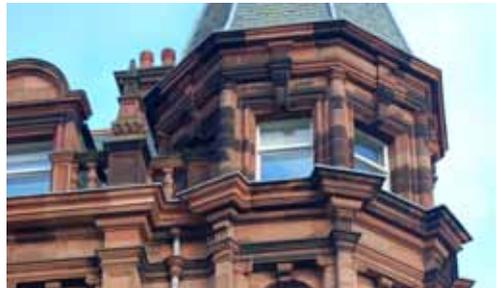
Fig 6 Different surface finishes on stone masonry attract differing degrees of soiling which adds depth and richness to the building.

The natural visual effects of ageing, including soiling, can enhance the appearance of an historic building (Fig 6). However, in some situations where excessive, it can indicate that damage is occurring (Fig 7). Intense biological growth or salt efflorescence on masonry commonly indicates a maintenance problem, whilst not necessarily being a problem in itself. Many such instances will be resolved following repair of, for example, damaged or blocked drainage features, or by re-pointing (Fig 8).

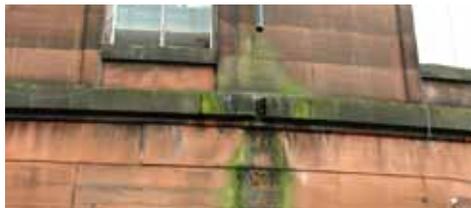
Fig 7 Intense soiling and biological growth on masonry is typically directly associated with maintenance issues.

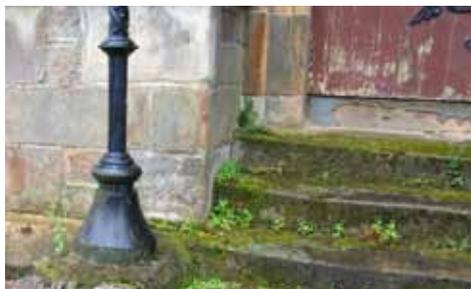
Fig 10 Build-up of biological growth on steps is considered undesirable from a safety viewpoint.

- Safety reasons
 - Remove slippery algal or moss growths on paving stones (Fig 10)
 - Remove wasp or bird nests from inappropriate locations
- Conservation reasons
 - As part of a conservation programme to inspect for and address damage
 - Remove damaging agents such as salts, bird droppings or tree seedlings
 - Remove soiling where it is causing damage
 - Remove graffiti where it negatively impacts the visual character of the building or structure (Fig 11)

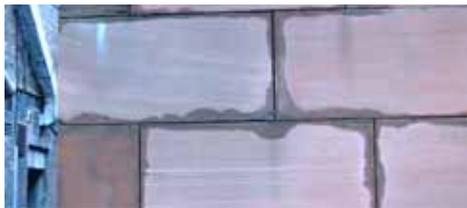
Fig 8 Water penetration to masonry caused by lack of maintenance and loss of mortar.

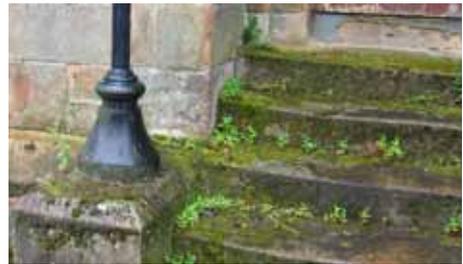
Fig 10 Build-up of biological growth on steps is considered undesirable from a safety viewpoint.

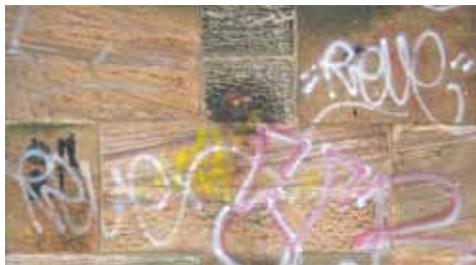
Fig 11 The presence of unwanted graffiti may justify stone cleaning.

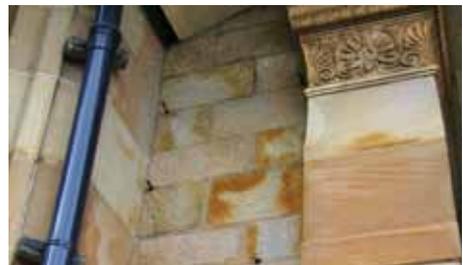
Fig 12 Surface damage, bleaching and iron staining to stone masonry caused by inappropriate and aggressive stone cleaning.

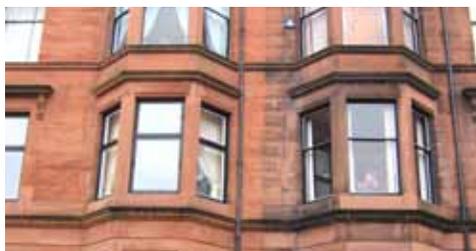
Fig 13 The cleaning of a facade (left side of image) is often considered desirable yet does not necessarily dramatically improve the aesthetics of a building.

The overall appearance of a façade may not be uniform after cleaning, as some stains may originate from minerals within the stone that have migrated to the surface and cannot be removed completely. Such stains may have been hidden by soiling and become conspicuous after cleaning, or may be generated by the cleaning process itself. Also, adjacent buildings cleaned at various times may always show differences in appearance (Fig 13).

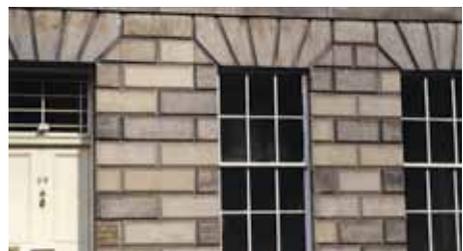
Fig 14 Careful selection of replacement stone can ensure the new stone is visually in keeping with the original appearance of a façade.

(though this should be a secondary consideration). If stone is selected carefully, it may blend in with the aesthetics of the aged building and there will be no need for cleaning (Fig 14 & 15).

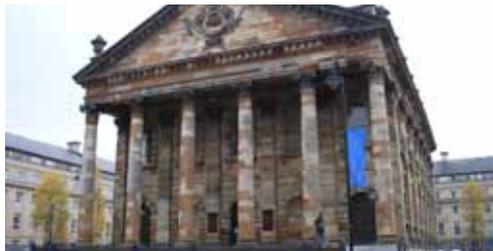
Fig 15 Poor repairs and inappropriate cleaning can severely reduce the visual appeal of a building.

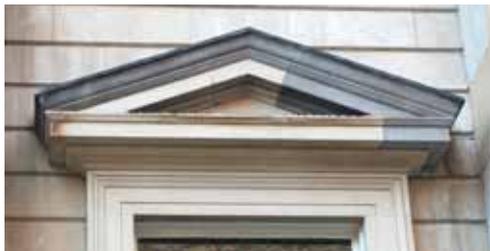
Fig 16 This window pediment was repaired using a dark coloured sandstone to match the soiled building façade, prior to cleaning which has then lightened the adjacent masonry.

Additionally, cleaning a masonry building where stone repairs have been made in the past may have unforeseen results. For example, repairs made to match soiled masonry can, after cleaning, appear unsightly as colours may not match and remedial work may be required (Fig 16).

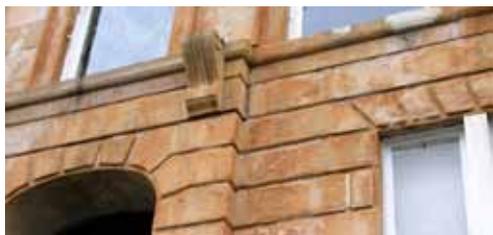
Fig 17 Severely damaged stone façade following inappropriate cleaning, resulting in a loss of the external patination layer, discolouration from oxidation and increased deterioration.

Aged masonry surfaces can develop stable patinas, which help protect the stone from weathering and decay. Stone cleaning may remove the surface patina resulting in a changed texture with increased surface area, leaving the stone more susceptible to soiling and decay (Fig 17, 18). Originally smooth finishes may become roughened or show an undulating surface, whilst textured stones may experience the opposite, losing detail and appearing flat (Fig 19). Brick masonry when cleaned may lose its vitrified surface (fire skin), leaving the material vulnerable to moisture penetration and consequent decay.

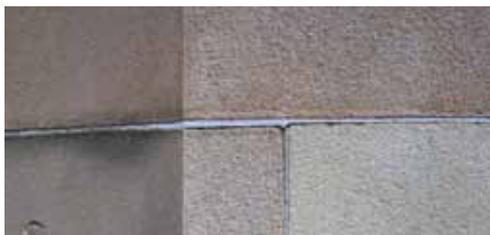
Fig 18 Original soiled (left) and cleaned (right) sandstone masonry showing loss of the original smooth surface, resulting in a roughened texture which may be prone to resoiling and decay.

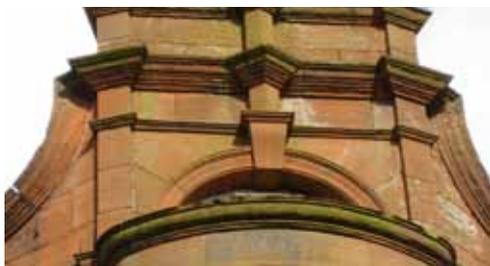
Fig 20 Recently cleaned sandstone building showing relatively rapid recolonisation and biological soiling.

It is unrealistic to expect a building to maintain a freshly cleaned appearance. Biological growth is known to quickly re-establish and may even be intensified on newly cleaned buildings. Additionally, new soiling cycles may exhibit different patterns and colours as the stone surface has been altered by cleaning (Fig 20).
