Short Guide

HISTORIC CONCRETE IN SCOTLAND PART 2: INVESTIGATION AND ASSESSMENT OF DEFECTS

Published by Historic Scotland, March 2014

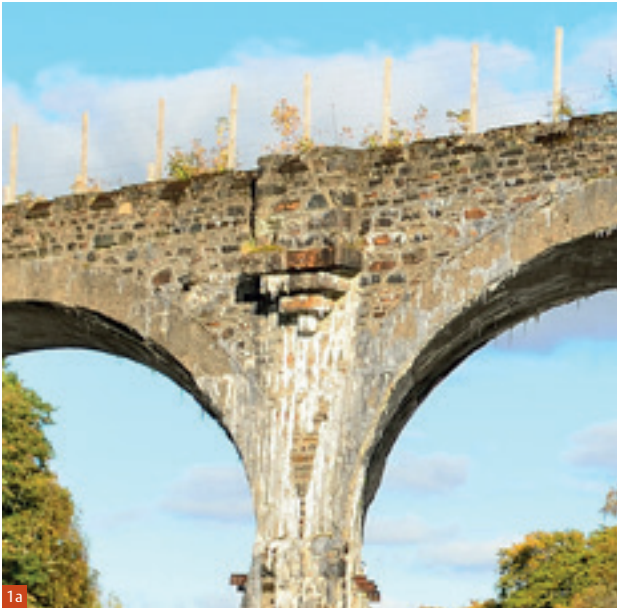
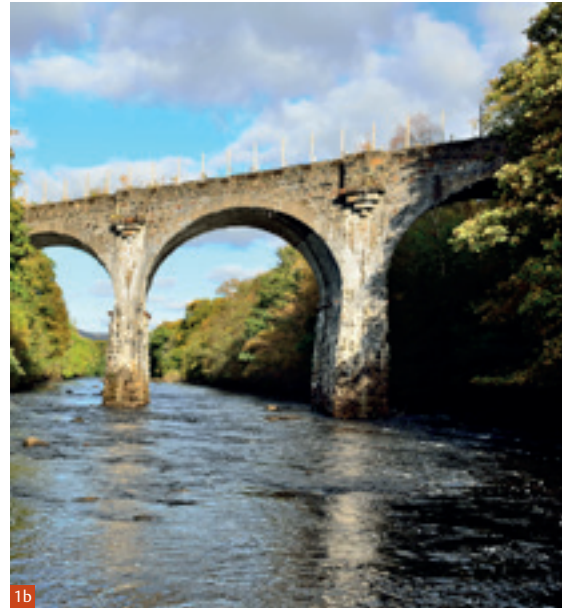
Fig.1a and Fig.1b Dochart Viaduct 1885-6, second oldest mass concrete viaduct in Britain (Category A-listed), © John Gray.

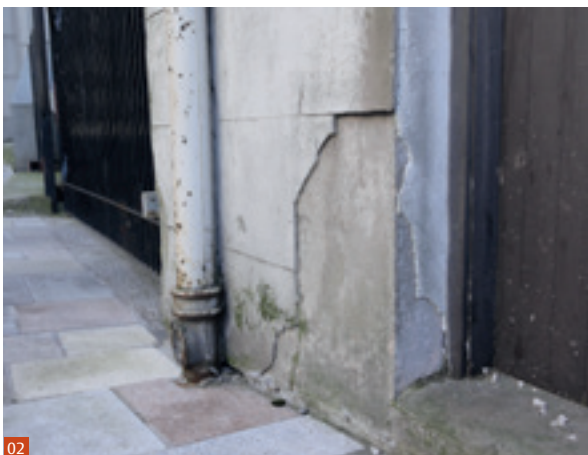
Fig.2 Shuttered mass concrete wall with an applied smooth cement finish on a theatre building, constructed in 1872 (Category A-listed).

When a smooth surface finish was required a more cement-rich mortar coat was applied to the exposed face of the base concrete, after the shuttering (formwork) was removed but before the concrete had gained full strength (Gaudette and Slaton, 2006). Early precast concrete and, indeed, more modern precast units were often produced in this way. The cement-rich outer layer produced a smooth surface which was also used to provide an increased water-resisting layer. With the passage of time, surface weathering and surface cracking can permit moisture penetration resulting in de-bonding between the facing mortar and the backing concrete. This process can proceed rapidly as the cement-rich layer breaks down. Sometimes a cement-rich coat was applied to the backing concrete after it had dried substantially, and in such cases de-bonding is also liable to occur (Fig. 2).

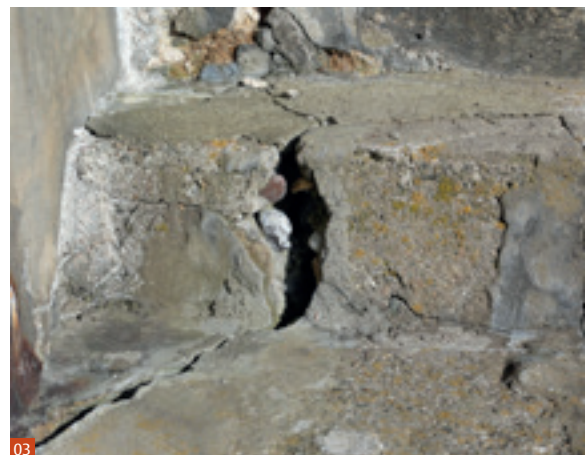
Fig. 3 The wall is poorly graded with large stones.

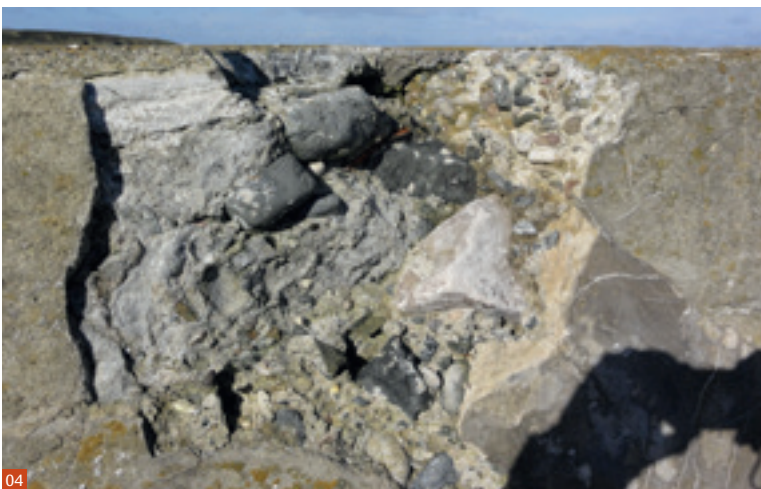
Fig. 4 Concrete harbour wall constructed from locally available aggregate, built c.1890.

Fig. 4 shows an area of disintegrated concrete on a harbour wall from c.1890. It illustrates the nature of the aggregate, which is of local origin, poorly graded with large stones (up to approximately 100mm) and possibly hand-compacted into the formwork. The precast concrete in Fig. 5 contains beach shingle aggregate which has been exposed because the cement binder has been eroded from the face of the block, most likely due to the inclusion of marine salts (chlorides) within the mix.

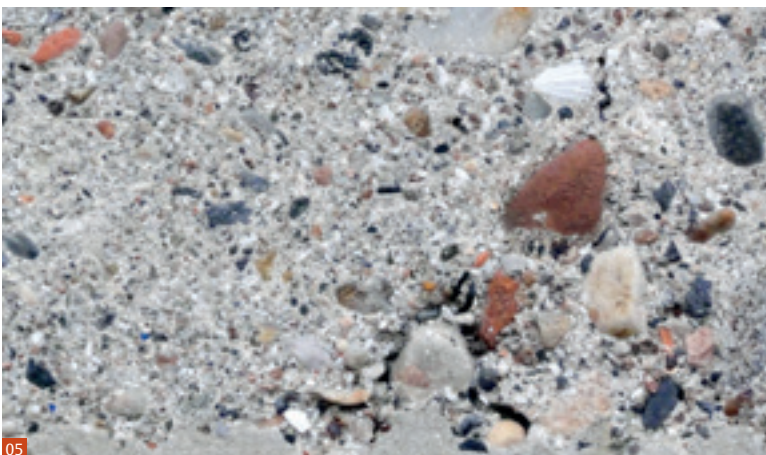
Fig. 5 The exposed aggregate in a precast concrete dressing. The aggregate is beach shingle with shell fragments, built c.1900.

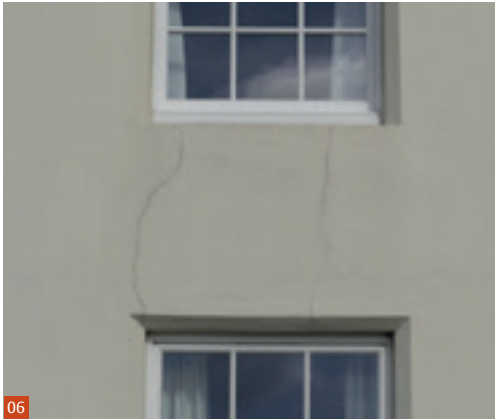
Fig. 6 Shrinkage cracks in a mass concrete wall, built c. 1880.

The main issue with respect to historic concrete is whether the exposed cracks allow ingress of moisture to accelerate the gradual breakdown of the exposed surface, corrosion of the reinforcement or lime leaching. The cracks shown in Fig. 6 and Fig. 7 are typical, often occurring at points of weakness such as openings.

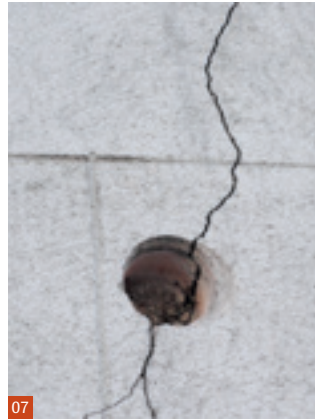
Fig. 7 The core removed from this mass concrete wall shows the crack penetrating through both the cement render and underlying concrete. Building constructed 1872 (Category A-listed building).

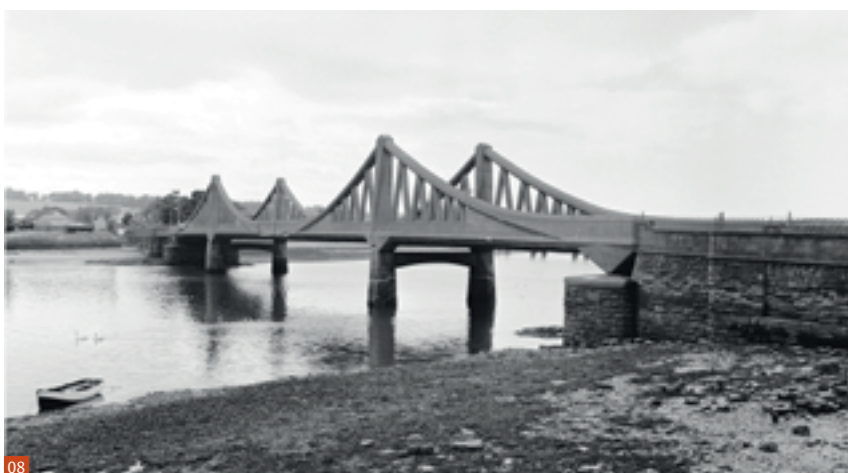
Fig. 8 Montrose Bridge, reinforced concrete cantilever construction. An unusual design for concrete construction (now demolished). SC 519533 © RCAHMS (Reproduced Courtesy of John R Hume). Licensor www.rcahms.gov.uk

ASR was not identified until the 1940s in the USA, with the first recorded case in the UK in 1971. The best known ASR problem in Scotland was the Montrose Bridge (Fig. 8), built c.1930, which was around 75 years old at the time of its demolition in 2004 (Doran, 2001). Defects due to ASR are unlikely to be a serious problem in existing Scottish historic structures given the elapsed time and the limited sources of reactive aggregates.

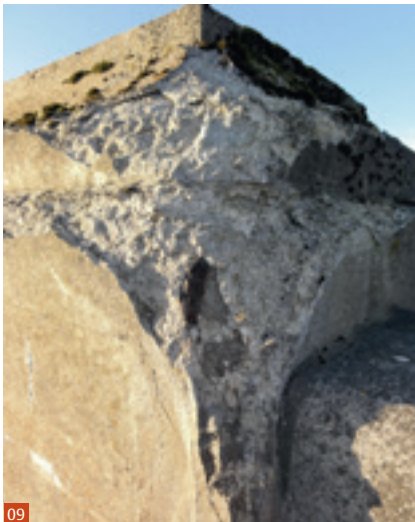
Fig. 9 Salt-induced deterioration of concrete on a reinforced concrete bridge, built c. 1930s.

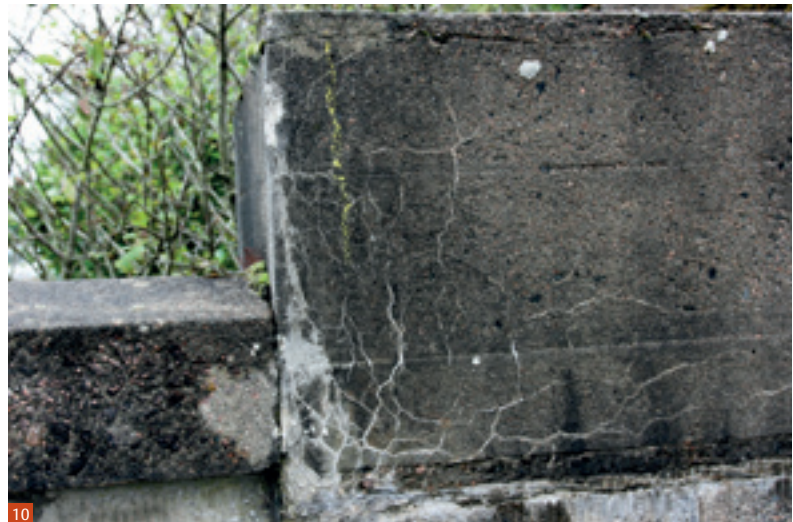
Fig. 10 Concrete deterioration as a result of chloride attack, bridge built c. 1937 (Category B-listed).

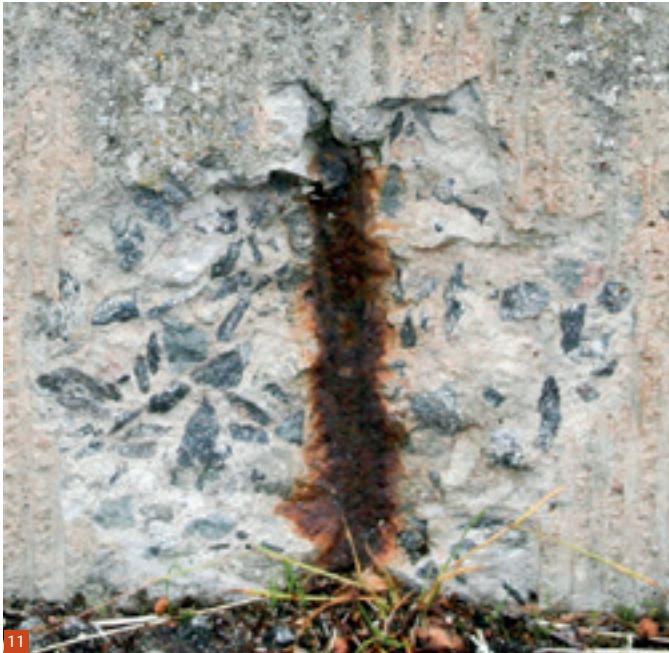
Fig. 11 Inadequate cover to the steel reinforcement has resulted in corrosion and spalling of the concrete.

The concrete deterioration shown in Fig. 11 is relatively recent and is likely to become a significant problem for the structure as there is evidence of spalling, indicating that steel reinforcement corrosion is developing rapidly. Fig. 12 shows cracking occurring due to reinforcement corrosion. Many of the historic reinforced concrete structures in Scotland are exposed to extreme or very severe environments. Nowadays, for new construction in such environments increased concrete cover is required as set out in *BS EN 1992-2:2005* (British Standards Institute, 2005). The current minimum requirements for concrete cover to reinforcement are contained within *BS EN 1992-1-1:2004* (British Standards Institute, 2004).

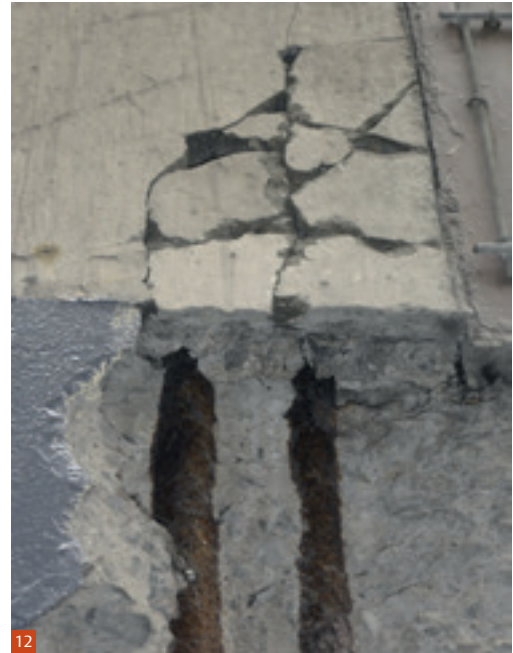
Fig. 12 Reinforcement corrosion, Lion Chambers, Hope Street, Glasgow, 1905 (Category A-listed).

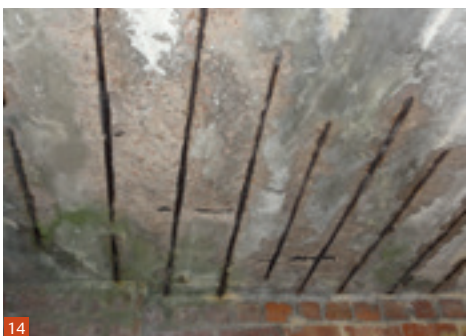
Fig. 14 Carbonation combined with lack of cover has led to subsequent reinforcement corrosion on this floor slab.

With the passage of time the depth of the carbonation and the permeability of the concrete increases. These processes affect the durability of the concrete covering the reinforcement. In the case of historic concrete, carbonation-exacerbated corrosion will become more prevalent as the concrete ages (Fig. 14).
