INFORM

STRUCTURAL CRACKS

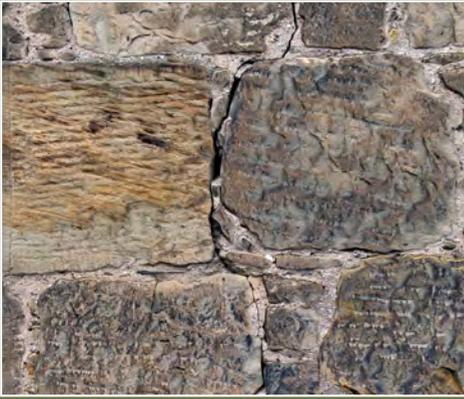
Fig. 1: A typical crack in a traditional stone wall.

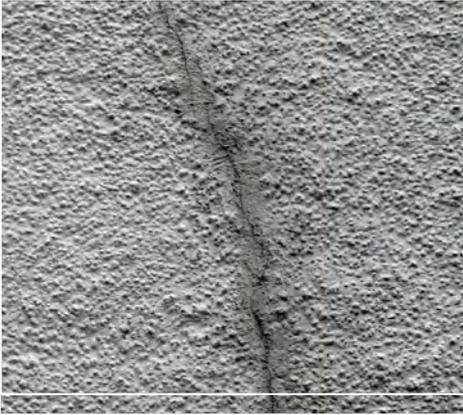
Fig. 2: A hairline crack on a rendered wall.

1. Negligible (Fig. 2). It can be generally assumed that hairline cracks with a dimension of less than a millimetre in width are of little concern, apart from the visual effects. Redecoration may be all that is required.

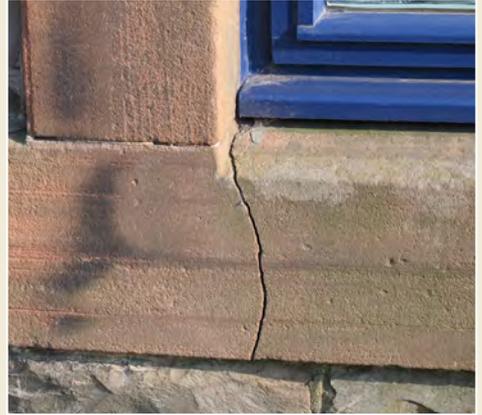
Fig. 3: A thin crack on a window cill.

2. Slight (Fig. 3). Over a period of time, if the structural movement has stopped, stabilised cracks that are between 1mm and 5mm in width can normally be dealt with through filling the open voids and carrying out redecoration on the interior and repointing the affected area on the exterior of the building.

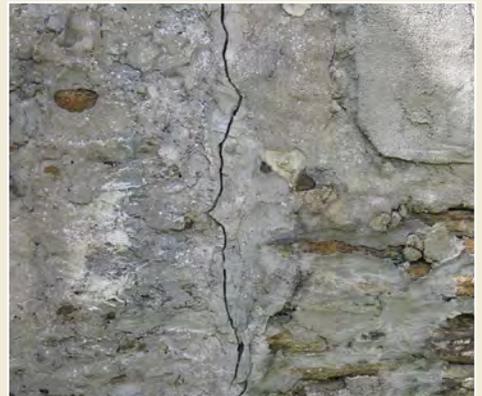
Fig 4: A medium sized crack on a stone wall. This will need remedial work.

3. Moderate (Fig. 4). Extending in a range of between 5mm and 15mm in width, moderate cracks will generally require some construction work to remedy. The related circumstances could also require the involvement of a professional to establish the cause of the cracks and to help identify the associated remedial work that needs to be carried out. In this width range, associated problems are also likely to emerge requiring localised replacement of fractured building fabric such as window sills,

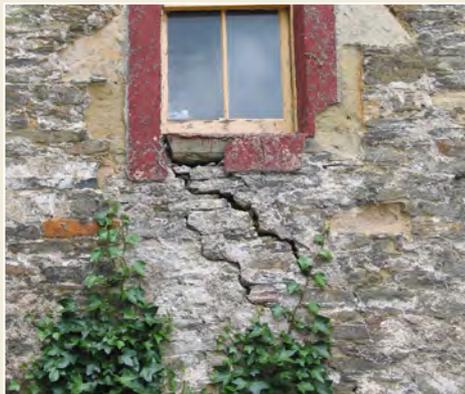
Fig. 5: A severe crack, requiring professional advice and stabilisation.

4. Severe (Fig. 5). Cracks extending in width up to 25mm usually indicate that extensive structural repair works will be required. Cracks of this dimension can also be accompanied by a variety of lesser cracks and may involve the door lintels, etc. Work may also be required to remedy any associated concerns regarding the weather tightness of the building. This may have been compromised through disturbance to roof coverings or rainwater goods as a result of structural movement.

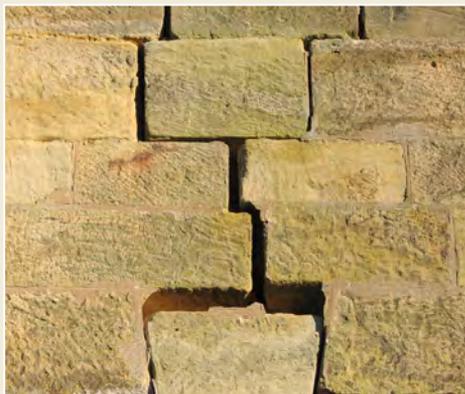
Fig. 6: Very severe structural movement, requiring temporary support work.

5. Very severe (Fig. 6). Cracks in excess of 25mm in width will generally indicate very severe structural damage. This will normally require major repair works that could well involve the partial or complete rebuilding of the affected area. Structural underpinning may also be necessary due to the danger of associated collapse and instability. Obtaining early professional advice will be essential in addressing the associated issues. The installation of interim temporary support work will most likely be necessary until the remedial works are carried out.

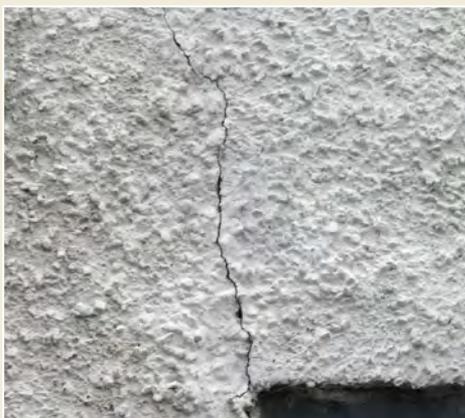
Fig. 7: A fine hairline crack on a rendered façade, possibly caused by normal seasonal expansion and compression of the building materials

Fine hairline cracks running across the face of a wall could indicate that a degree of shrinkage or settlement has occurred in the fabric (Fig. 7). As most pre-1919 buildings use lime mortar, the structure can readily accommodate such fine defects without undue concern. Indeed, hairline cracks may be seasonally driven, appearing and disappearing dependent on the prevailing conditions. Modern cement-based renders are more prone to cracking as they have less flexibility than lime-based wall coverings.

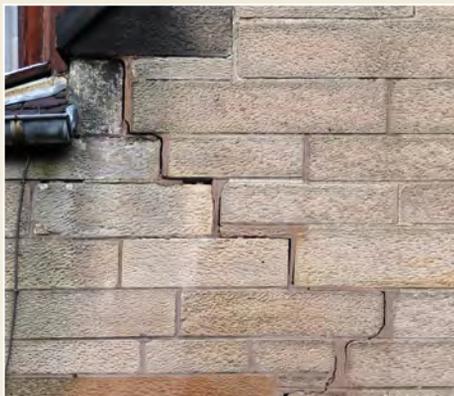
Fig. 8: A stepped crack running diagonally.

A diagonally running stepped crack, with the appearance likened to that of a stair when viewed edge on (Fig. 8), can indicate that structural settlement is happening. This could be due to upheaval at foundation level or some other form of slippage. Usually starting off as a hairline, this pattern of crack tends to follow the alignments of the horizontal beds and vertical joints in the built structure. If settlement continues, the crack can consequently grow in width and individual stones or bricks can become loose and dislodged. The advice of a professional should be sought at an early stage.

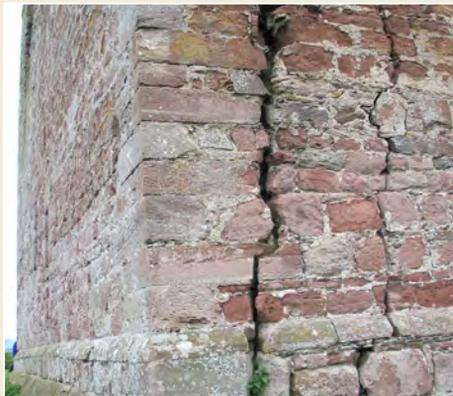
Fig. 9: A vertical crack running through both, mortar joints and stones.

Vertical, or near vertical, cracks can also be a sign of serious structural problems (Fig. 9). If the cracks are wide at the top and tight at the bottom this can mean that one or both ends of the building foundation are dropping, or that the middle of the foundation is rising. Vertical cracks also usually mean that the stresses have been sufficiently severe to crack individual stones or bricks in the wall, making the broken pieces also unsafe. If the cracks are wider at the bottom and tighter at the top, then the opposite effects could be occurring.

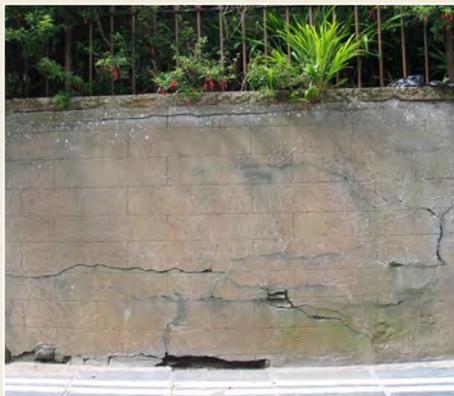
Fig. 10: Cracks indicating outward pressure at the foot of the retaining wall, probably due to moisture retention behind the cement render.

Retaining walls are often under additional pressure from the material held back. Excessive moisture held back by harder modern mortars can exacerbate the issues by making the earth less stable. In Figure 10, the pressure is showing by distorting the masonry outwards along the mortar beds. In this case, consideration should be given to removal of the render coat, repointing, and the provision of weep holes at the base of the wall.

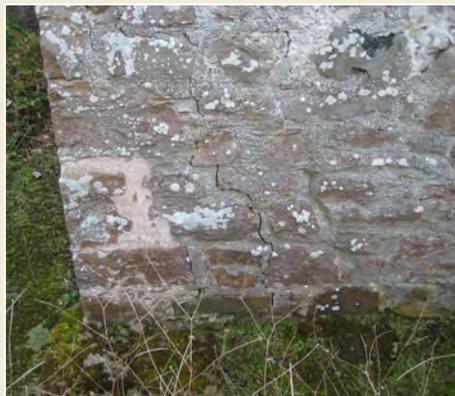
Fig. 11: Cracks due to softer ground on a damp corner.

In some buildings, it is common to see settlement of corners, particularly gable ends where leeching of mortar has occurred on the quoins. In addition, corners can settle if the foundations are wet and the surrounding soil has become softer or has been washed out (Fig 11).

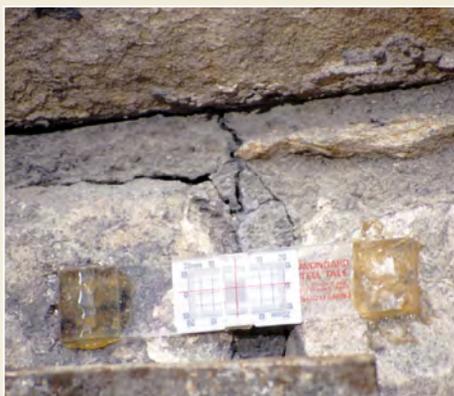
Fig. 12: A tell-tale installed over a crack.

As most cracks develop slowly, it is often good practice to set up a monitoring regime to check for further movement. Basic do-it-yourself methods of monitoring may be useful but are unlikely to be accurate enough to give detailed results when compared to the more professional options, which a structural engineer or surveyor will put in place. This can be achieved with proprietary “tell-tales” (Fig. 12) or the taking and recording of regular micrometer readings across the crack (Fig. 13).

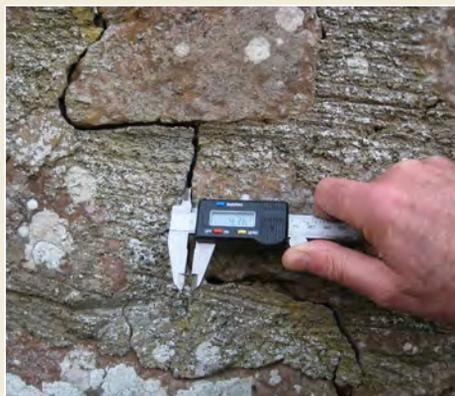
Fig. 13: Using a micrometer to monitor a crack.
