## 11 Annat Road, Perthshire

Thermal improvements to an interwar period cottage.

This publication should be quoted as:  
Historic Scotland Refurbishment Case Study 20

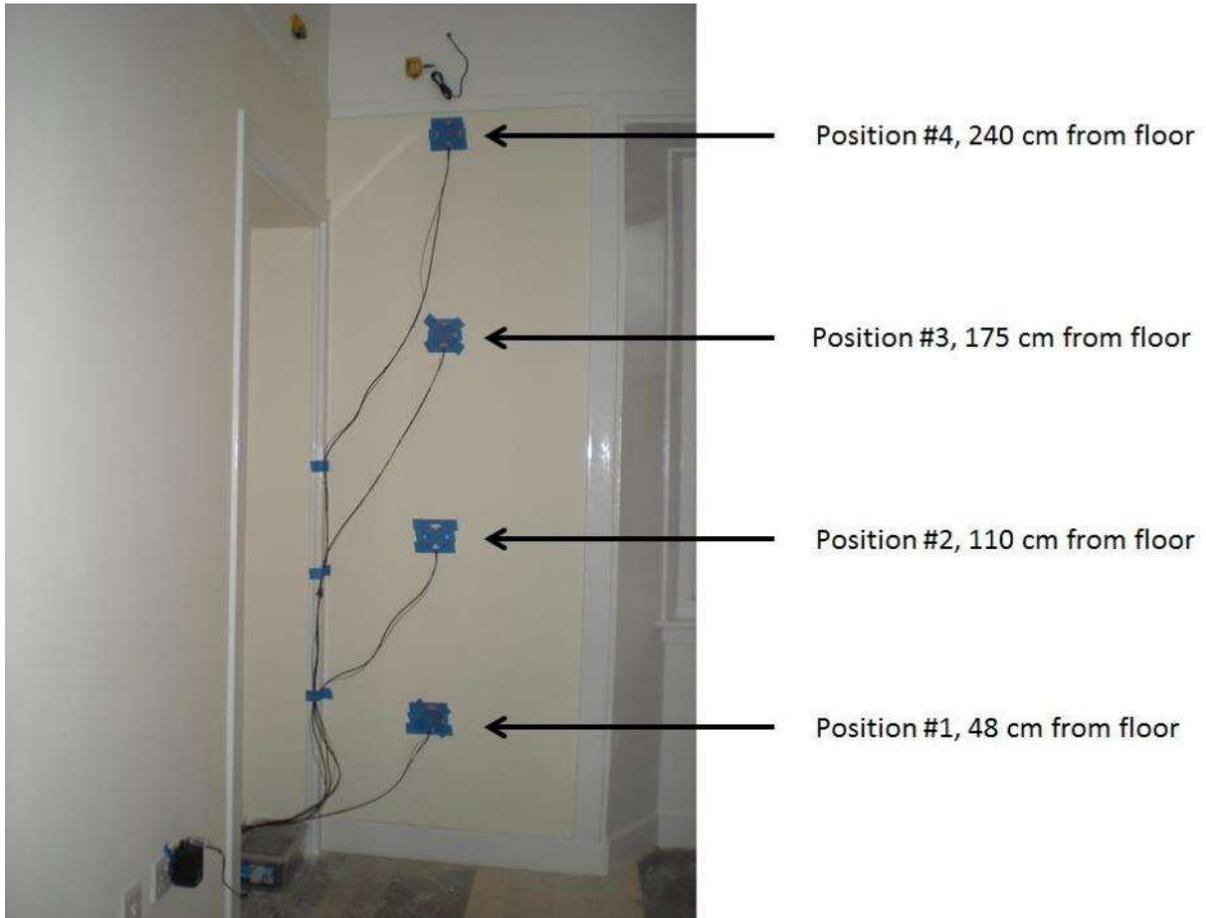
With the work complete in February 2015, there was time to conduct limited heat flux measurements in the finished building. To obtain an average value, four heat flux plates were mounted on the wall in bedroom 1 (Fig. 10). The measurements were then compared with those taken in the Autumn, and also from a similar property close by. The U-values showed good improvement in all areas. This monitoring will have to be conducted over a three year period to fully assess the effects of the wall insulation. Table 2 shows these initial results.

Figure 10: The heat flux plates used to assess *u*-values in position
