Trial Church Heating: Radiant Panels and Air Source Heat Pump at Kilmelford Church

This publication should be quoted as:
Historic Environment Scotland
Refurbishment Case Study 19

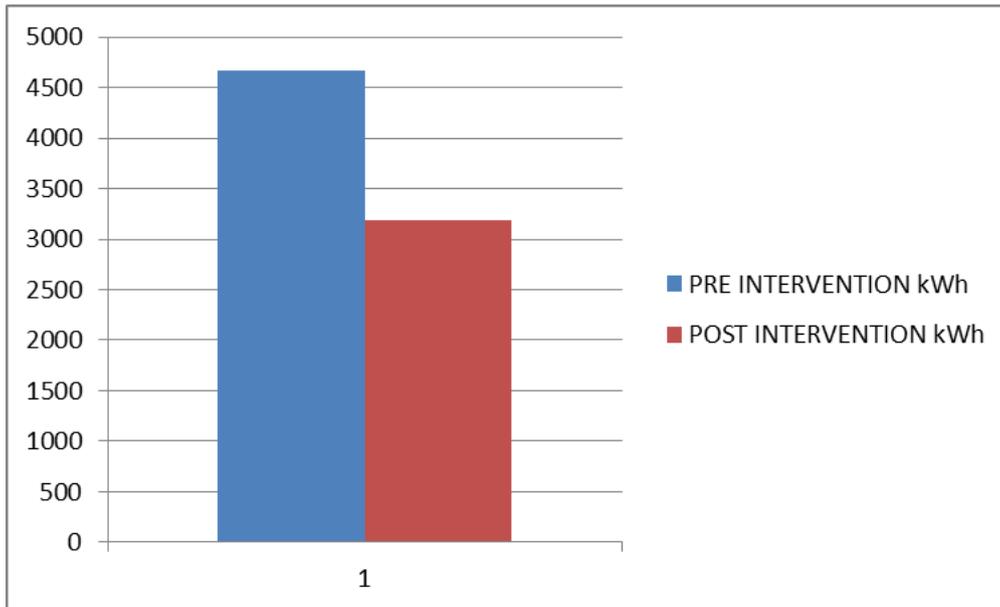
Fig. 9: Graph showing the pre- and post-intervention energy consumption

Figure 9 shows that following the intervention, the energy usage of the church has reduced. In the four years before the intervention, energy usage was on average 4674.25 kWh per year, and in the year following the intervention, energy usage was 3185 kWh per year. While more data is required for accurate assessment, initial indications are that the new heating regime has resulted in a saving of approximately £250 per year, whilst also delivering improved thermal comfort and heating to the building fabric.

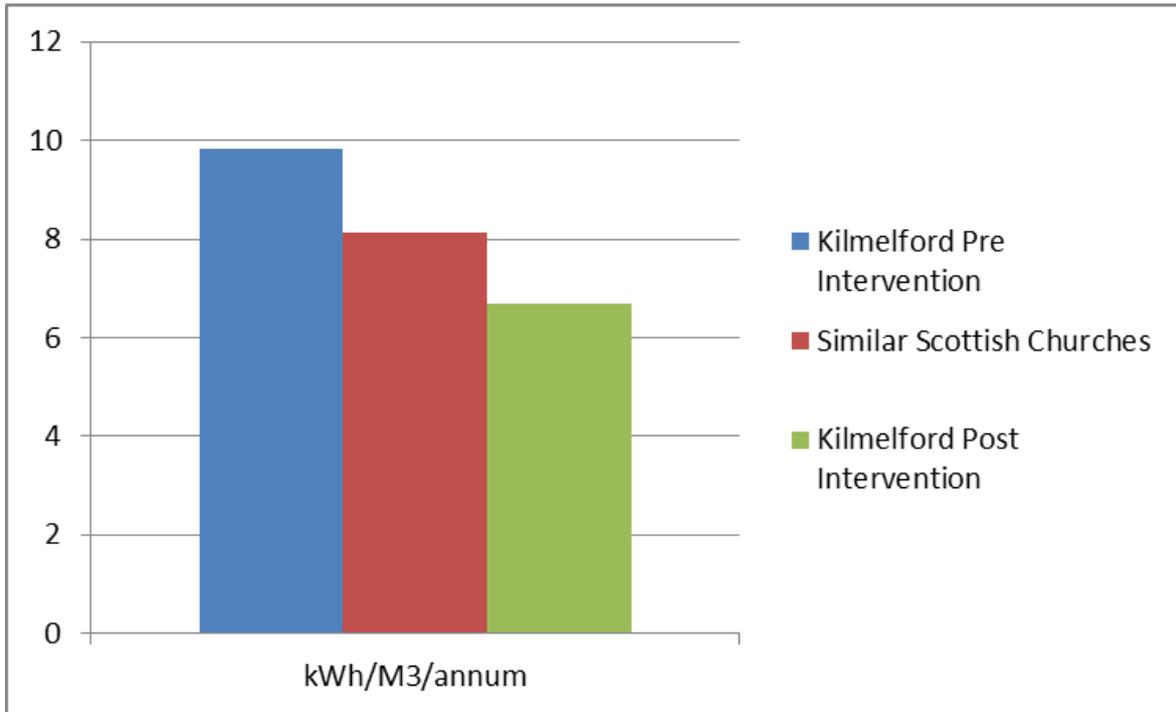
Fig. 10: Graph showing Kilmelford Church's pre- and post-intervention energy consumption compared with similar Scottish churches

Compared with the average energy consumption for 16 similar Scottish churches, the post-intervention energy consumption for Kilmelford Church was considerably lower (Fig 10).
