# INFORM

INFORMATION FOR HISTORIC BUILDING OWNERS

## Repairing Traditional Brickwork

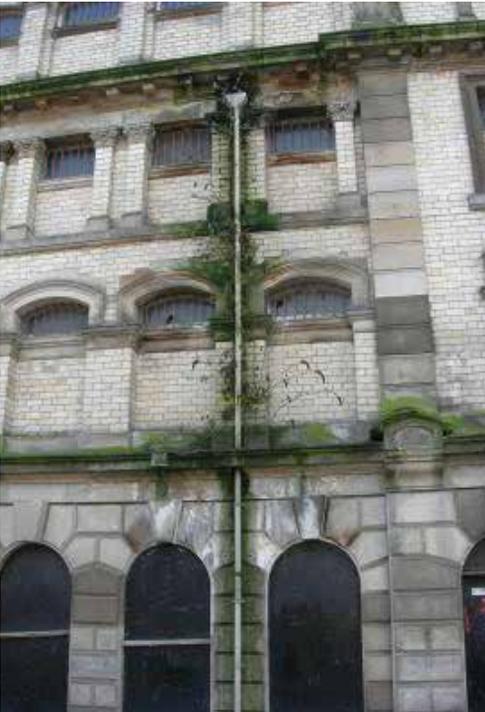
**Fig. 2** Water ingress from sources such as blocked gutters or downpipes is a major cause of deterioration of brickwork.

One of the most common and serious problems which can affect brickwork is uncontrolled water ingress. This can be a problem on exposed areas of a building such as upper floors and chimney stacks and in the vicinity of leaking gutters and downpipes. Other areas at particular risk are parapets, chimneys and quoins (brickwork on the corner of a building). Once water has begun to penetrate brickwork it can quickly spread to affect a large area. Causes of water penetration and associated deterioration can include failure of roof systems including copings and flashings, blocked or damaged rainwater goods, infiltration through failed mortar, inadequate surface drainage and windblown rain.

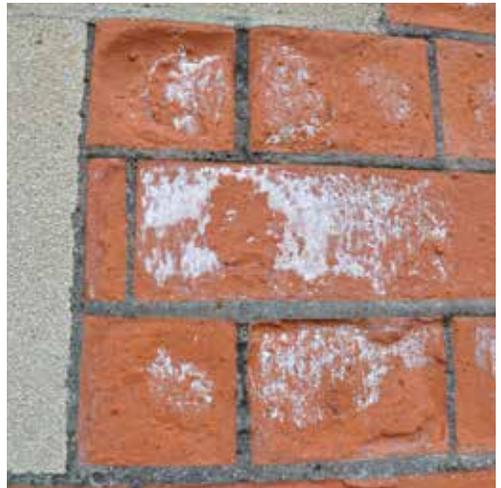
**Fig. 3** The presence of salts within brickwork is most commonly seen by a white residue on the surface of the brick.

Salts can be a major cause of deterioration in brickwork. Salt can enter bricks through water ingress. In coastal areas salt can come from the sea and, in winter, the application of road salt is a threat. Salt is damaging because it creates expansion of crystals within bricks. This can eventually force the structure of the brick apart. Salts can come from within the bricks themselves or from the application of inappropriate mortars or renders. Brick-lined chimney flues are also vulnerable as sulphates can be introduced when flue gases condense. This is a common problem where a chimney has been sealed without adequate ventilation. The most obvious sign of the presence of salts is efflorescence, a white powdery deposit on the brick. In severe cases a thick build up of white crystals can form. Efflorescence can also be caused by the improper use of cement mortars during repair. To prevent significant deposits of efflorescence from causing damage to bricks it should be regularly brushed off the surface using a non-ferrous bristle brush and the source of water causing the build up of the deposits rectified.

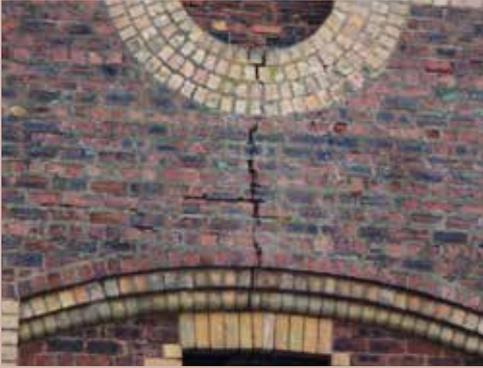
**Fig. 4** Cracking is the most common sign of structural problems. A careful assessment of the cause and likelihood of further movement should be made in such circumstances.

The most common sign of a structural fault in brickwork is cracking. This can be caused by structural movement, unstable foundations, or defects in the original construction. Minor cracking will be superficial and restricted to a few isolated bricks but extensive cracking can be an indication of a more serious problem. Professional advice should be sought where structural movement is thought to be ongoing.

In minor cases of cracking it will be necessary to carefully cut out the affected bricks and mortar joints. Fractured bricks should be replaced (as described later in this guide) with joints being repointed in an appropriate mortar. Where bricks are displaced due to structural movement particular note should be taken of any areas where the wall face projects outwards. This will usually indicate the presence of some structural movement and lead to the creation of ledges on which water can gather and penetrate into the building.

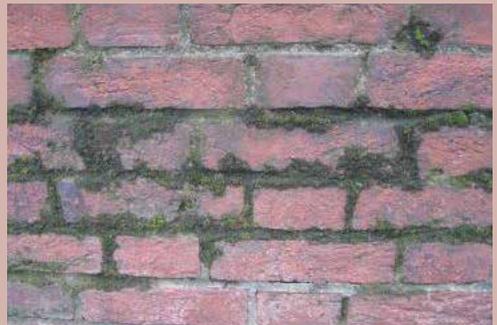
**Fig. 5** The presence of biological growth on brickwork is generally an indication of excess moisture from a building defect.

Vegetation can be very harmful to brick structures if left unattended. Ivy can cause serious damage particularly where some minor decay is already in evidence. This allows growth to gain a foothold on the surface of the brickwork and penetrate into the wall core. Moss or lichen is likely to be a sign of a long standing water penetration problem and will damage bricks further by encouraging more water to penetrate the wall.

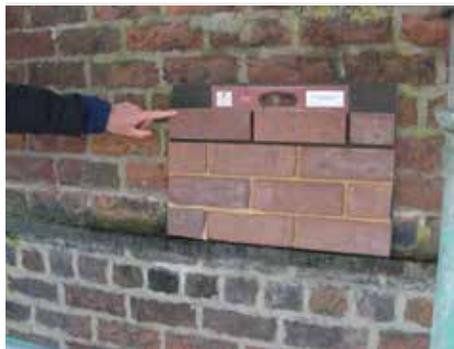
*Fig. 7 Replacement bricks should match those in situ as closely as possible, samples of bricks should be checked to gauge their suitability for a repair project.*

Replacement bricks should match as closely as possible the type, colour, texture, size and shape of those which they are replacing.

It is also important to use bricks of sufficient durability; for modern bricks this is likely to be those with an F2 rating for frost resistance and an S2 rating for soluble salts using the new European Standard. In some cases replacement bricks may require to be specially manufactured in order to match those they are replacing; a number of companies offer a brick matching service. When introducing new bricks it is not advisable to use a colour stain to tone them in with the existing wall; the weather will do this over time and colour staining can introduce harmful agents to the brickwork. Second-hand bricks may be available through salvage yards and other building material suppliers. Careful inspection of these is necessary in order to ensure they have not been damaged by demolition or mishandling.

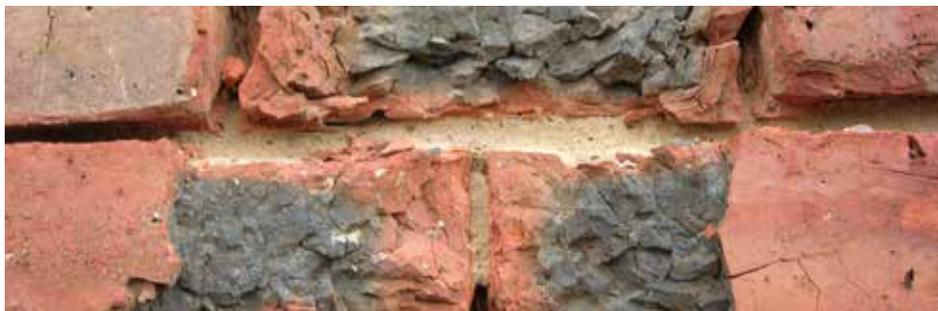
*Fig. 6 Where bricks have spalled, cutting out and replacement will often be the most appropriate repair technique.*

In some cases it may be necessary to replace single bricks or small areas of brickwork, particularly where spalling has occurred. Care should be taken when cutting out the affected bricks not to cause new damage to the surrounding area. Only bricks which have suffered decay should be replaced and a thorough survey of a wall should be carried out to identify which are sound and which need to be removed.

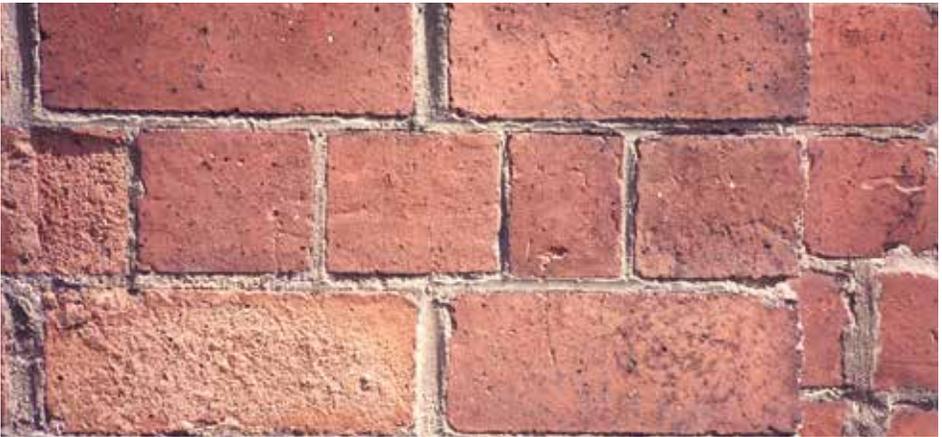
*Fig. 8A Brick before cleaning.*

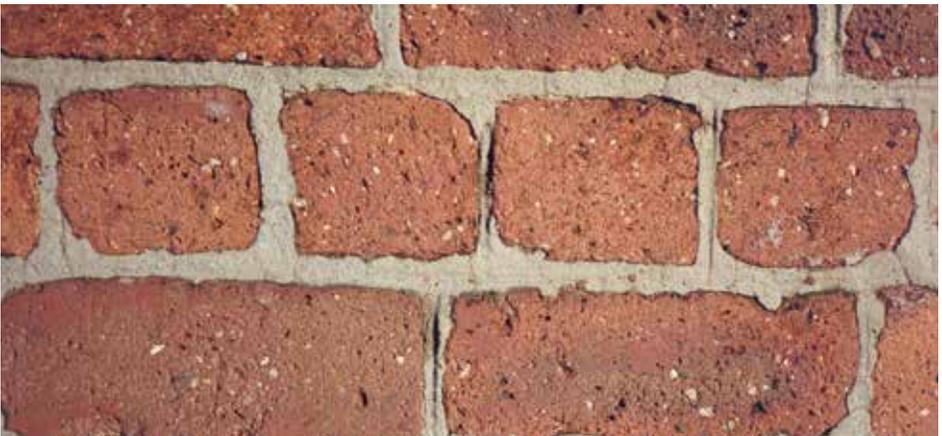
*Fig. 8B Brick after cleaning showing the potential damaging effects of abrasive cleaning methods. Note the loss of the protective external surface making the bricks more prone to decay.*

a non-ferrous bristle brush to remove some surface deposits but care should be taken to avoid exposing the brickwork to excess water. To avoid penetration into the brick, care should also be taken not to be too vigorous in scrubbing the face. The use of high pressure hoses is also not recommended, as this will force water deep into the structure. Other methods using chemicals or mechanical means should only be used where absolutely necessary following thorough assessment of the affect the cleaning method has on test panels.

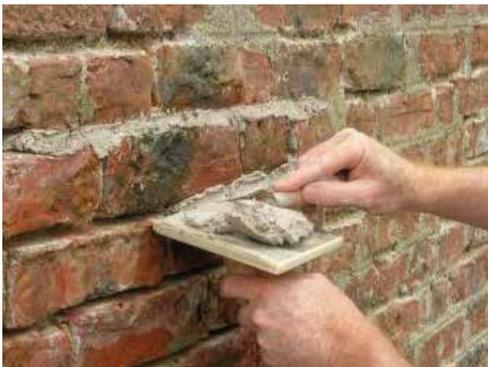
*Fig. 9 Joints should be well raked out and dampened before re-pointing work takes place.*

Throughout the life of a brick building there will always be some loss of the original mortar. This can lead to a need to repoint areas of brickwork, although weathered pointing can still function adequately provided the joints are not allowing the ingress of excess moisture. Where re-pointing is necessary the raking out of the old mortar should be carefully carried out in order to avoid damage to bricks. The joints between bricks should be raked out to a depth at least two and half times their height i.e. if a joint is 10mm in height it should be raked back at least 25mm or until sound mortar is reached. The raked out joints should then be brushed clean and well dampened down prior to new mortar being inserted. The after care of re-pointing work is also important and it should be protected from excess moisture, frost and too rapid drying.

For traditional brickwork the most appropriate repair mortar will generally be lime based. Modern cement mortar should not be used as a replacement for lime mortar as this removes the ability of the wall to allow moisture to be released. Whenever re-pointing is being undertaken it is important to use a matching mortar type to that used originally which may require the use of mortar analysis.
