# INFORM

INFORMATION FOR HISTORIC BUILDING OWNERS

## Bronze

The care and  
maintenance of  
monumental bronze

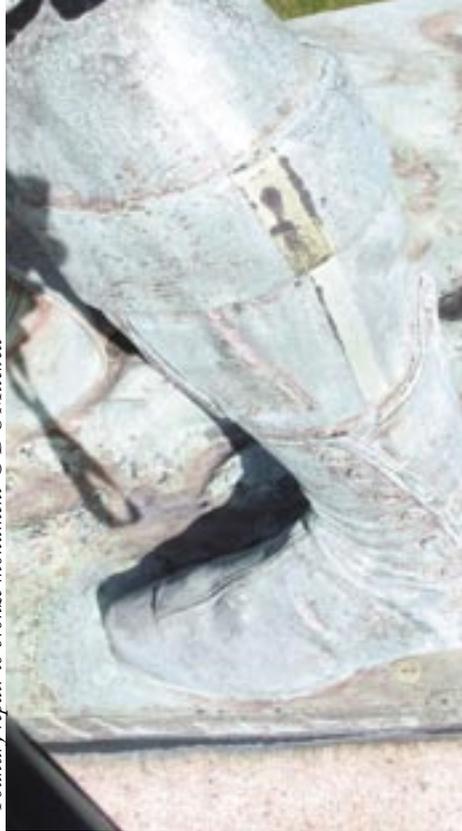
*Foundry repair to bronze monument © D S Mitchell*

Following the casting of a bronze, minor defects in the casting are repaired in the foundry, or detail chased in by hand. This original work can often be mistaken for subsequent repairs. Examples include small patches, 'stitch'-type repairs using bronze rods or larger

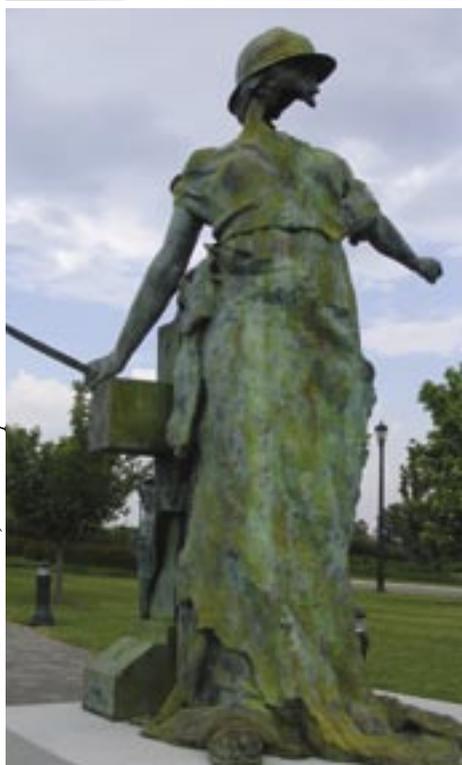
*Artistic Bronze Patination, Chemical patination © D S Mitchell*

Patination is a change to the surface colouration of the bronze, caused by the natural reaction of the bronze to chemicals in the environment, corrosion, or applied in the foundry using chemical means. 'Artistic' bronzes often vary in patination from those used in a commemorative context that were often patinated to a brown-black lustre. The patination is much more than a simple colouration of the surface. The sculptor may have intended to create a patination which varied across the metal surface, to accentuate features or to create optical highlights. On completion, the surface of the bronze would be heated to a high temperature. Traditionally, beeswax was then applied. Contemporary microcrystalline waxes perform the same function but without the chemical disadvantages of beeswax. On commemorative plaques, the raised letters would often be polished to provide a contrasting highlight.

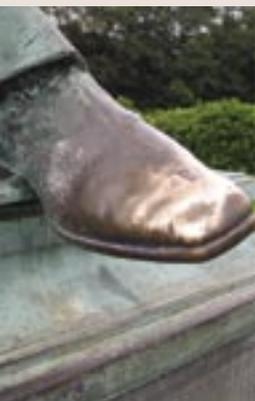
*Patination loss by handling © D S Mitchell*

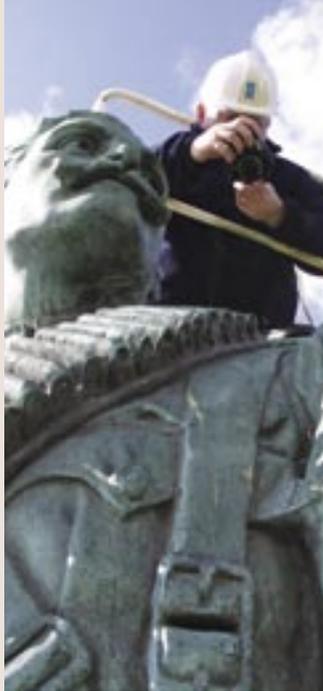
*Inspection using hydraulic platform allows full access © D S Mitchell*

Access to public monuments can often be awkward, and may require 'out-of-hours' work to minimise traffic disruption. Some monuments are accessible by temporary scaffolding or a hydraulic platform. Care should be taken at all times to protect the monument from damage.

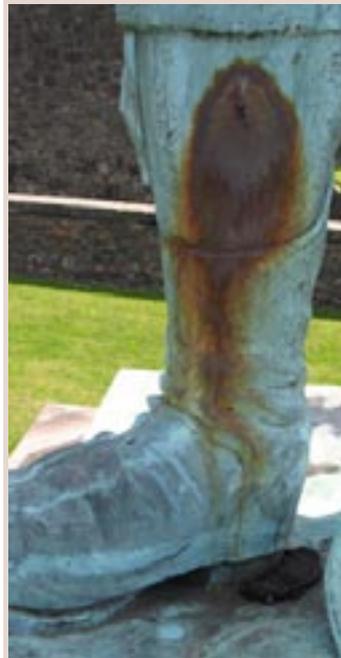
*Wrought iron armature captured in bronze during casting, subsequently corroding © D S Mitchell*

**Structural problems:** Iron armatures (often wrought iron) are commonly to be found within statues, left over from the casting process or left in place to

offer some structural support. Wrought iron expands considerably as it corrodes, which can cause 'corrosion jacking' of the surrounding bronze. Armatures may also have been knocked out of position into the path of the hot bronze during the casting process. Fixings into masonry can be areas for concern, as can the stability of the masonry sub-structure. The advice of a specialist should be sought to determine appropriate repairs.
