INFORMATION FOR HISTORIC BUILDING OWNERS

Biological Growth on Masonry:

Identification &
Understanding

HISTORIC SCOTLAND
ALBA AOSMHOR

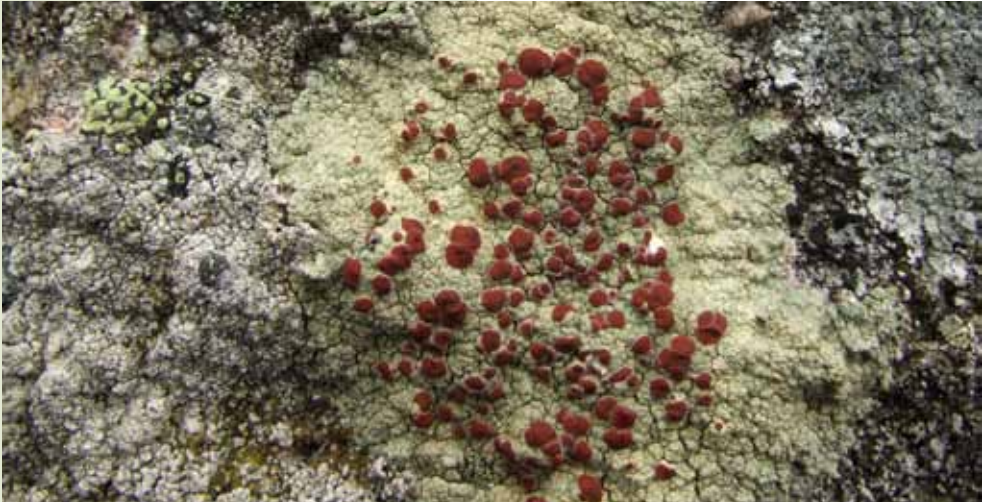
Fig. 1 Grey-green crustose lichen with blood-red fruiting bodies growing on granite in Aberdeenshire.

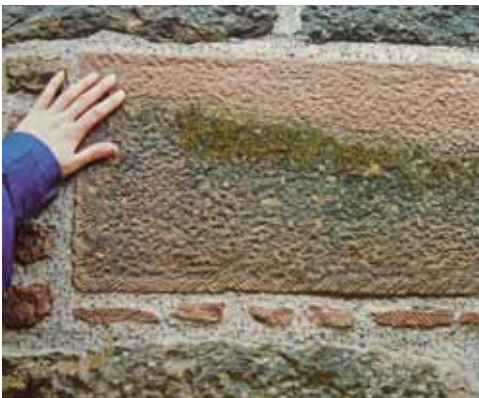
Fig. 2 Inhibited biological growth due to alkaline conditions caused by new mortar.

Fresh mortar is particularly alkaline and may act as a biocide, killing off nearby biological growths (Fig. 2). Over time mortar alkalinity levels decrease to a level that some organisms can tolerate, but as mortar often remains more alkaline and porous than most stone, different species may be found growing on mortar and adjacent masonry.

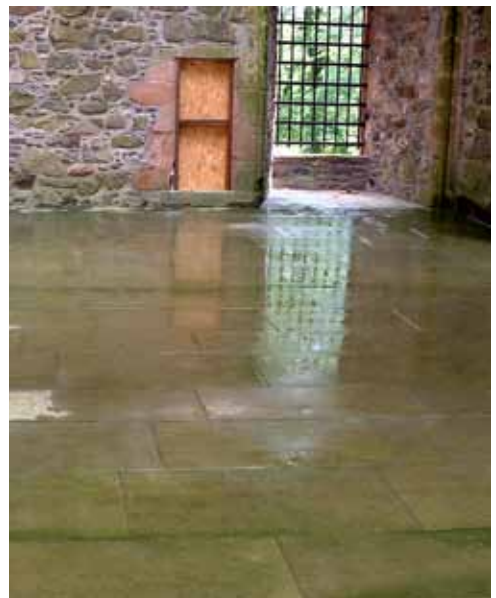
Fig. 3 Slime producing algae may result in slippery surfaces.

In general, algal growth on masonry is superficial and does not penetrate or cause physical damage. However, a thick algal layer located within the joints between stones may create an environment that encourages the establishment of woody plants that may be damaging. Some species of algae produce excessive amounts of slime that may expand and contract upon wetting and drying, which may cause flaking or spalling of a stone surface. These slime layers may also be slippery on paving stones, causing a safety hazard (Fig. 3).

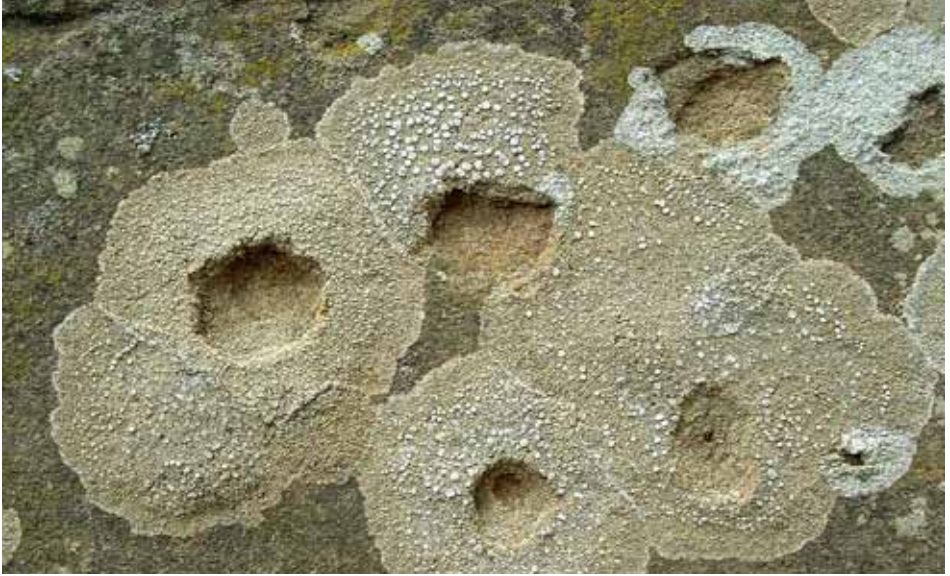
Fig. 4 Rare example of damage to sandstone masonry caused by lichen growth.

Lichens are a symbiotic intergrowth of algae and fungi. Lichens also have hyphae that anchor them to stone surfaces and secrete acid compounds that may dissolve mineral grains. Lichens are slow growing and rarely cause significant damage to masonry. Lichens may provide some protective benefits by both blanketing the stone, as well as interacting with the outer stone surface to reduce moisture ingress. In rare cases, some species may cause bleaching, blistering or pitting of a stone surface (Fig. 4).

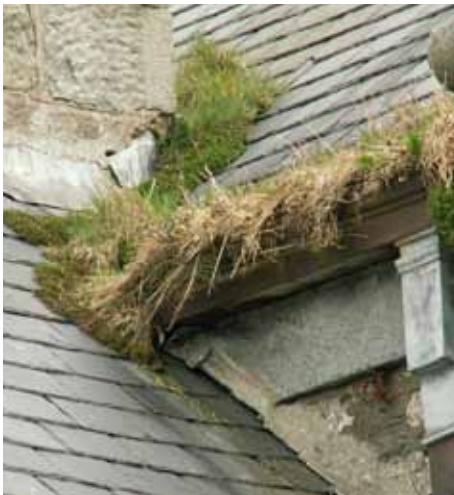
Fig. 5 Guttering clogged by plant growth.

Mosses are simple plants, consisting of a leaf region and a primitive root which attaches to the stone. They occur mostly in cracks and crevices, and on wetted slopes such as roofs. Moss retains water extremely well, and this can keep a masonry surface in a persistently wet state, which exacerbates stone decay. When moss becomes dislodged, it can clog up gutters leading to drainage problems.

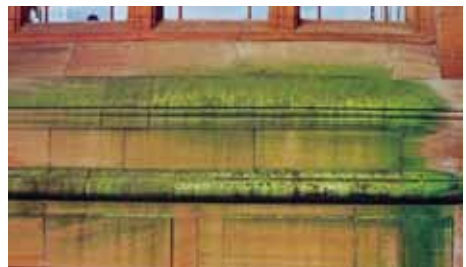
Fig. 6 Rapid re-colonisation by algae of a recently cleaned sandstone building.

Stonecleaning for purely aesthetic reasons is not encouraged, but cleaning may be necessary in order to undertake a conservation survey or to address damage to a building. Consent is normally required to carry out cleaning on listed buildings, scheduled monuments and structures within conservation areas. Any cleaning treatment involves some risk of damage, and the end result may be unpredictable and may not be entirely effective. Whilst stonecleaning may reduce the appearance of surface biological growths, it is unlikely to render the surface uninhabitable. Spores of some species may survive the cleaning process, and re-establishment of organisms on the cleaned stone surface can occur within a matter of months. Re-growth of green algae may even accelerate following cleaning (Fig. 6). Some lichens partially penetrate the stone surface and may leave behind “ring marks” after removal. Stonecleaning is also likely to roughen the surface of stone and increase surface porosity, creating even more favourable conditions for biological growth than before.
